UNITED STATES COAST GUARD

**REPORT OF THE MARINE BOARD OF INVESTIGATION
INTO THE
IMPLOSION OF THE SUBMERSIBLE TITAN
(CG 1788361) IN THE NORTH ATLANTIC OCEAN
NEAR THE WRECK SITE OF THE RMS TITANIC
RESULTING IN THE LOSS OF FIVE LIVES
ON JUNE 18, 2023**

MISLE ACTIVITY NUMBER: 7724663

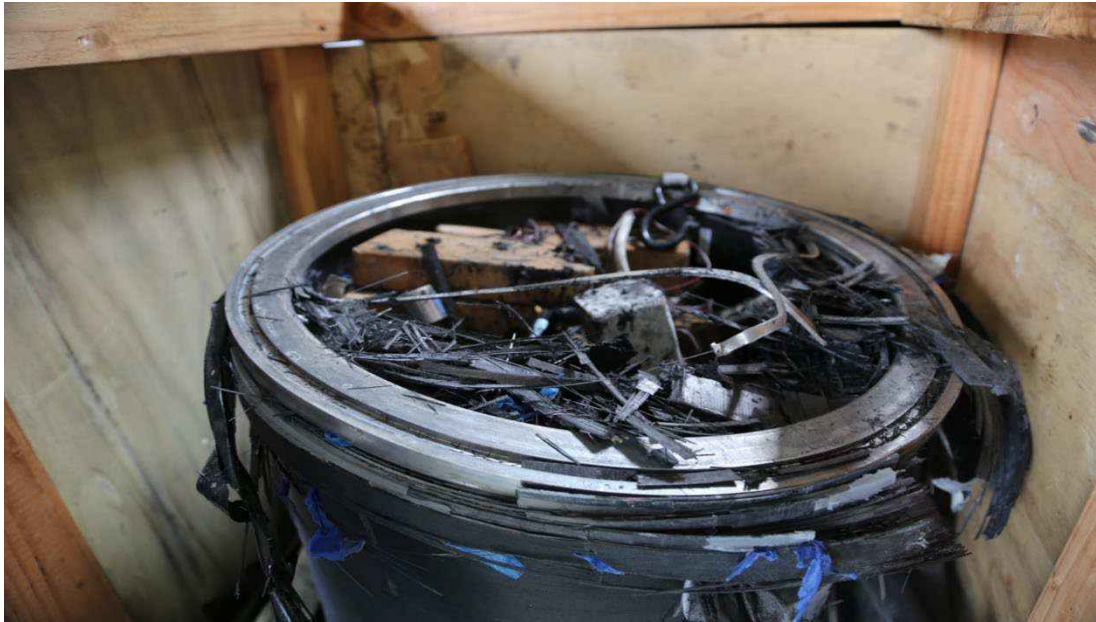
Figure 79: Fourth one-third scale model produced by Spencer Composites post-implosion. Source: OceanGate.

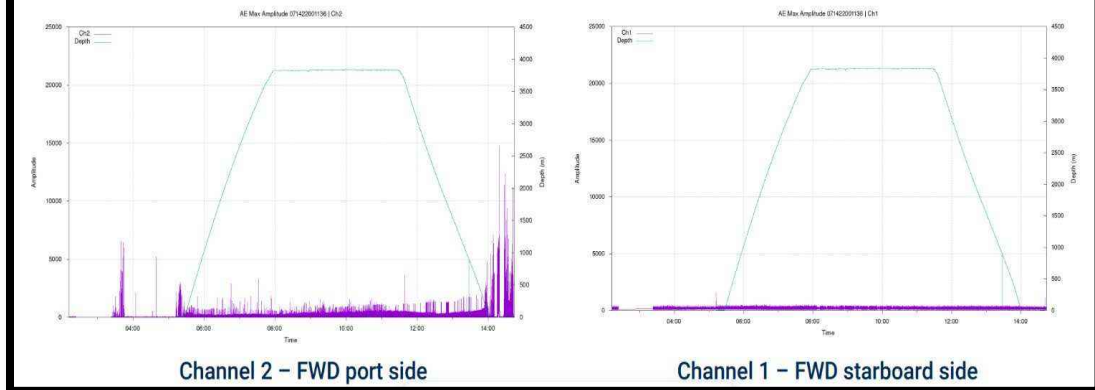
RTM – Acoustic Emission – Dive 76

Figure 106: TITAN Dive 76 acoustic emissions for Channel 1 and Channel 2 showing no acoustic emissions, even during periods of launching and recovery. Source: NTSB Materials Laboratory Factual Report.

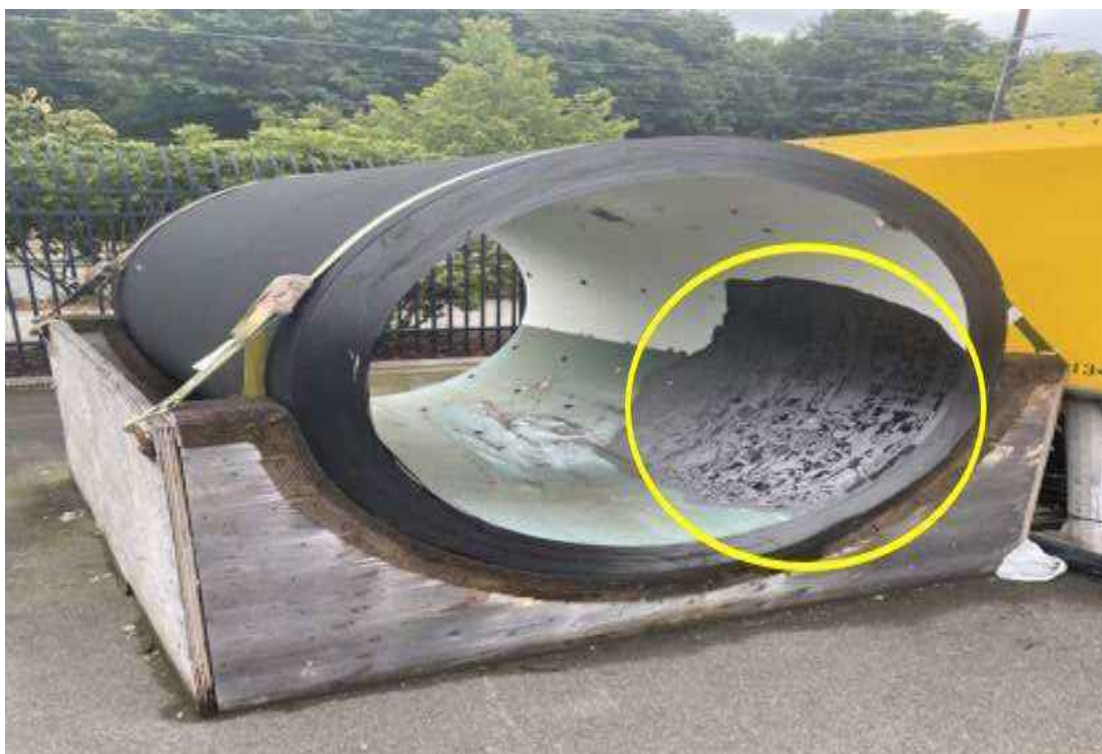
Figure 132: Photo of the first TITAN hull taken by the MBI on August 2, 2023, at OceanGate's Everett, Washington facility. The interior section of the hull where the crack was ground out is visible within the yellow circle added by the MBI. Source: USCG.

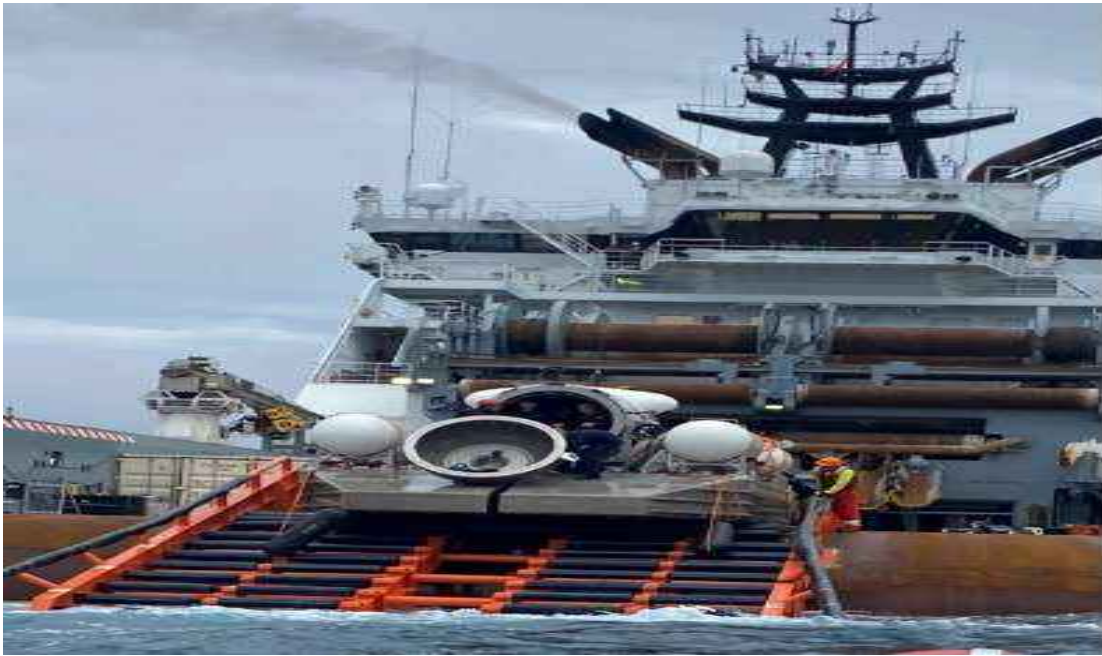
Figure 199: TITAN and the LARS positioned on the aft deck of the HORIZON ARCTIC after the forward dome fell onto the LARS during TITAN recovery operations on June 30, 2021. Source: HORIZON ARCTIC crew member.

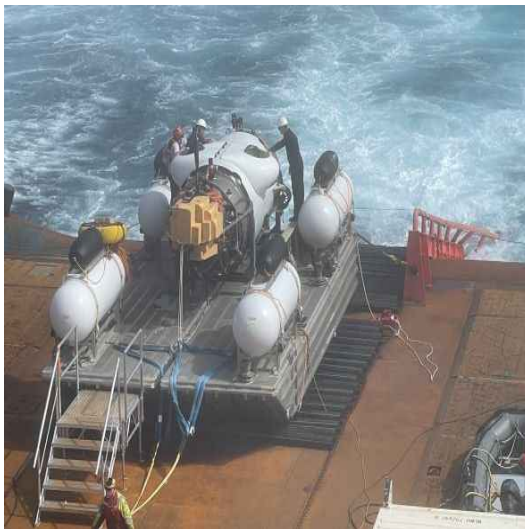
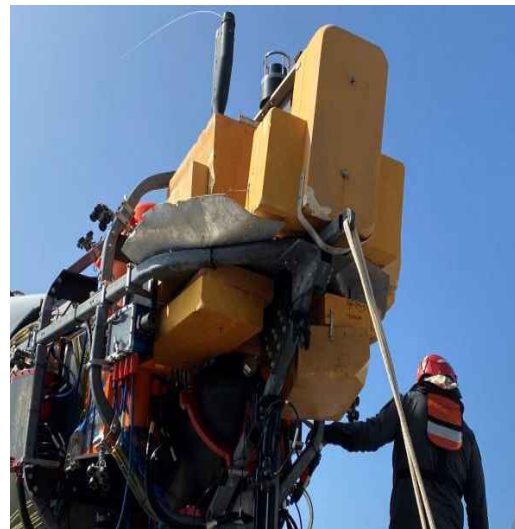
Figure 214: Images of the aft portion of TITAN on June 21, 2022, after it sustained damage while attempting to dock with the LARS after Dive 73. Source: Former mission specialist.

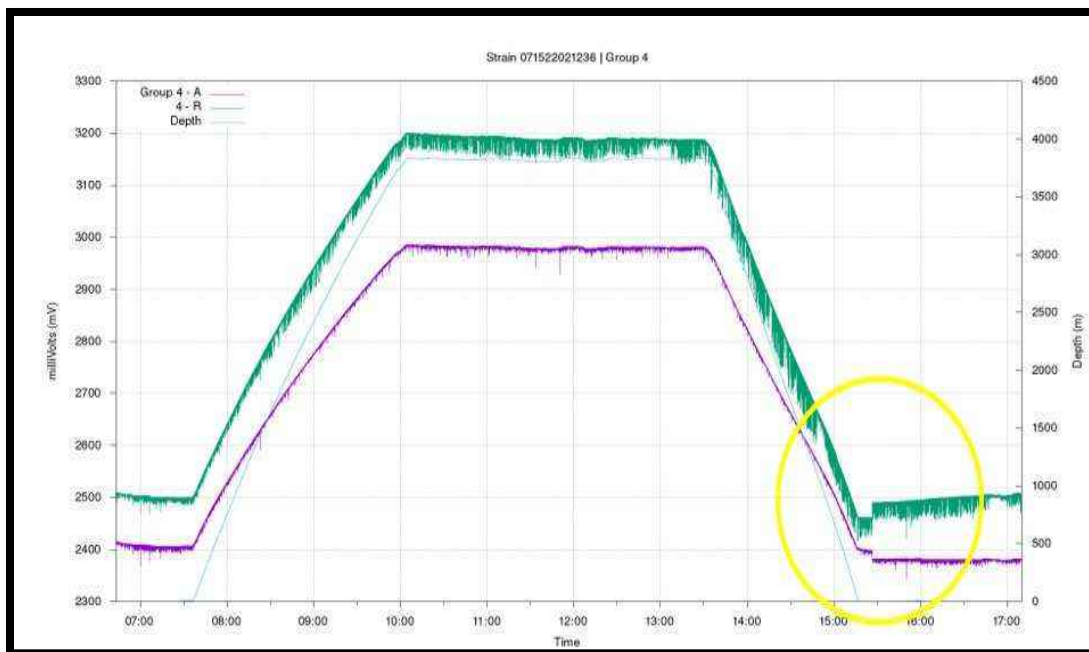
Figure 216: TITAN strain data for Dive 80. The yellow circle (added by MBI) highlights strain data at the time of the "loud bang". Source: OceanGate.

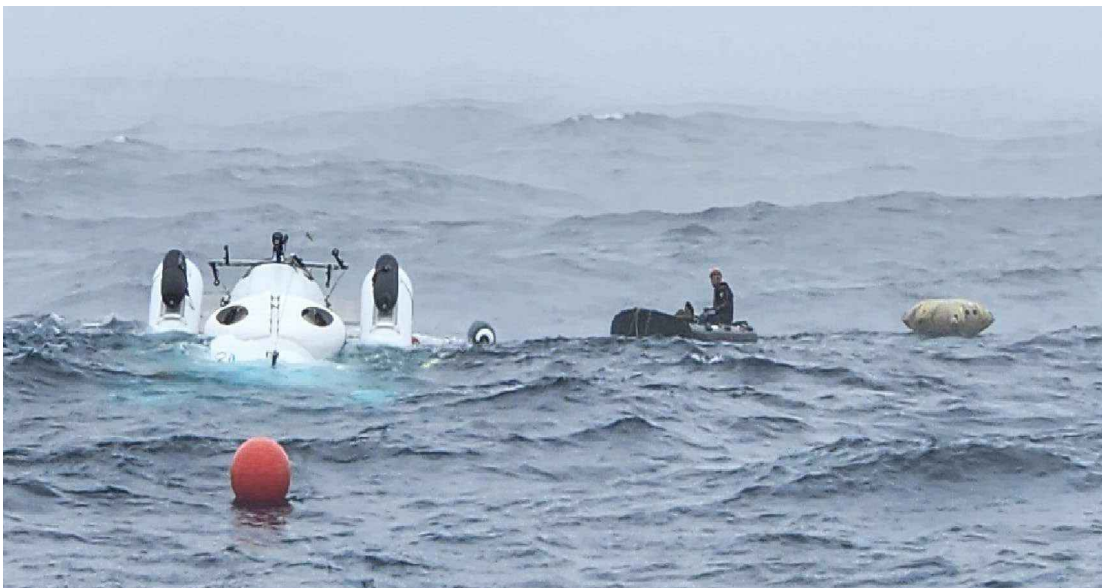
Figure 238: TITAN partially submerged due to complications with the LARS platform at 11:14 a.m. on May 24, 2024. Source: Former mission specialist.

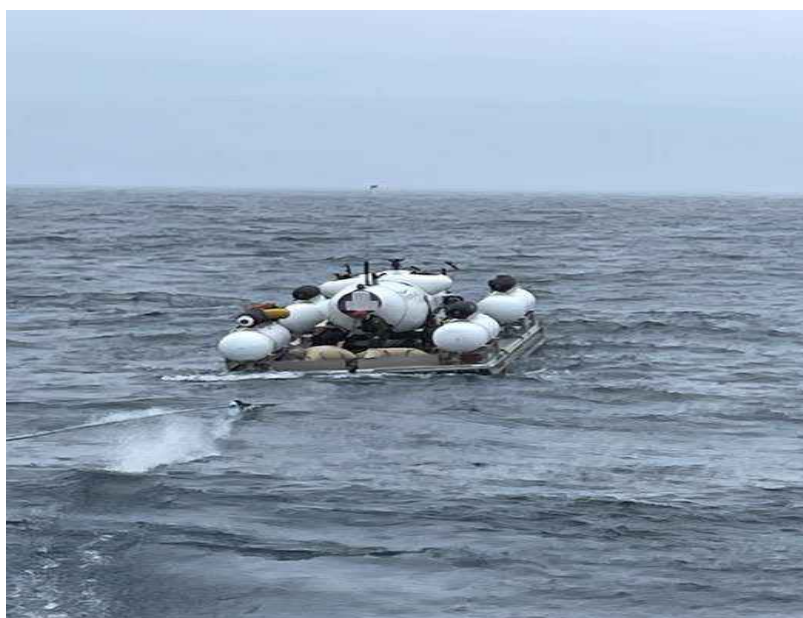
Figure 240: TITAN being towed by POLAR PRINCE on May 25, 2024, with missing tail cone due to the May 24th incident, heading to Witless Bay, Newfoundland for a damage assessment. Source: Former mission specialist.

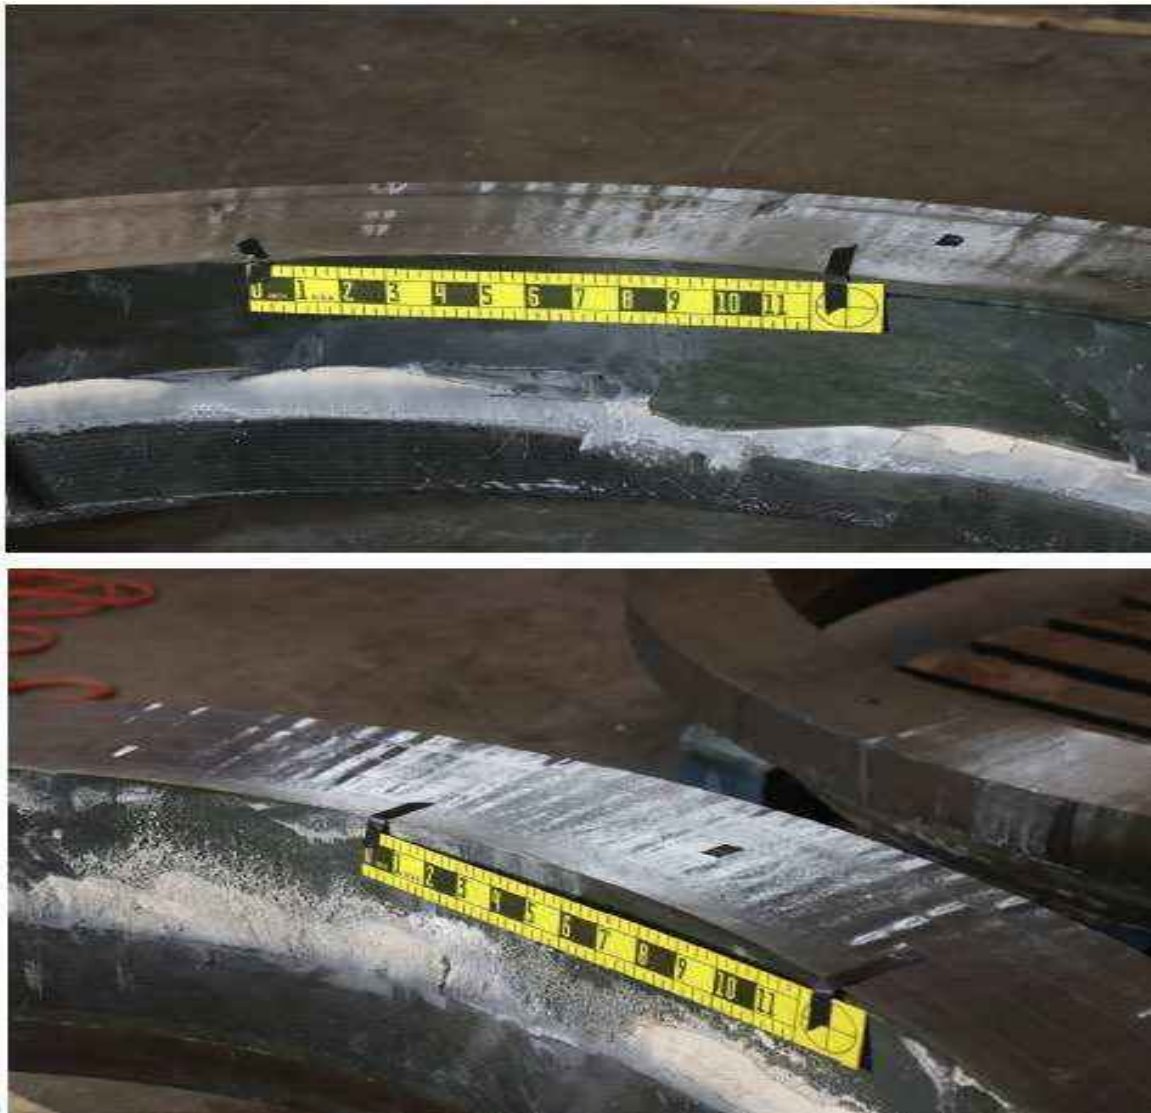
Figure 257: Images of the trimmed end faces under oblique lighting showing wrinkles and waviness in the carbon fiber orientation. Local variations in fiber orientation result in the observed light/dark brightness variations. Source: NTSB Materials Laboratory Factual Report.

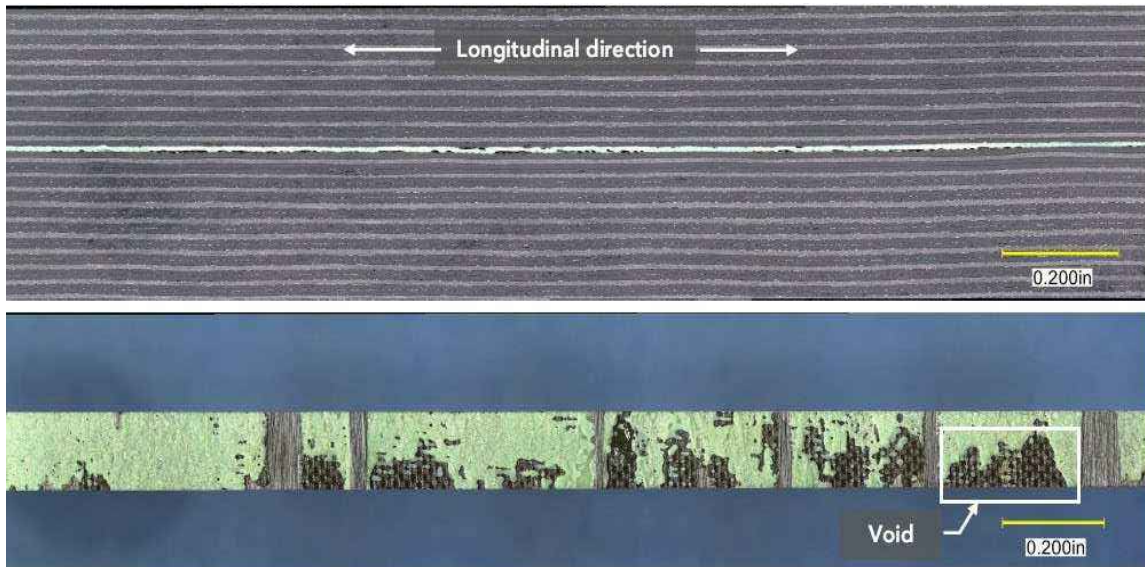
Figure 258: Top Image: Cross section image of the adhesive between layers 1 and 2. Areas of voids are present at the layer 1/2 interface. Lower image: Top view of the adhesive on the interface surface after the above pictured layers were separated by the NTSB lab. Multiple voids are visible where the glue layer was not consistently applied. Source: NTSB Materials Laboratory Factual Report.

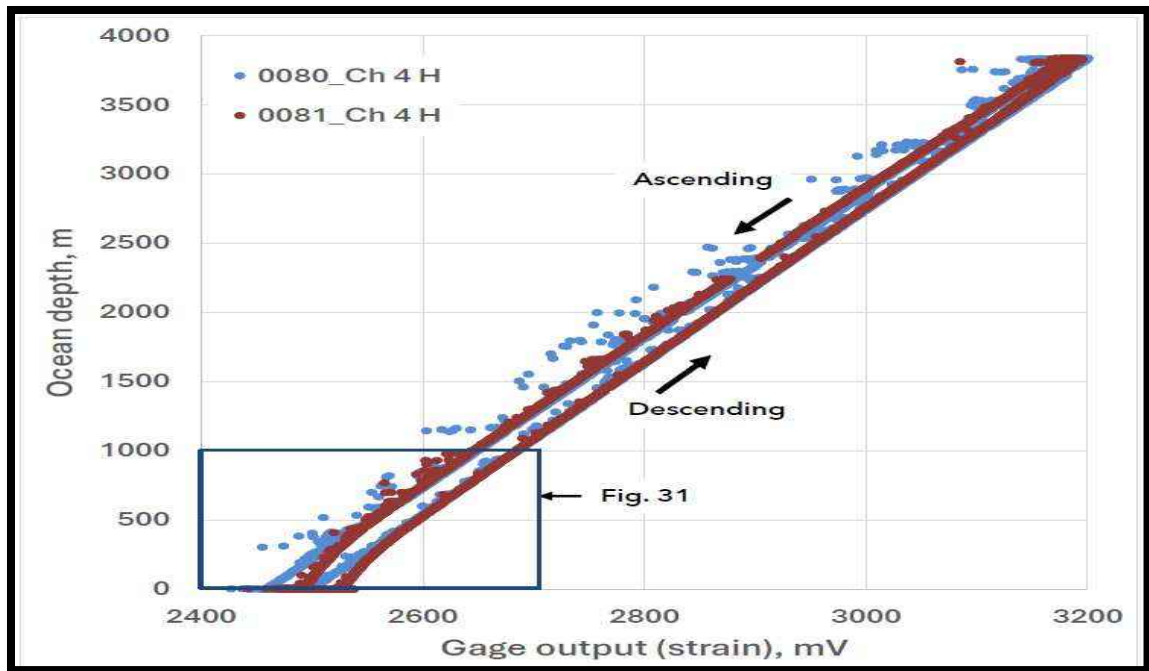
Figure 266: Plot of dive depth as a function of strain gauge output for Dive 80 and 81 – Gauge Group 4 – hoop strain gauge.
Source: NTSB Materials Laboratory Factual Report.

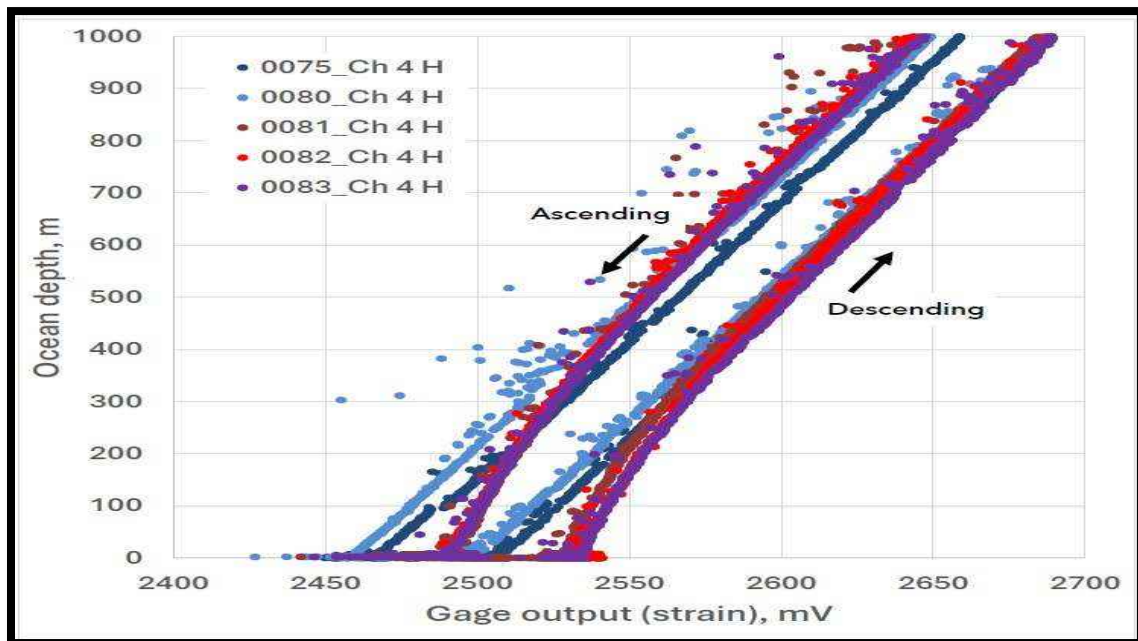
Figure 267: First and last 1000 m of dive depth for Dives 75 and 80 – 83 – Gauge Group 4 – hoop strain gauge.
Source: NTSB Materials Laboratory Factual Report.

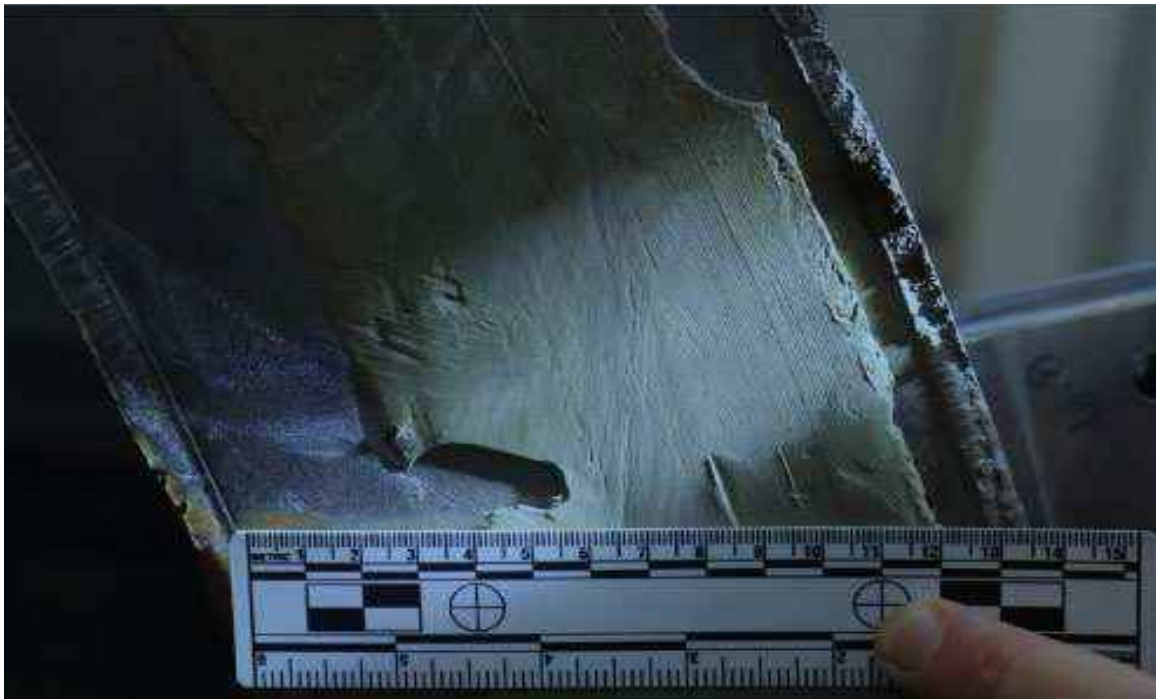
Figure 269: Aft segment under oblique lighting condition showing the disappearance of the hull end machining marks toward the inner surface. Source: NTSB Materials Laboratory Factual Report.

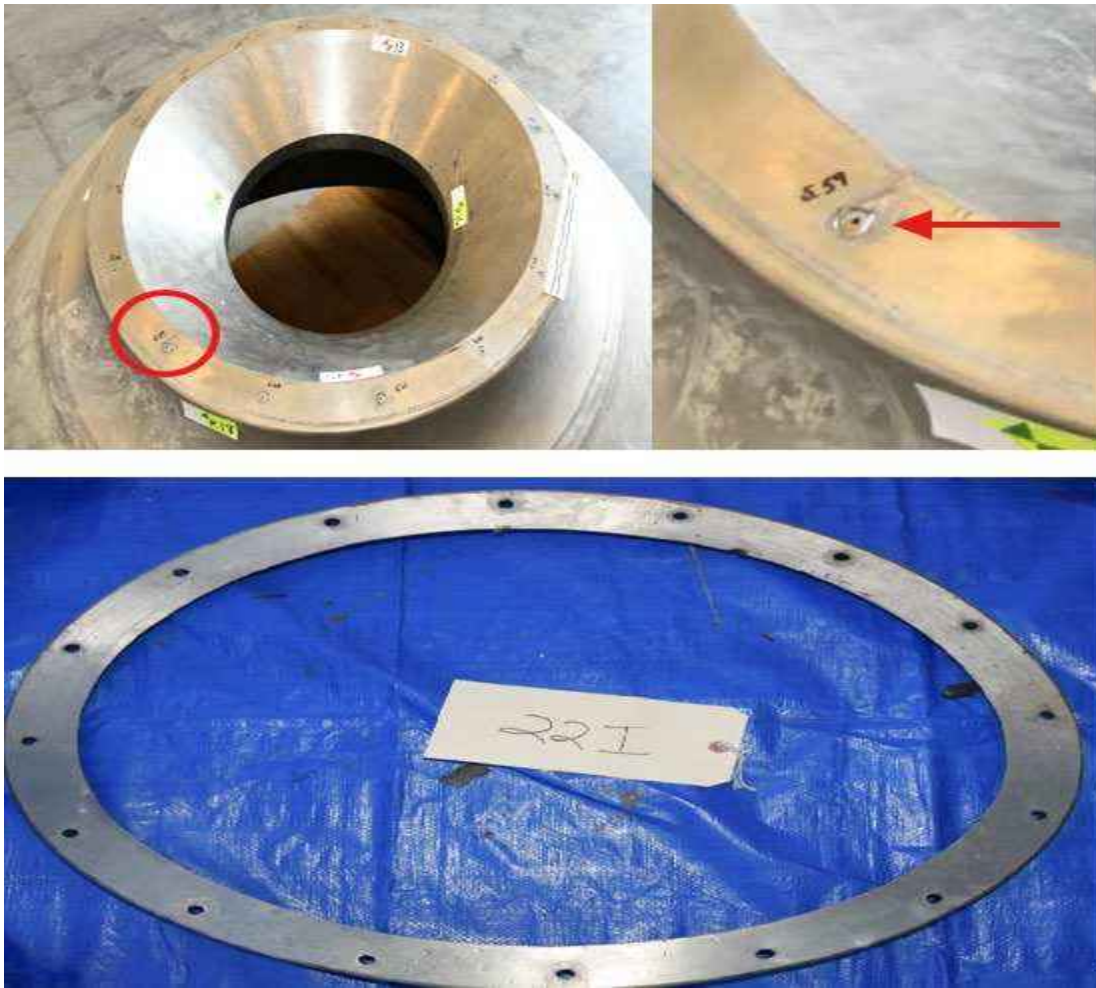
Figure 270: (Top left) TITAN’s forward dome is pictured post-accident with all 16 of its viewport retaining ring bolts sheared off. The red circle identifies 1 of the 16 sheared bolts, which the MBI labeled as 5.59. (Top right) A closeup of the sheared window retaining bolt 5.59. (Bottom) TITAN’s window retaining ring, which was recovered from the seafloor post-accident bent slightly outwards with elongated bolt holes. Source: FBI ERT.
