Paving Pompeii: The Archaeology of Stone-Paved Streets

ERIC E. POEHLER AND BENJAMIN M. CROWTHER

Careful survey of Pompeii's lava-stone pavements reveals a complex history of their origin, their repair, and the municipal administration that oversaw them. Our paper first examines two processes that inform our survey's methodology: the laying of a stone pavement and the subsequent patterns of wear that degraded it. We describe the five forms of evidence from Pompeii's streets that resulted from these processes and allow for the identification of individual sections of paving. Using both relative and absolute chronological evidence, we order these sections of paving into eight phases of development. Finally, a detailed analysis of the frequency and extent of these individual paving events sheds light on a pavement's expected life-span as well as implications for the administrative and financial upkeep required to maintain a street network.¹

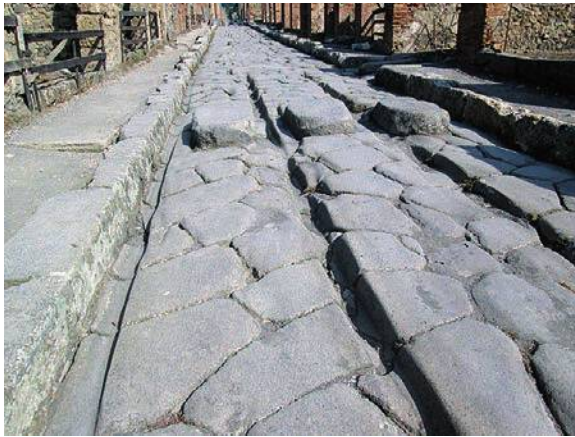
FIG. 4. Deep ruts on via Stabiana (PE_006) between vicolo di Balbo and via degli Augustali; view to north.

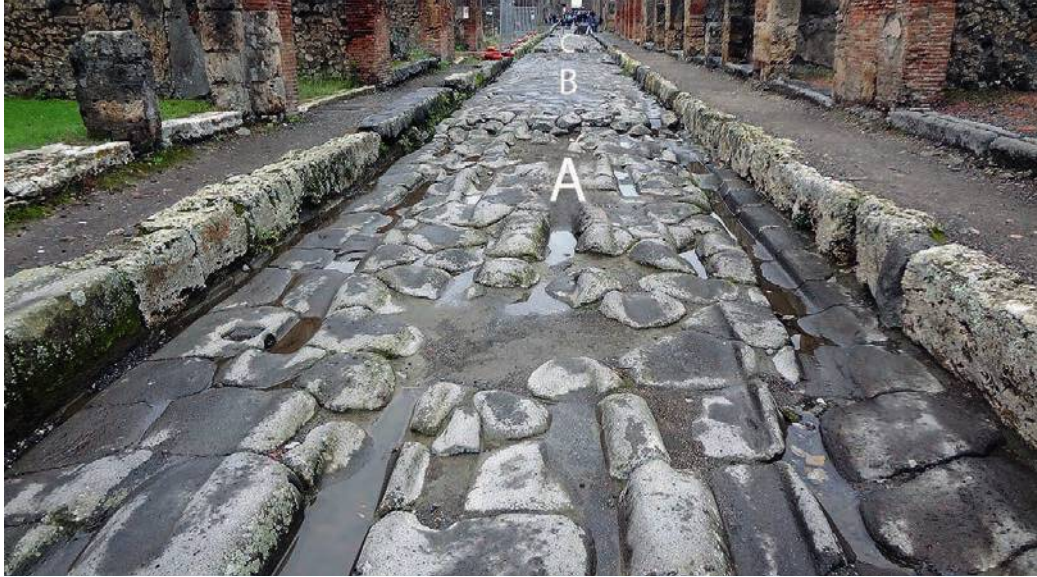
FIG. 6. Differential paving on via della Fortuna; view to west. Area of exceptionally deep ruts (A, PE_091) meets short section of repair (B, PE_090), followed by another deeply rutted section (C, PE_129).

exceptionally deeply rutted pavement (fig. 6[A]) is replaced by a short section (ca. 15 m) of fresh pavement (see fig. 6[B]), before returning again to a state of disrepair (see fig. 6[C]). The stark difference in the character of these pavements and the immediacy of the change in rut depth make both the event of repaving and its extent obvious.

The change in rut depth on via della Fortuna emphasizes a clear difference in the surface of the two pavements, because several deep ruts end at the very same location. Whereas differential paving is defined as the general change in character between pavements, terminating ruts distinguish pavements through the abrupt end of one or more clearly identifiable ruts. This form of evidence provides a definite chronological indicator because the ruts' sudden termination can only be explained by the removal and replacement of the previously rutted stones. It does not necessarily follow, however, that all traffic was halted at these locations after repaving. In fact, over time, terminating ruts acted as guides for additional rutting, and shallower ruts often continue directly onto the newer pavement.²² The depths of such continuing ruts, however, are a benefit to interpretation as they provide some indication of the amount of time that had passed since the newer section was repaired. One of the best examples of this class of evidence is found at the intersection of vicolo del Farmacista and via Consolare, where a deep rut in vicolo del Farmacista dissipates precisely at the junction between worn and unworn paving stones (see figs. 1[5], 7). Clearly, the repair of via Consolare removed the earlier rut; thereafter, as the deep ruts in the via Consolare that curve southeast toward the via delle Terme show, traffic bypassed vicolo del Farmacista. The changed traffic pattern left a broad, pockmarked section of paving—a wearless area—where the via Consolare passes the end of the vicolo del Farmacista.

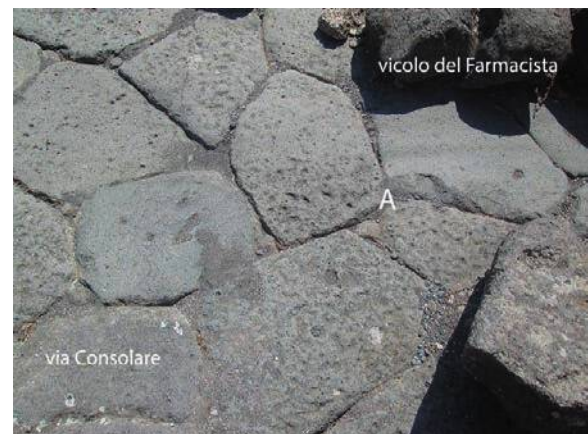
FIG. 7. Terminating rut (A) on vicolo del Farmacista (PE_126) at the pockmarked wearless area on via Consolare (PE_002). View from above, to south.

wearless area at vicolo del Farmacista and via Consolare described above (see fig. 1[5]), the only other wearless area is found one block away, at the intersection of via delle Terme and via Consolare (see figs. 1[3], 5[C]). Bounded by a set of deep curving ruts, a large area of pockmarked paving stones demonstrates the absence of regular traffic moving through the southwest part of the intersection. The absence of traffic across both wearless areas is the effect of the construction of a large ramp and drain across the inter-

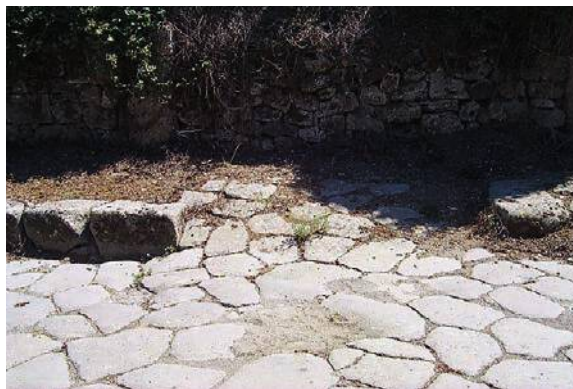
FIG. 8. Continuous paving of via di Nola at vicolo IX 14–III 8 (PE_131); view to south.

The absence of the four categories of evidence just described indicates that a pavement, one which otherwise might be expected to be divided into two or more segments, belongs to a single event. Occasionally, a segment of paving passes through an intersection, connecting two (or more) blocks of a street in a single event of paving. An example of this, the continuation of vicolo degli Scheletri across vicolo della Maschera (see fig. 1[6]), shows linear abutments on the northern and southern edges of the intersection and a concomitant depth of rutting throughout. In other places, pavements continue around the bend in a street, such as where vicolo della Regina turns north at the edge of the Triangular Forum (see fig. 1[7]). A section of more than three blocks of via di Nola shows a related example. This PE is a single, continuous surface intersected by four streets from the north and four from the south, only one of which is known to have had an earlier *silex* surface. At each of the four southern streets, via di Nola's pavement continues southward seamlessly for a few meters (see figs. 1[8], 8). These extensions indicate that these streets likely had only ever been given beaten-ash surfaces, since there was no earlier pavement to abut. At the same time, the extensions suggest the expectation that someday these streets would be paved in stone.²⁴ In all these examples (and others not mentioned), the characteristics of an uninterrupted paving event continue beyond the boundaries of one street and bind the surface of another street (or several streets) to it. Identifying continuous pavements is therefore of particular use in defining larger PEs, which reveal more ambitious activities of paving or replacement.

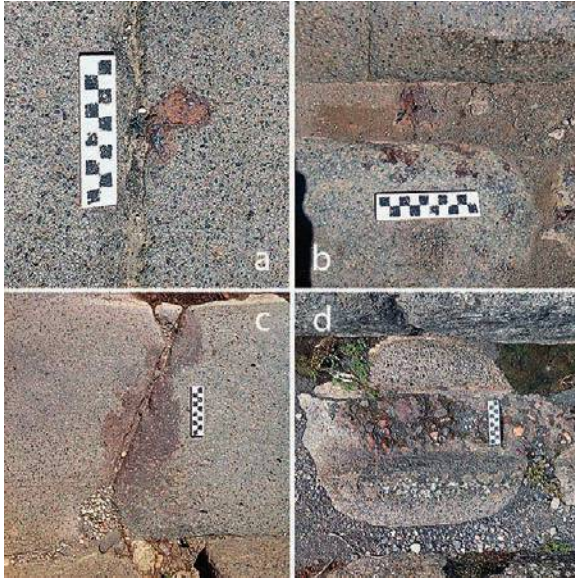
FIG. 15. Evidence of iron used to repair the streets of Pompeii: a, iron droplet; b, iron splatter and mass; c, iron staining; d, iron “slurry” filling rut.

ing stones. In more than two-thirds of these repairs, however, there is clear evidence that iron and iron slag had been applied to the street in liquid form, including droplets (fig. 15a), splatters (see fig. 15b), and large stains found only at the seams between paving stones (see fig. 15c). This remarkable and controversial phenomenon is the subject of another publication; for the present discussion, it is sufficient to say that the evidence leads to a single conclusion that is as surprising as it is inescapable: in the final days of their city's existence, Pompeians poured a molten iron slurry into the streets to fill holes and deep ruts (see fig. 15d) and to fuse together those pavements in danger of unraveling by the absence of compression among the paving stones.⁸³

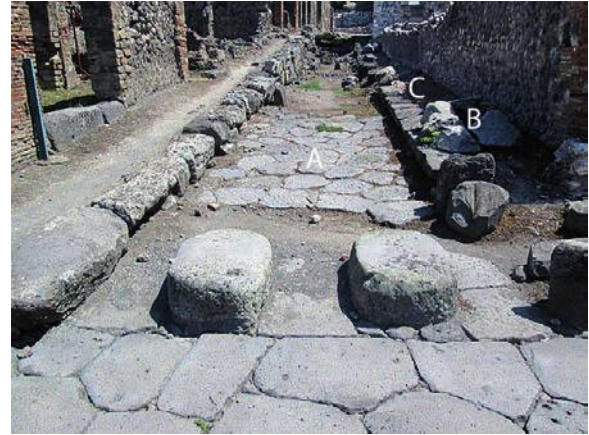
FIG. 16. Vicolo delle Conciapelle (PE_136) at via Stabiana (PE_097); view to east. Evidence for repaving in process: A, new paving; B, paving stone pile for reuse; C, paving stones recut into D-shaped curbstones.

First, the old, weathered stones were ripped up and split for reuse as curbstones on the same street, then new pavers were laid in place after the boundaries of the street were defined (fig. 16[A]).⁸⁷ The evidence for this process is remarkably clear: not only does a pile of loose paving stones now sit on the southern sidewalk (see fig. 16[B]), its curb made from characteristic D-shaped stones that result from splitting the pavers (see fig. 16[C]) but also one former paving stone on vicolo del Conciapelle was found with scoring marks along its bottom side in preparation for being split.⁸⁸

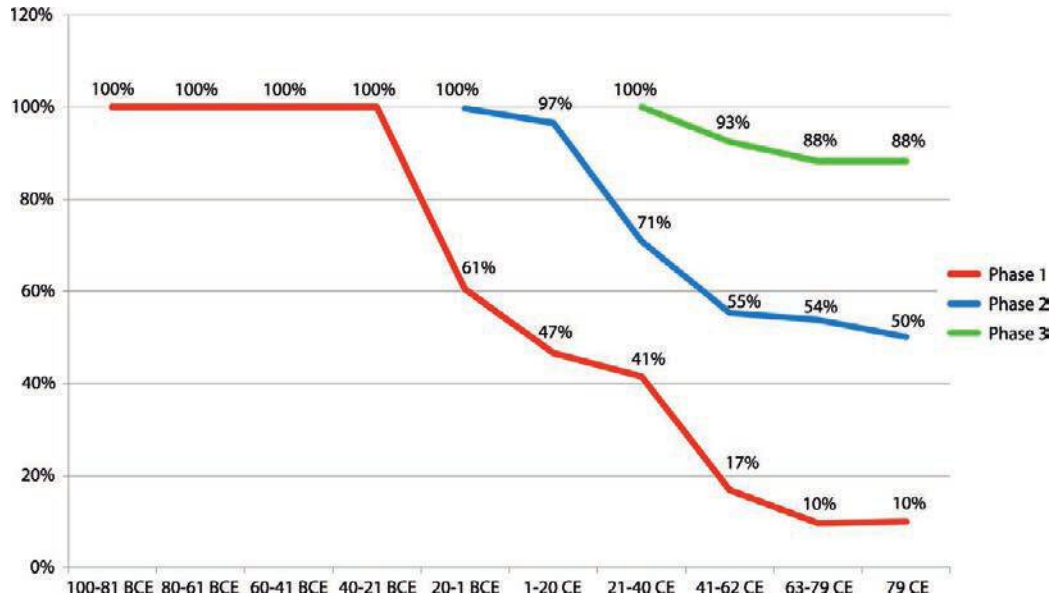
FIG. 17. Survivorship curve of paving events, Phases 1–3. Value represents the percentage of the original paved area remaining by time period.
