# The Iron Streets of Pompeii

ERIC POEHLER, JULIANA VAN ROGGEN, AND  
BENJAMIN CROWTHER

In July 2014, we conducted a survey of Pompeii's street network to document traces of iron that were observed on the stone-paved streets, which resulted in the identification of 434 instances of solid iron and iron staining among the paving stones. This paper describes the iron deposits, categorizing them into six observable types, and argues that, in the final days and weeks before the eruption of Mount Vesuvius in 79 C.E., Pompeians were—in addition to using solid iron wedges—pouring molten iron and iron slag onto their streets as a method of emergency repair. Before discussing the evidence available for how the melting, transporting, and depositing of these ferric materials might have been accomplished, we address whether the Romans had the technical ability to achieve sufficiently high temperatures to melt iron, finding much evidence to affirm the claim that they did. Finally, we consider why Pompeians undertook such measures to repair their streets. Recent research on the costs of paving stone streets in terms of time, money, and opportunity provides the economic context for this novel re

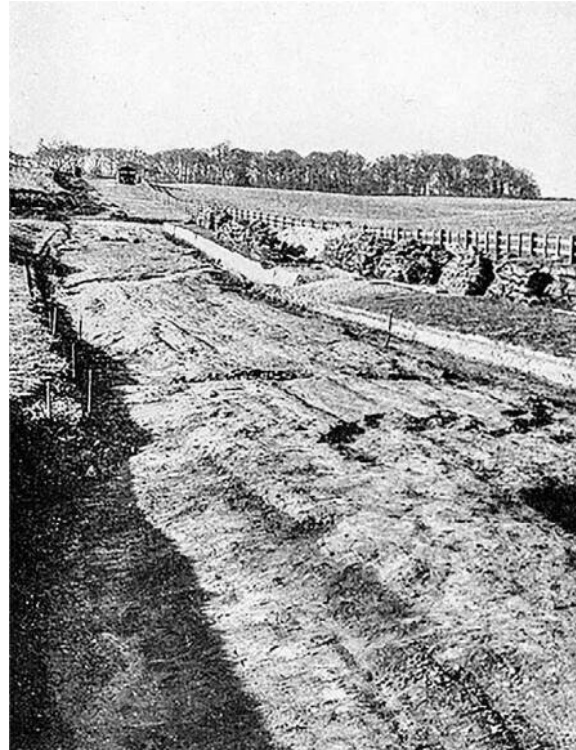
FIG. 1. London-Lewes Way, a Roman road near Holtye, Sussex, paved in iron slag (Margary 1965, frontispiece).

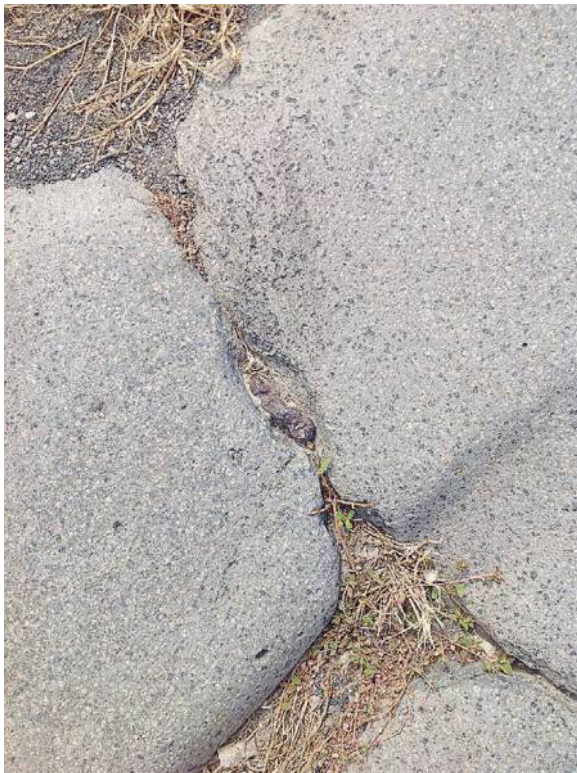
FIG. 3. Example of Type 1, solid without staining, Supplementary Table, ID\_044, Via Stabiana (ID = iron deposit). The damage to the paving stones around the iron suggests that the iron was pounded into the junction.

by the breakage on each of the stones surrounding the point of entry.<sup>15</sup> This breakage may have occurred at the end of the process of driving the iron into place, as the hammer likely hit the stones while making the iron flush with their surface. A few solid iron pieces found lower than the street level might have been countersunk with another device,<sup>16</sup> but often the poor condition of the iron suggests that it has eroded down to its present elevation. Examples of molten iron can be identified by the irregular shapes of the remaining solids that conform to the contours of the surrounding lava-stone pavers.

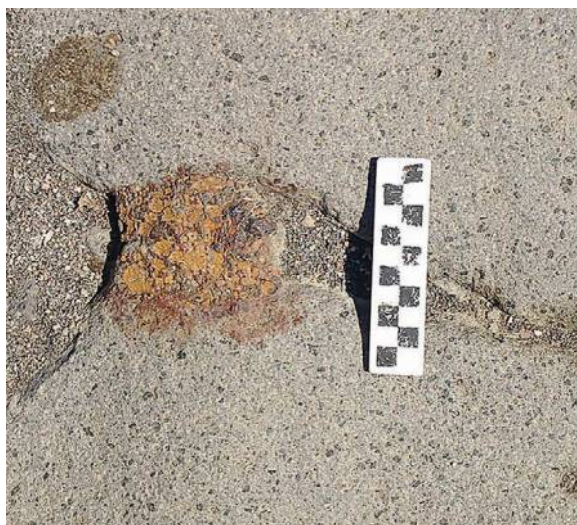
FIG. 5. Example of Type 2, solid with staining, Supplementary Table, ID\_381, Via Stabiana. Note the irregular form of the iron and the inconsistency of its oxidization.

Those examples in which a solid iron mass is found accompanied by staining make it abundantly clear that most iron pieces in the streets, including many Type 1 deposits, were in fact originally poured into place (fig. 5). In these 78 examples, an obvious iron stain can be observed on the stones adjacent to the solid iron piece and directly connected with it, indicating that the stain

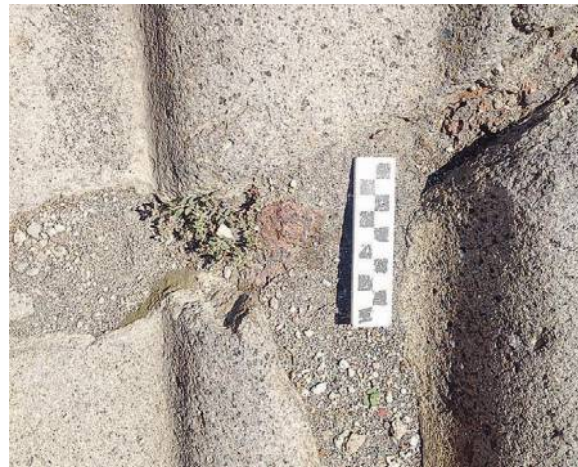
FIG. 4. Example of Type 1, solid without staining, Supplementary Table, ID\_297, Via Stabiana. Note the solid iron at the bottom of a deep rut and degraded iron filling between paving stones.

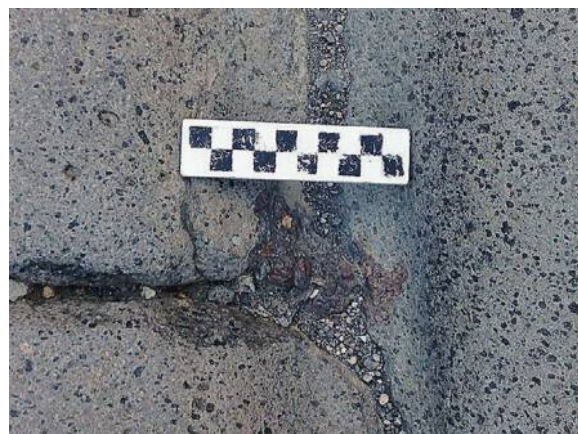
FIG. 6. Example of Type 2, solid with staining, Supplementary Table, ID\_328, Via Stabiana. Note the undulating surface of the iron and the adjacent stains.

and the solid represent a single event.<sup>17</sup> An instructive example on Via Stabiana (fig. 6) shows not only how the molten iron/iron slag stained the three stones surrounding the rut it was poured into but also how the solid iron reflects the plasticity of its molten state. The stain's undulating, flowlike surface adheres and conforms to the particular contours of the lava stones and the rut cut into them. These examples are clearly distinct from smears of iron on paving stones, stepping stones, or curbstones caused by the passage of wheeled vehicles with iron tires, even when such smears are near solid iron deposits in the street.<sup>18</sup>

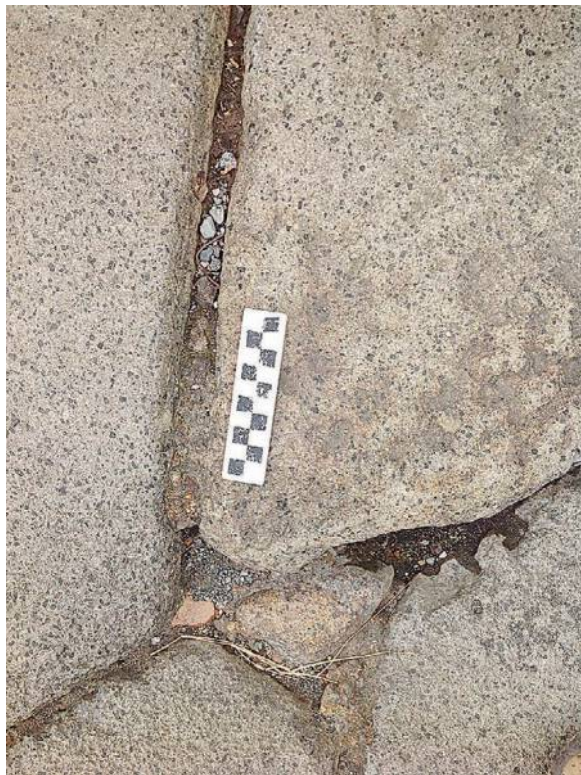
FIG. 7. Example of Type 2, solid with staining, Supplementary Table, ID\_157, Via della Fortuna. Note the ferric materials filling the junction between paving stones and the stains in the pockmarks on top of one paving stone.

In another example of Type 2 (solid with staining), a dark red-to-purple stain (fig. 7) is preserved only within the small pockmarks on the surface of one paving stone at the intersection of four paving stones. There are no stains on the surfaces of the other three stones, though staining does appear on a small capping cobble within the intersection of the pavers. A solid remnant of iron/iron slag remains in the junction between the pockmarked stone and the adjacent paver.

These observations demonstrate that an iron-rich material was poured on the surface of the pockmarked stone and was then redirected into the interstices among the pavers. One might be inclined to explain the fact that the stain no longer covers the entire area on the top of the paving stone by subsequent rutting from regular use, but the pavement had only recently been repaired.<sup>19</sup> It is clear, therefore, that these small

depressions on the stone left by chiseling to create its flat surface are stained by (rather than filled with) this iron material because that material was not allowed to set in place. Finally, this solid mass of iron/iron slag and staining are accompanied by, but not in physical contact with, two individual droplets on an adjacent stone.<sup>20</sup> These droplets (discussed in more detail below) document the events associated with introduction of the iron/iron slag into the street as a liquid.

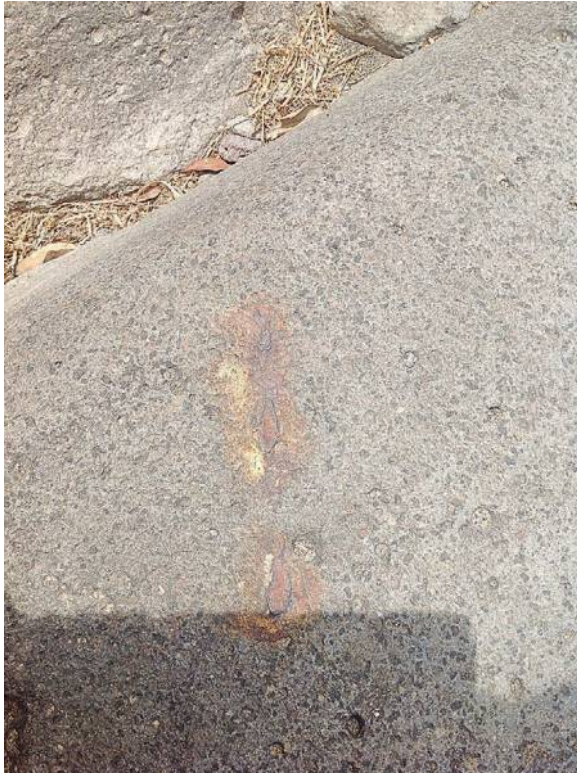
FIG. 8. Modern example of Type 2, solid with staining, Supplementary Table, ID\_004, Via Stabiana. The stains were made by the feet of modern steps that have now been removed.

It might be argued that iron staining in the street can be explained by a solid iron object that, having been abandoned in the street prior to the eruption (or after excavation), oxidized and stained the surrounding stones. Three modern stains on the paving stones near the Porta Stabia that were created by the placement of a modern metal stairway,<sup>21</sup> later removed, help test and

disprove this hypothesis. Although their colors are not significantly different from ancient stains, these stains are distinct both because they retain the form of the previous objects' linear and rectangular shapes and because they rest in the middle of a paving stone (fig. 8). Conversely, the irregular shapes of ancient stains supports the notion of their fluid state at the time of deposition. Finally, unlike the modern stains, ancient staining—excluding droplets or splatters of droplets (discussed below)—occur only at the abutments between paving stones and not in the middle of a paver.

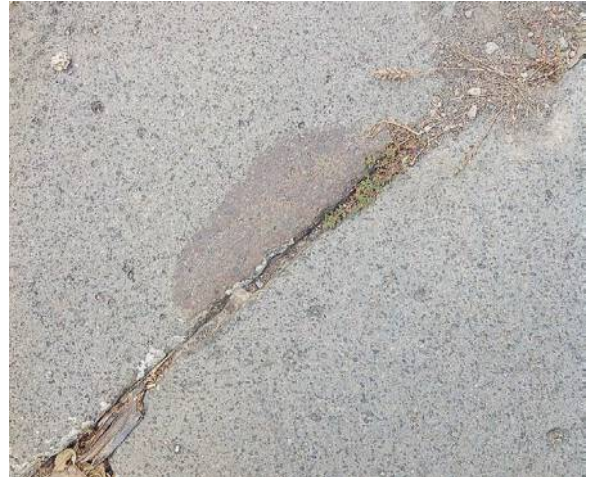
FIG. 9. Example of Type 3, staining at pour point, Supplementary Table, ID\_432, Via Stabiana.

In the case of iron stains interpreted as pour points, molten ferric materials were apparently poured into gaps between paving stones to repair the spaces between and below them. As the molten material was poured, it covered the adjacent stones and flowed into the gap, but when the material hardened, it did not fill the gap up to the level of the street surface. Such stains occur both in the junctions between two stones and in the intersections of three or more stones. Ancient stains range in color from a light reddish-orange to a dark purplish-gray and differ in intensity and consistency from faint enough to be partially transparent to sufficiently thick to retain a metallic sheen.<sup>22</sup> The color of a stain can differ even within a single pour point.<sup>23</sup> One of the best examples of this comes from a deeply rutted section of Via Stabiana where the undulating edges of an orange-to-purple stain can be seen to flank the junction between two paving stones between which the molten material seeped (fig. 9). Although this stain is relatively large at more than 30 cm in length, some stains are exceptional in size, covering five paving stones and reaching over a meter in length.<sup>24</sup>

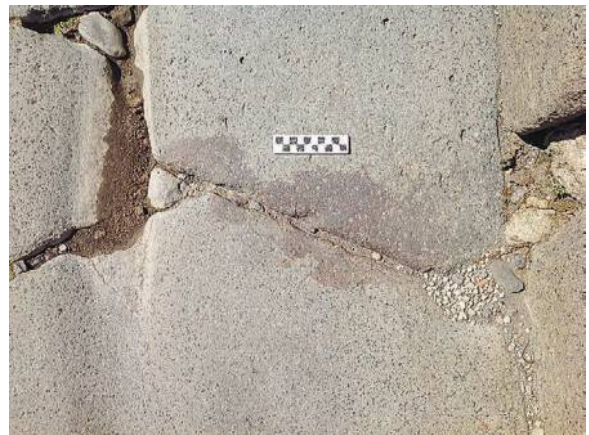
FIG. 10. Example of Type 3, staining at pour point, Supplementary Table, ID\_008, Via Stabiana. Note that the iron materials stain only one stone of the junction.

Most stains do not cover all the stones at a pour point. Instead, it is common that only one side of the pour point is stained, indicating that a guide was used for directing the molten iron/iron slag (fig. 10).<sup>25</sup> The flat face of an iron spade would work well not only to perform this function but also to push or scrape any sufficiently inviscid material on surrounding stones into the cavity (as in the example of Type 2, solid with staining; see fig. 7). If molten iron/iron slag hardened on the surface of a street, a spade also could be used to

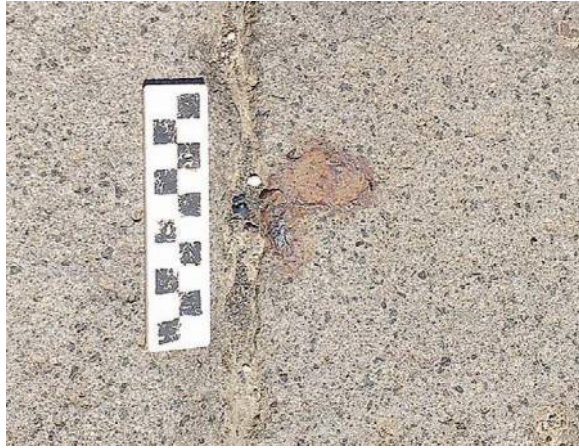
FIG. 11. Example of Type 4, droplet (with staining), Supplementary Table, ID\_316, Via Stabiana. Note the coronal shape and metallic sheen of the edge of the droplet.

The liquidity of the material staining the streets is also demonstrated by the 86 instances of individual droplets of iron or iron slag that we found in Pompeii. We documented droplets in all areas of the streets, including inside deep ruts and on the top of paving stones. This distribution supports the obvious conclusion that droplets were not an intentional part of the deposition of material but are instead accidentally produced, and they serve as evidence for that material's presence in and movement through the streets. Droplets are identified by a red-orange to purple-gray stain and/or by a more three-dimensional form accompanied by a metallic sheen (fig. 11).<sup>26</sup> In the for-

mer instance, the droplet had either been scraped up at the time of deposition, leaving only a stain, or had been partially worn away by the movement of vehicles over its position.<sup>27</sup> In the latter instance, the droplet remained largely in its original form.

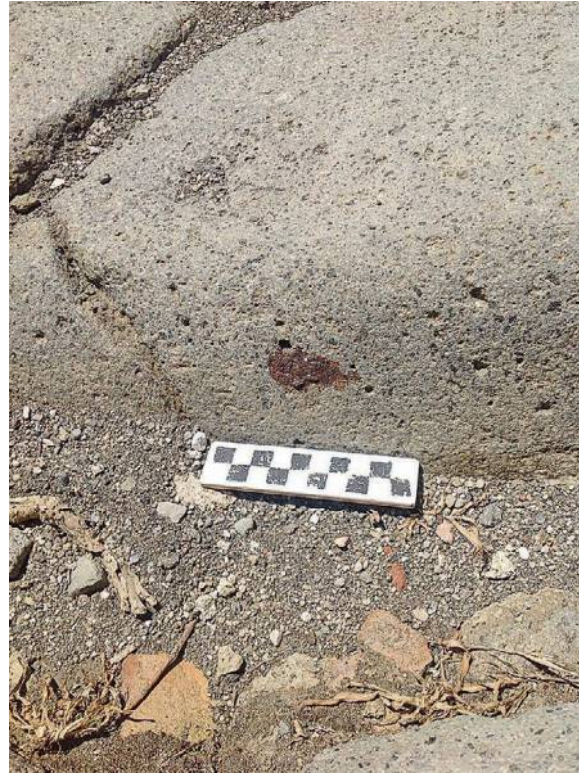
FIG. 12. Example of Type 4, droplet (with staining), Supplementary Table, ID\_081, Via del Vesuvio. Note that the droplet adhered to the vertical sidewall of a rut, and some of the molten material collected at the bottom of the stain in a raised lip.

One example of Type 4 on Via del Vesuvio is a droplet that had landed on the steeply sloping face of a deep rut. The molten iron material not adhering to the stone sagged to the bottom of the stain and formed a small

lip (fig. 12). Such examples of droplets found inside ruts are especially instructive as they demonstrate that either the duration of time or the volume of traffic was not sufficient to wear away these accidental deposits of iron/iron slag before the eruption in 79 C.E. The position of droplets inside ruts, where the wheels of vehicles would grind over them, would make them highly susceptible to erosion.<sup>28</sup> That they remain, and remain in some cases with little to no evidence of wheel wear, leaves one with the inescapable conclusion that the droplets were landing on the streets in Pompeii in the final weeks or days before the eruption.<sup>29</sup>

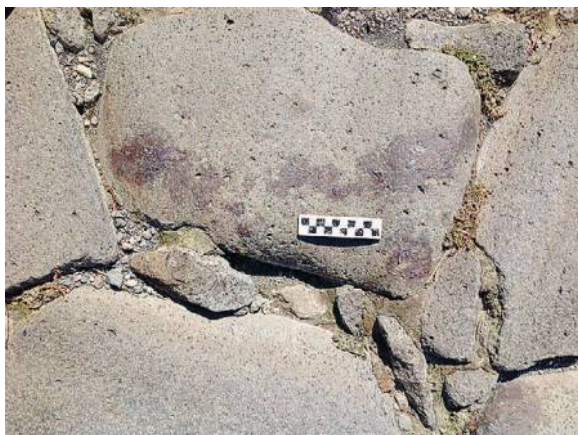
FIG. 13. Example of Type 5, splatter (with staining), Supplementary Table, ID\_429, Via Stabiana. Note the linear arrangement of staining and droplets across the paving stone.

tion. The 38 examples of splatters appear to result from accidental spillage. For example, a collection of droplets could be created by molten material that dripped unintentionally near a pour point. Like water dripping from a glass that is only slightly tilted, the molten material might have run down the outside of its container, collected at its base, and then dripped onto the pavement near the actual pour point. One stain has a particularly linear appearance, as though molten iron/iron slag had dribbled onto the stone as this container was transported above and across it (fig. 13).

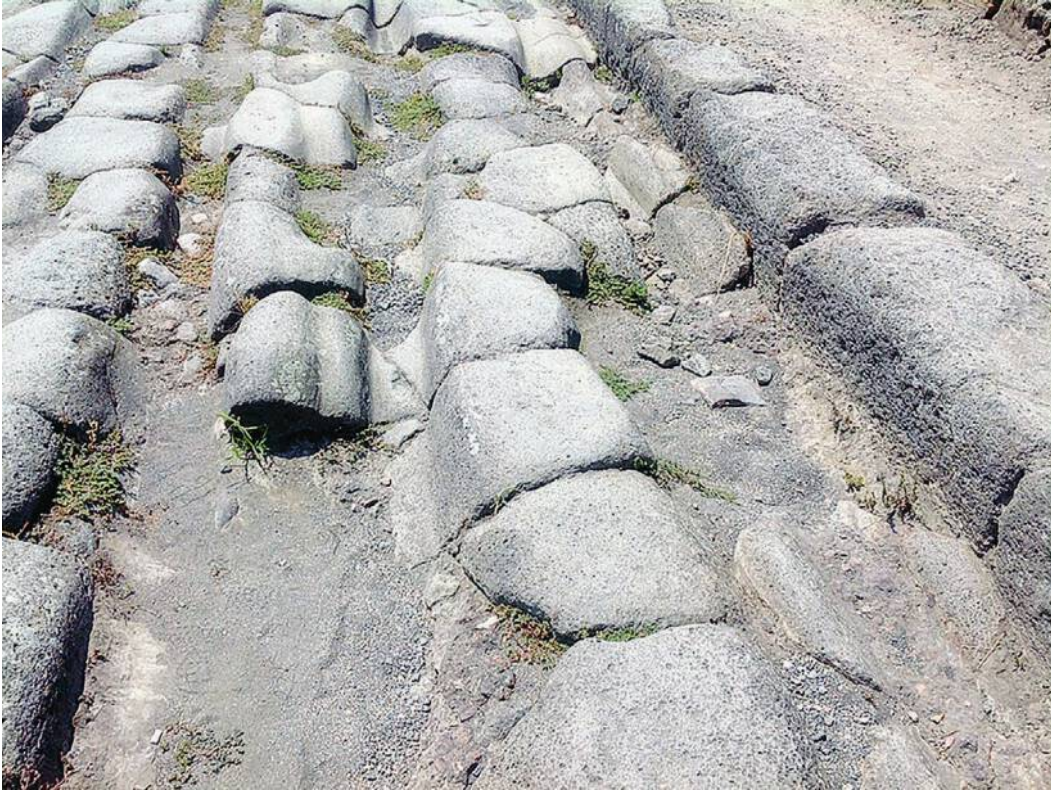
FIG. 14. Deeply rutted section of Via della Fortuna containing remnants of many repairs.

Even if we allow for a layer of repair only 2 cm deep within a much deeper rut and estimate that 50% of its volume consisted of nonferric materials, the volume of ferric material is considerable. Our calculations indicate that more than 70 liters of molten iron/iron slag was poured onto this section of Via della Fortuna to repair it.<sup>33</sup> How deeply these repairs might have pen-

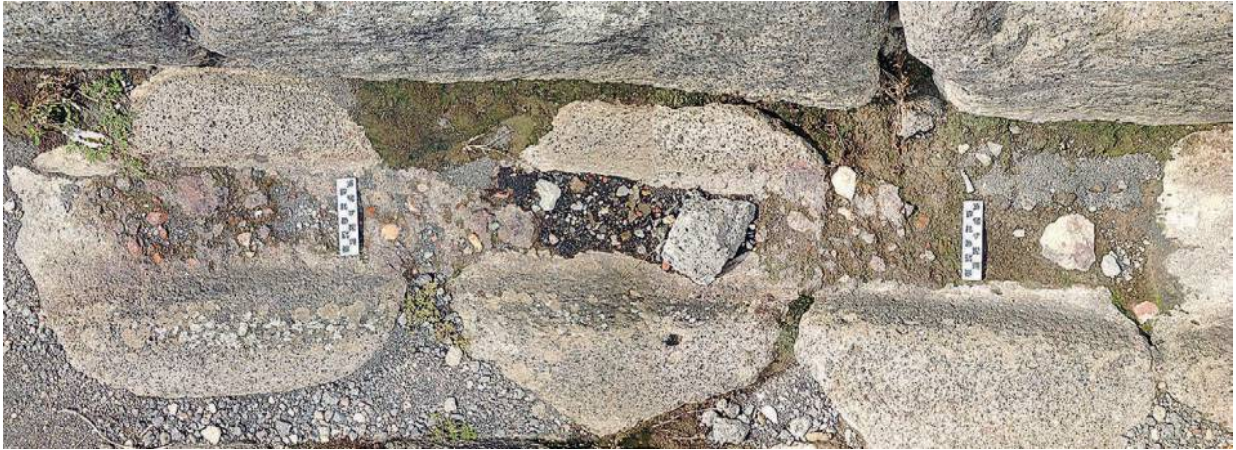
FIG. 15. Example of Type 6, repair with composite materials, Supplementary Table, ID\_168, ID\_169, Via della Fortuna. Note that the deposit contains ceramics, including terracotta, as well as pieces of marble or white limestone, and it fills only the bottom of the rut.

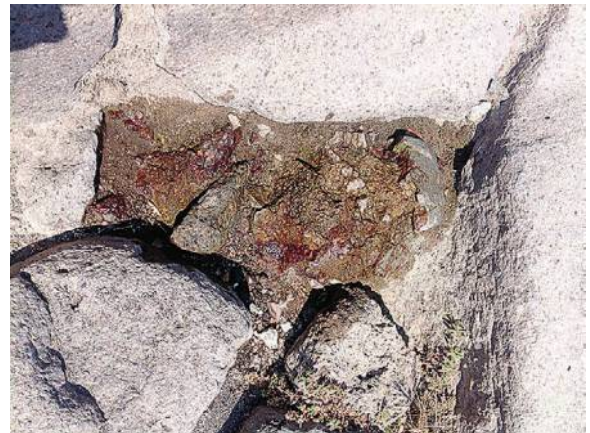
FIG. 16. Example of Type 6, repair with composite materials, Supplementary Table, ID\_422, Via Stabiana. Note that the deposit (ca. 40 cm x 20 cm) includes large stones and that it fills a large gap between paving stones.
