UNITED STATES COAST GUARD

**REPORT OF THE MARINE BOARD OF INVESTIGATION
INTO THE
IMPLOSION OF THE SUBMERSIBLE TITAN
(CG 1788361) IN THE NORTH ATLANTIC OCEAN
NEAR THE WRECK SITE OF THE RMS TITANIC
RESULTING IN THE LOSS OF FIVE LIVES
ON JUNE 18, 2023**

MISLE ACTIVITY NUMBER: 7724663

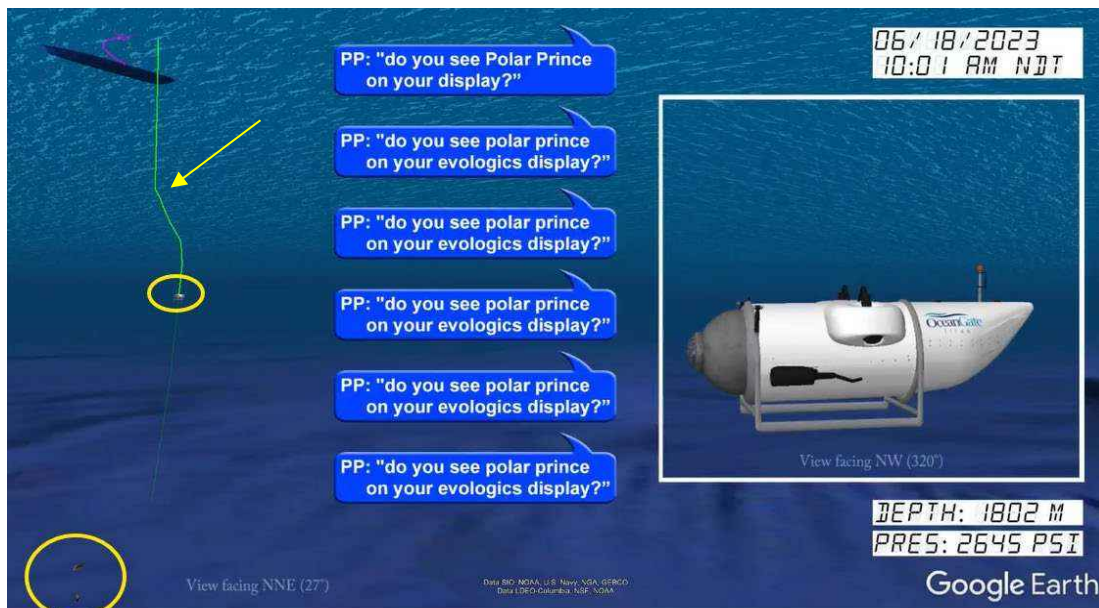
4.1.43. At 9:53:51 a.m., there was a loss of communication between the TITAN and the POLAR PRINCE. Just prior to the loss of communication, the TITAN had noticeably veered off direct course of descent to the TITANIC location. The POLAR PRINCE sent the communication, “do you see Polar Prince on your display?” The TITAN did not respond, and the POLAR PRINCE sent the same message multiple times over the next 13 minutes.

Figure 32: Excerpt of Coast Guard animation. The yellow arrow indicates the depth where TITAN veered off course and temporarily lost communications with the POLAR PRINCE. The yellow circle outlines TITAN and the bottom yellow circle outlines the TITANIC wreck site. Source: USCG Auxiliary.

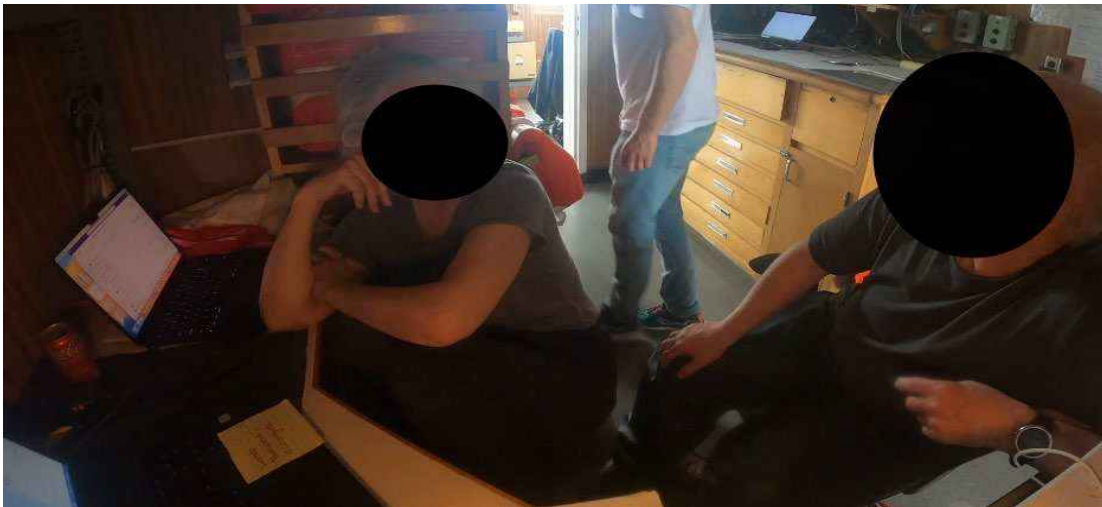
4.1.52. At 10:47:11 a.m., the TITAN communications and tracking team, while in the chart room in the aft section of the POLAR PRINCE bridge, heard a sound described by the leader for communications and tracking as a “bang”. Upon hearing the noise, the leader turned to another OceanGate employee assisting with the comms and tracking and stated, “What was that bang?”. The assistant did not respond to the question and the MBI was unable to find evidence of any further discussions of the “bang” heard on the bridge of the POLAR PRINCE.

Figure 33: Still frame captured from a video of the OceanGate Communications and Tracking Team after a sound was heard coming from outside. The leader of the Communications and Tracking Team is seated on the left. Source: OceanGate.

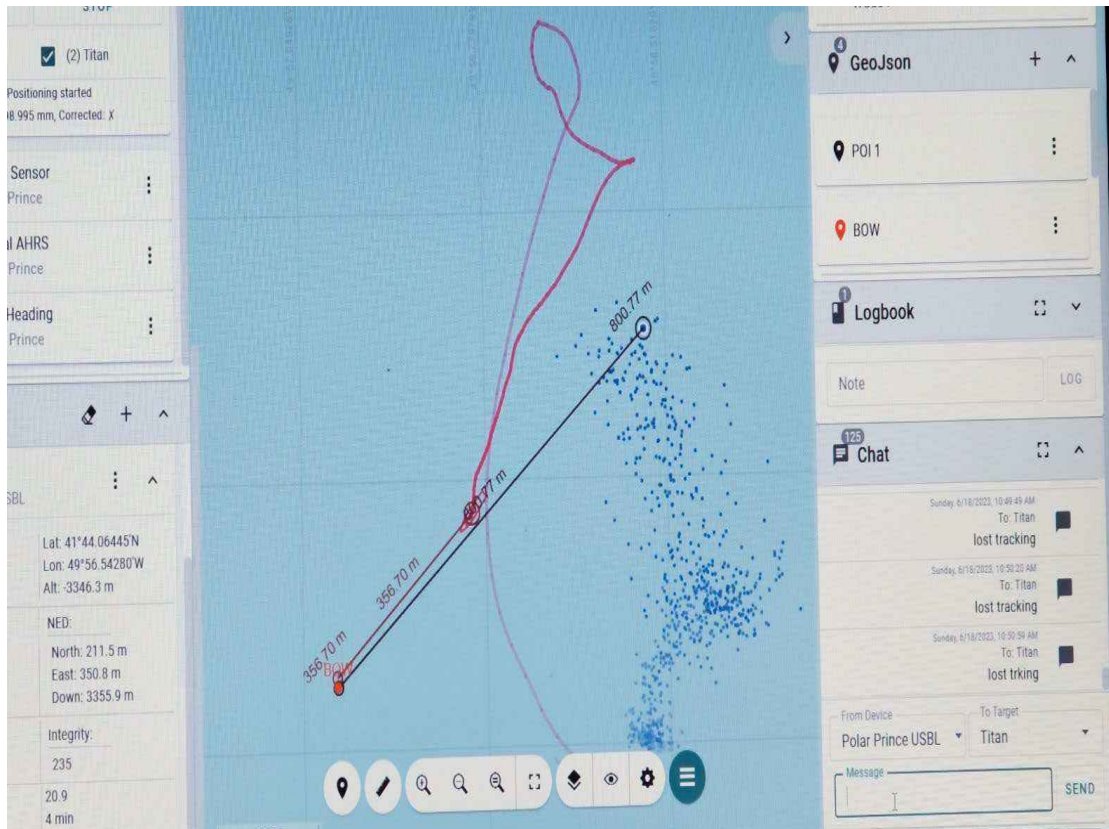
4.1.57. At 10:49:11 a.m., approximately two minutes after hearing the “bang”, an OceanGate employee assisting with comms and tracking pointed to the tracking computer and stated, “we have lost tracking.” The team leader for the communications and tracking team then stated, “for two minutes.” The loss of tracking time corresponds with the time of the “bang” sound that was heard. The OceanGate communications and tracking team then sent several messages to the TITAN stating, “lost tracking” and requesting that the TITAN’s crew increase the power to their EvoLogics modem. There were no further responses from TITAN.

4.1.58. At approximately 10:51 a.m., the communications and tracking team leader called the Mission Director into the bridge office and notified him that they had not had communications and tracking for four minutes. The team leader also confirmed that tracking had been reliable up until the point where communications and tracking were lost.

Figure 36: Image of the EvoLogics tracking computer display when the Mission Director was notified of the loss of communications and tracking of the TITAN. Source: OceanGate.

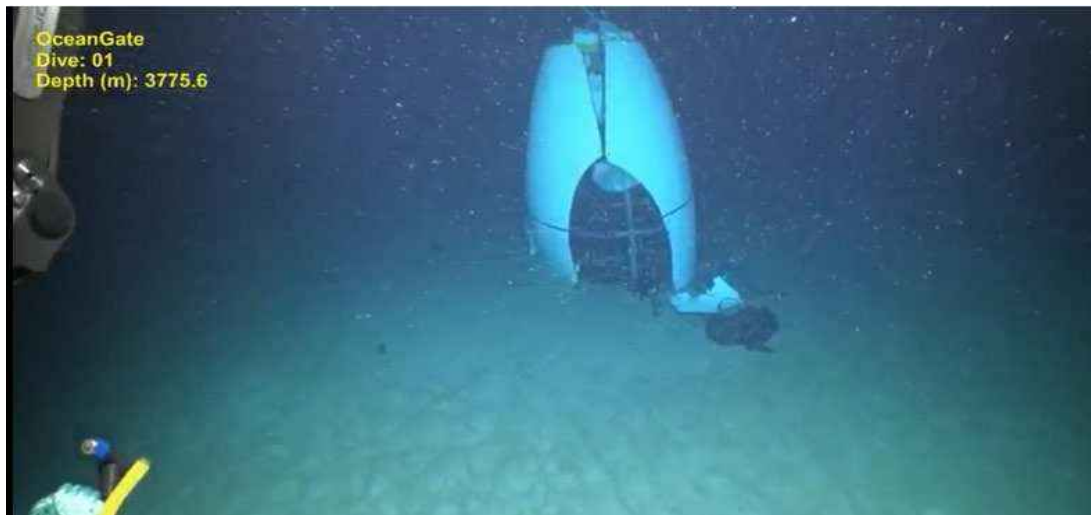
4.1.72. On June 22, 2023, at approximately 09:40 a.m., the Pelagic Research Services Odysseus ROV, deployed from the HORIZON ARCTIC, discovered the aft tail cone and other debris of the TITAN on the seafloor after an extensive search. This discovery provided conclusive evidence of the catastrophic loss of the TITAN and the death of the five individuals aboard.

Figure 41: ROV image of TITAN aft tail cone. Source: Pelagic Research Services, June 2023.

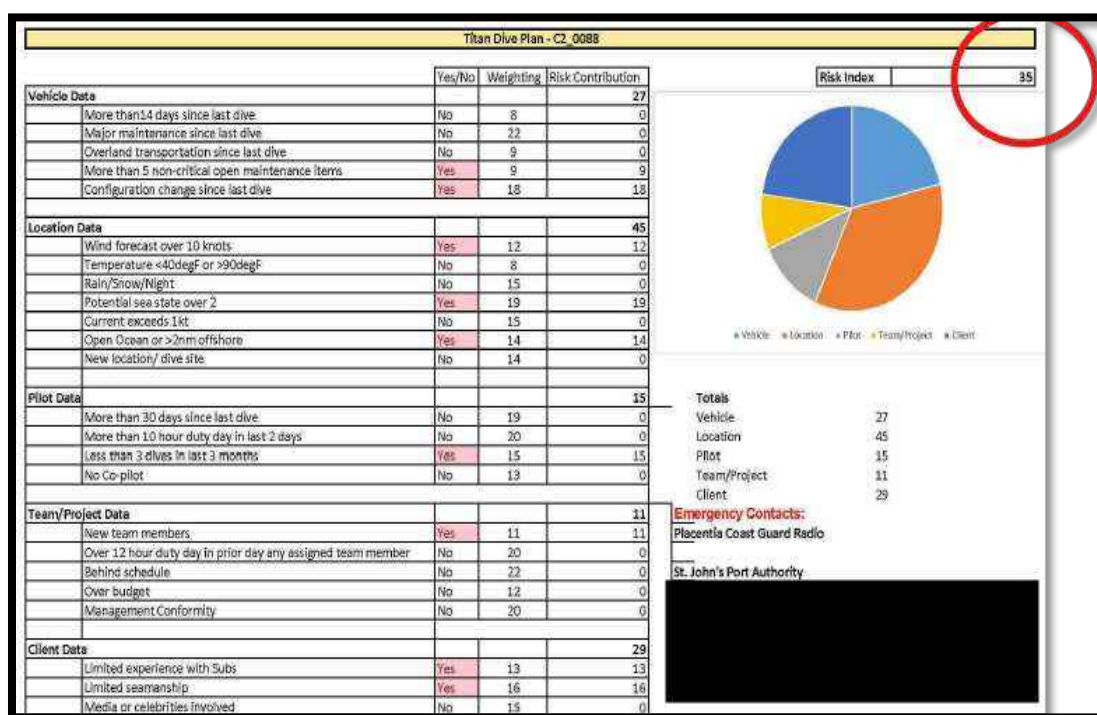
4.6.9.11.1. The Risk Index was determined by reviewing each subcategory under the following five categories: Vehicle Data, Location Data, Pilot Data, Team / Project Data, and Client Data. Each subcategory was given a weight or number based on its severity. If the specific condition existed (yes / no), then the weight or number was added to the risk contribution. Figure 50 is TITAN’s Dive 88 Risk Index Matrix, where the Risk Index was calculated to be 35. The MBI was unable to determine how the Risk Index number was computed based on the values indicated in Figure 50.

4.6.9.11.2. The MBI was neither provided with nor able to locate any OceanGate documentation assigning a risk classification (e.g., low, medium, high) corresponding to the calculated Risk Index number. As a result, the significance of a Risk Index value of 35 remains unknown. OceanGate employees and mission specialists interviewed were unfamiliar with any formal risk classification system or terminology. The average Risk Index for all TITANIC Expedition dives was 36.

Figure 50: Dive 88 Risk Index. The MBI added the red circle to highlight the Risk Index calculation. Source: OceanGate.

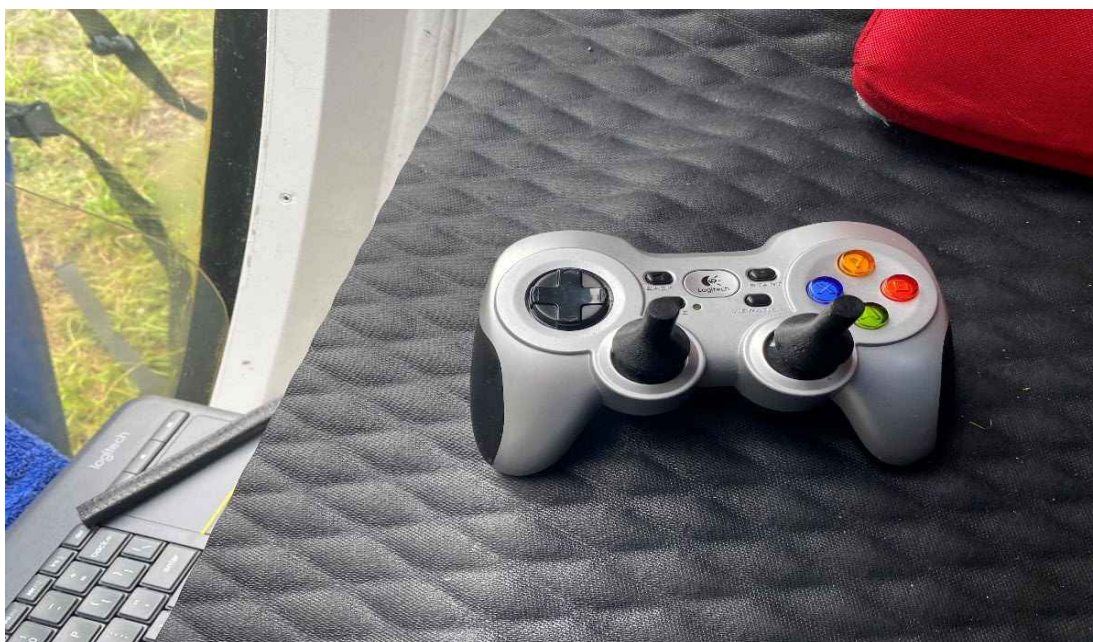
4.10.8. On December 31, 2014, the UW-APL released a collaborative video displaying the CYCLOPS I being operated with a PlayStation® controller²⁷. A few months later, on March 11, 2015, the CYCLOPS I was on display at the Seattle Museum of History and Industry. An article highlighting UW-APL's release stated that the CYCLOPS I used mostly off-the-shelf commercial thrusters and components and that "the vehicle is eventually intended to be rented to clients for research, resource exploration, photography or even tourism, at a cost that would be higher than today's shallow-water subs but lower than the single-person subs now available only to very wealthy explorers."

Figure 65: Photo of the Logitech PlayStation controller inside CYCLOPS I taken by the MBI at its temporary storage site at USCG Sector Field Office Fort Macon, North Carolina on October 26, 2023. Source: USCG.

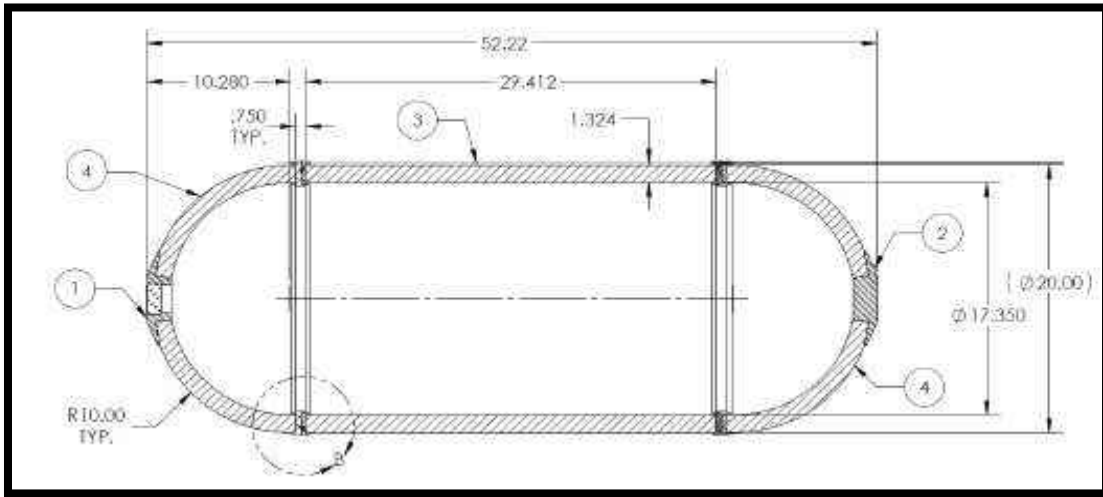
Figure 73: CYCLOPS (TITAN) one-third scale pressure test. Source: UW-APL.

4.12.4. The first scale test was conducted on December 21, 2015, at the UW-APL School of Oceanography pressure test chamber located at the Ocean Science Building at the University of Washington. During MBI testimony, the UW-APL project engineer stated, “The first one collapsed, it was a catastrophic failure.”

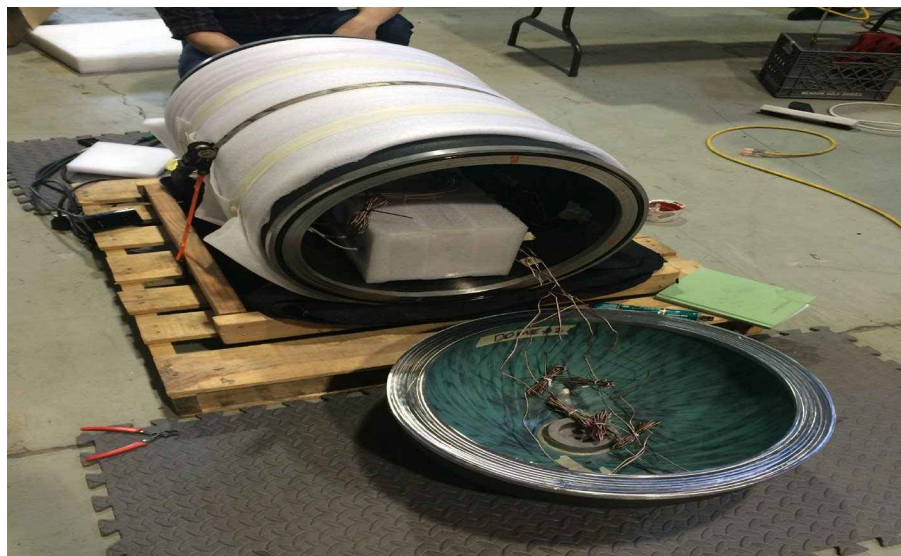
Figure 74: First one third scale model produced by Spencer Composites. Source: OceanGate.

“As many of you already know, we conducted a pressure test of a one-third scale model of our Filament Wound Carbon Fiber (FWCF) hull. At a pressure of 4,285 psi (the pressure at approximately 10,000-feet of depth) one of the hemispherical endcaps failed just outboard of one of the large stainless-steel inserts. While the failure was unexpected at this depth, it was well short of the design operating depth of 20,000 feet, a FWCF hemisphere was always viewed as an extreme technical challenge. Even Boeing with all their computer capacity admitted they were unable to analyze such a structure. Fortunately, there was no damage to the main cylindrical section, which is the critical part and a shape that is far better understood.

After an initial review yesterday by Spencer Composites (fortunately our new Board member, was able to fly the failed components to them within 5 hours of the failure), it is believed that the hemisphere buckled which was the reason our strain gauges did not give us warning of the failure. For the next test we will include acoustic monitoring which should give a better warning of this type of failure. Being able to consistently predict a pressure vessel failure is a key to ensuring we have a safe system that can operate for many years in varied conditions.”

4.12.6. The failure of the composite endcap prompted OceanGate to discontinue the use of composite end caps in favor of metallic alternatives—specifically titanium, aluminum, or steel. These materials would undergo testing over the next year to evaluate their compatibility with the pressure vessel. Mr. Rush underscored the achievements made so far, emphasizing that OceanGate’s core business model prioritizes "extreme efficiency."

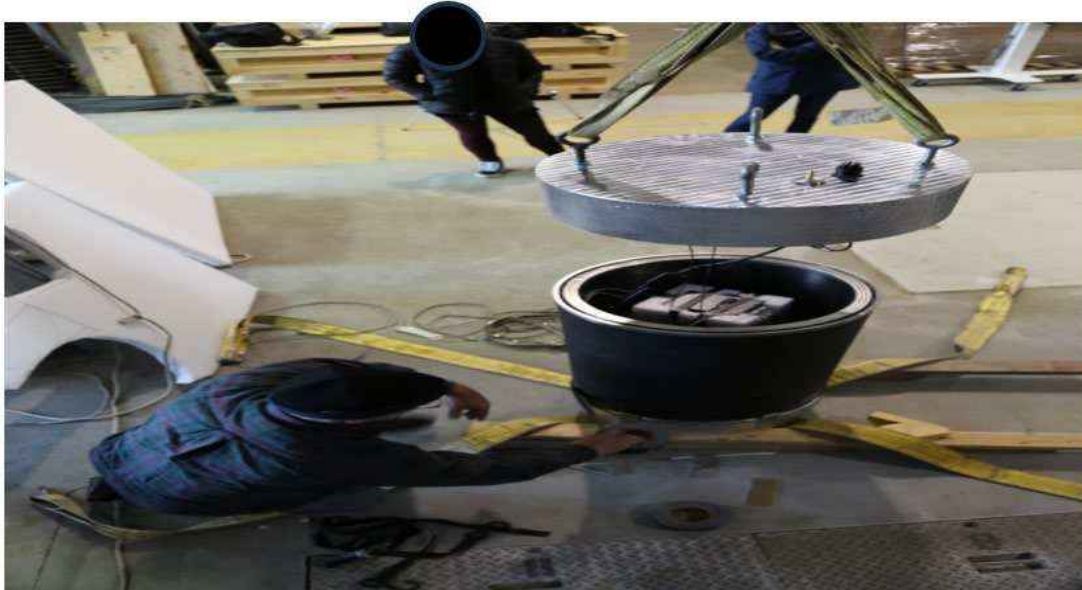
4.12.7. In February 2016, as noted in the UW-APL invoice and the OceanGate April 2016 Newsletter, OceanGate conducted the second one-third scale model test of the CYCLOPS II (First TITAN hull) carbon fiber hull cylinder, reaching a pressure of 6,000 psi before imploding, which corresponds to an ocean depth of 4,200 m. The UW-APL project engineer reported, “The second one was also a catastrophic failure, but I believe it was the domes that failed rather than the cylindrical section.”

Figure 76: Second one-third scale model produced by Spencer Composite’s with metallic domes. Source: OceanGate.

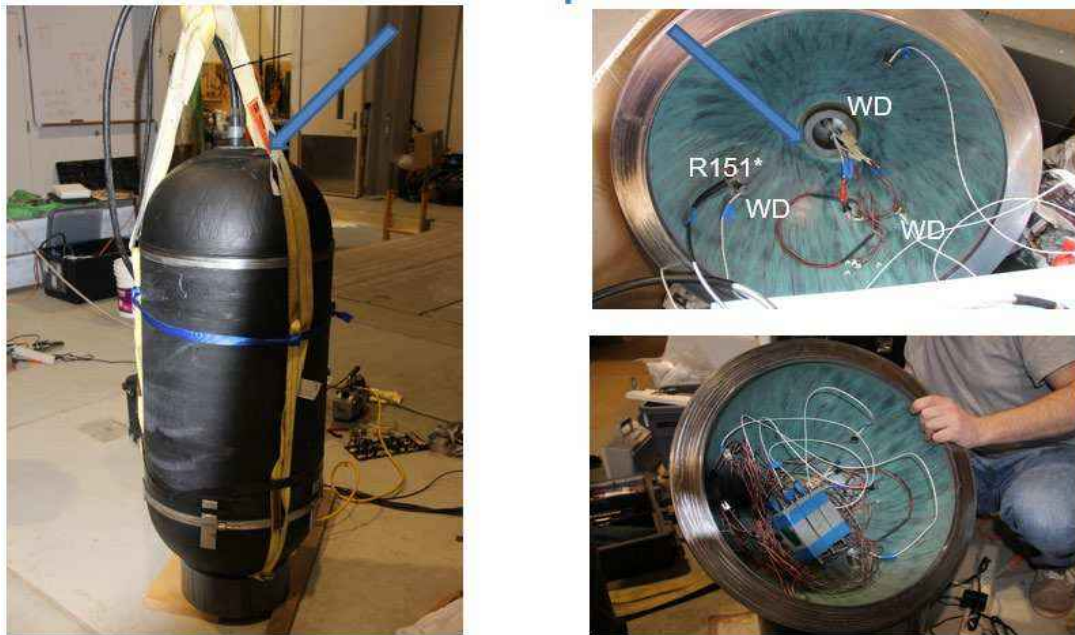
4.12.8. On March 11, 2016, during a third one-third scale model test, the model featured two carbon fiber hemispherical end caps attached to the main cylinder. This time, the team successfully utilized acoustic monitors to anticipate the effects and impending implosion of the hull. According to UW-APL Notebook page 66, failure occurred at 4,009.01 psi, when the top end cap imploded.

Figure 77: Placement of sensors and preamplifiers in the third one-third scale model test cylinder. Source: OceanGate.

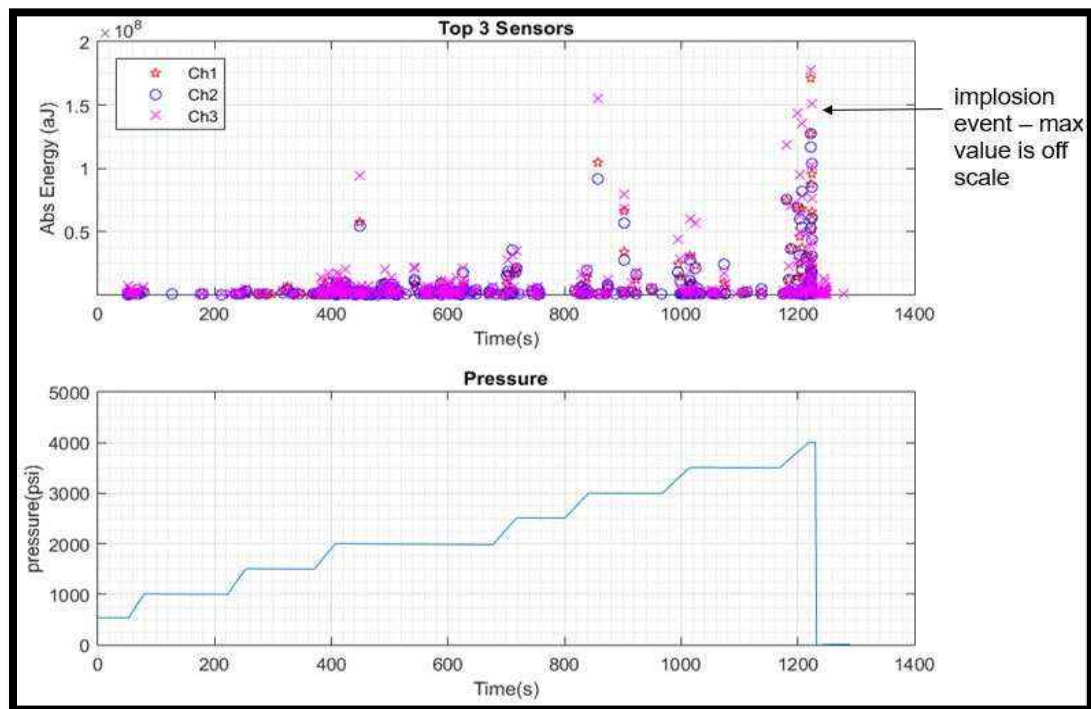
Figure 78: Acoustic emissions of top hemisphere. Source: OceanGate.

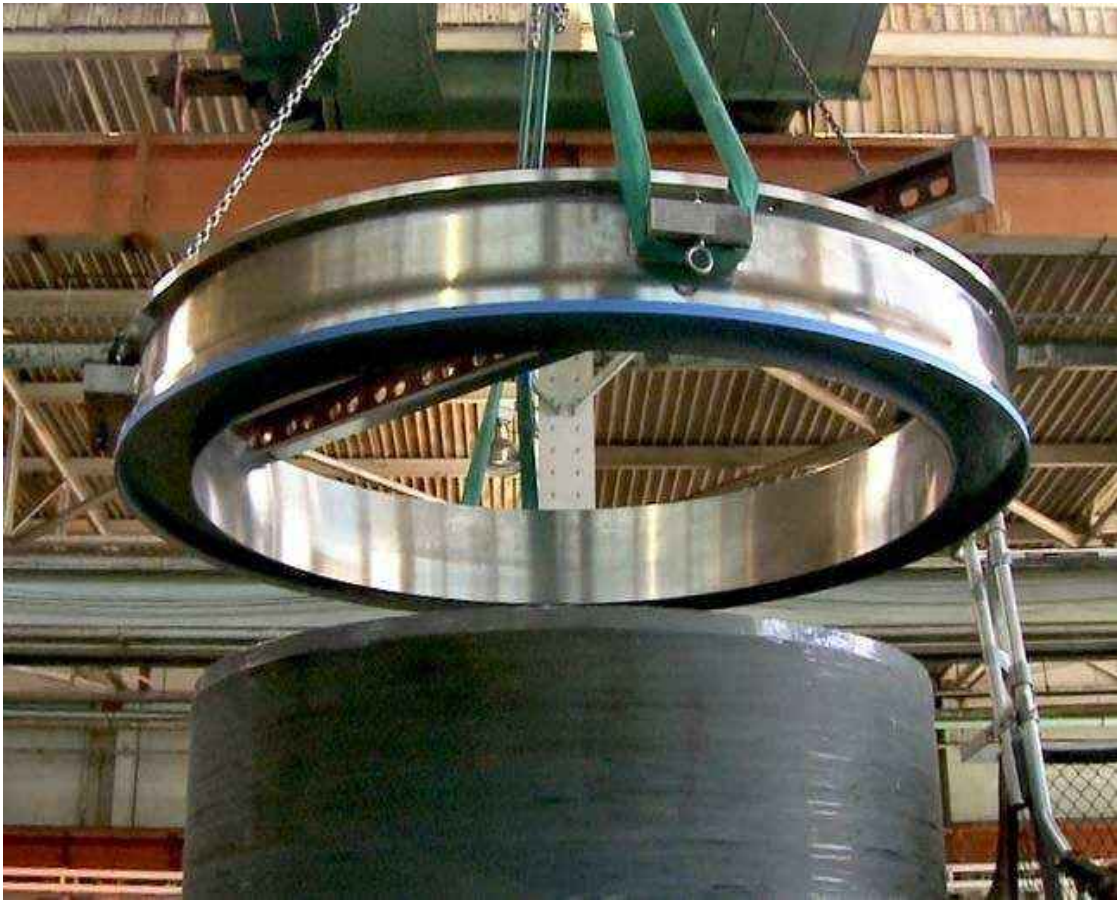
Figure 88: Adhesive applied to carbon Fiber Hull and “c” channel of forward segment in July of 2017. Source: OceanGate Expeditions.

4.16.3. The adhesive used in the adhesion process was HYSOL[®] EA 9394, also known as Henkel LOCTITE EA 9394 AERO. This adhesive was applied to the ends of the carbon fiber hull and the "C" channel of the fore and aft segments. The “C” channel of the segments was approximately 1.37 depth x 5.01 width inches with a slight taper at 0.88 depth inches in the notch. The hull was then inserted into the “C” channel. To form the joints, the aft joint was created by first lowering the hull down onto the segment, and the forward joint was then formed by lowering the segment down onto the hull, with the entire assembly oriented vertically. According to the Director of Engineering, despite concerns about its flexibility and uncertainty about whether this material had been used in the deep-sea submersible industry before, the adhesive choice was confirmed. OceanGate’s Director of Engineering stated that while they had hoped for a more flexible material, “NAME REDACTED (the manufacturer) preferred not to change the adhesive.”

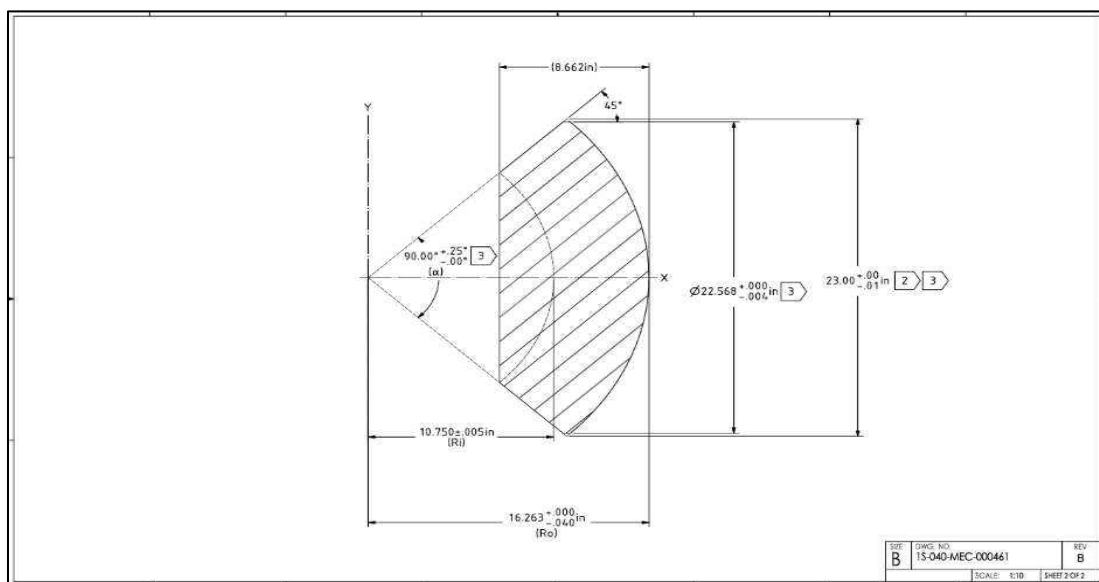
OceanGate submitted a purchase order to Hydrospace Group, Inc. (HSG) to create a 23-inch acrylic frustum dome designed for use with PVHO materials certification. The window was intended to meet the PVHO certification requirements and was priced at \$33,450. However, OceanGate specifically requested a conical external facing shape and a flat internal facing shape dome window, which would provide better viewing from inside the submersible. This window design, as proposed, was not an approved PVHO geometry, meaning it did not comply with established pressure vessel standards for human occupancy.

Figure 90: Acrylic Window Drawing for TITAN. Source: OceanGate.

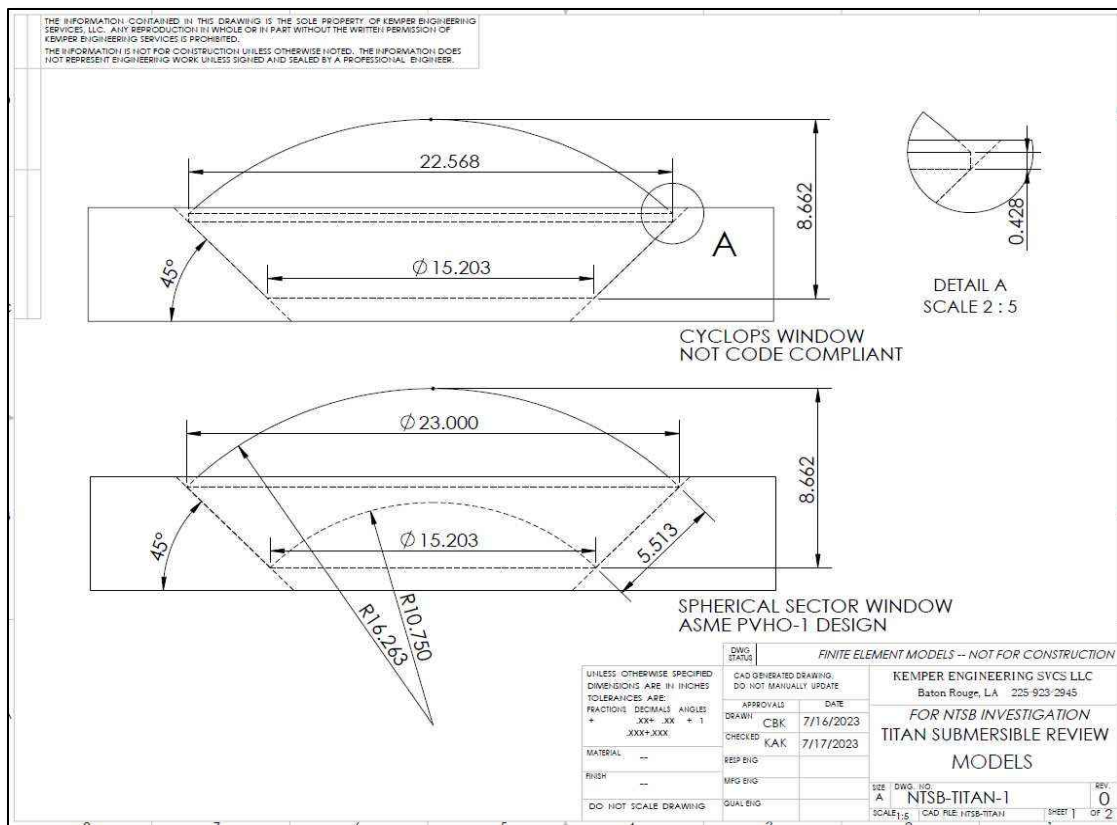
4.17.1.2. Hydrospace Group, in response to the request, suggested a hybrid design combining a conical frustum flat disk window with a spherical sector window. Hydrospace was willing to support the flat dome concept, provided OceanGate performed the necessary work to produce a PVHO drawing and obtain the associated PVHO Design Certification (FORM VP2). This certification would require both an FEA and prototype testing to ensure the window's structural integrity under deep-sea pressures. OceanGate decided not to follow through with producing the required design certification or testing, even for scaled-down models of the flat dome windows. Instead, Hydrospace Group offered to produce a spherical sector dome that would fit the same housing, meet PVHO compliance, and be rated to a depth of 4,000 m (13,123 feet). This alternative offer was also declined by OceanGate.

Figure 91: Acrylic Window Design for TITAN; ASME PVHO-1 Non-Code Compliant (top); ASME PVHO-1 Compliant (bottom). Source: Kemper Engineering.

4.17.1.3. OceanGate's decision to forgo testing and certification led to further complications in the development of the window. OceanGate had hoped that combining the strength of a spherical window with the optical clarity of a flat design would meet both their safety and visual requirements. However, the hybrid window concept, combining flat on the inside and round on the outside surfaces, remained a non-standard geometry that could not be certified under existing PVHO guidelines without extensive testing. This meant that OceanGate would need to perform computer analysis, physical testing, or a combination of both to validate the design's safety and optical performance. Without these steps, the hybrid window could not be considered certifiable under PVHO standards.

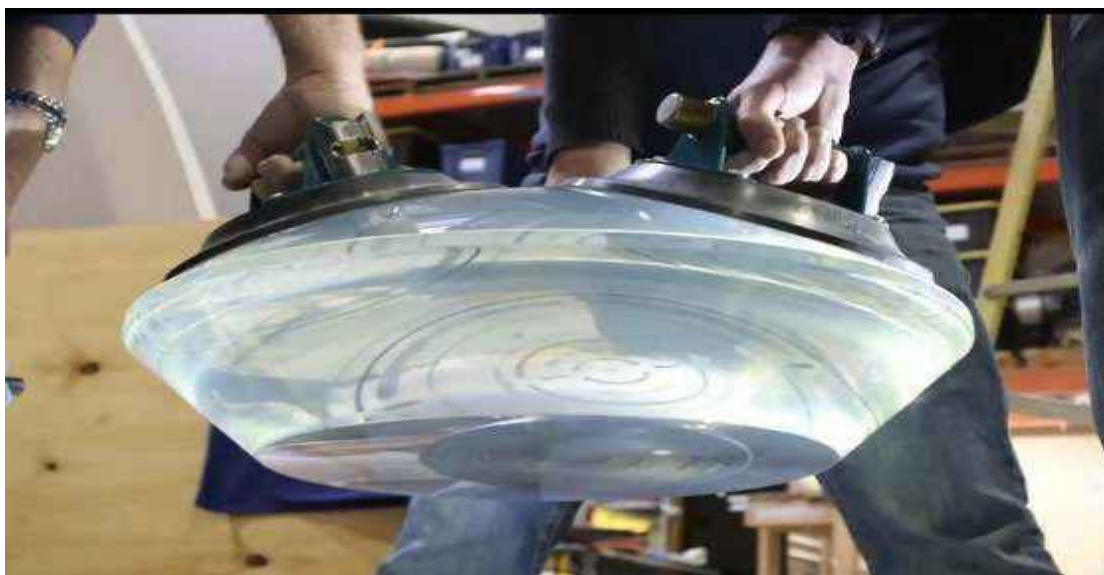
4.17.1.4. When completed, the acrylic forward main window had an inner diameter of 12.5 inches and an external diameter of 23 inches with a center thickness of seven inches. The rating of the window that Hydrospace produced

for OceanGate was 945 psi, calculated per the ASME PVHO standard at a temperature of 50° Fahrenheit (F). This pressure rating was marked on the window and registered in Hydrospace's database. However, 945 psi is only rated for a maximum depth of approximately 650 m (2,150 feet).

Figure 92: TITAN acrylic window from Hydrospace Group. Source: <https://ocean-archives.github.io/>.

4.17.1.5. This Hydrospace manufactured window was used on the TITAN until December 2019, when it was dropped, damaged, and subsequently replaced.

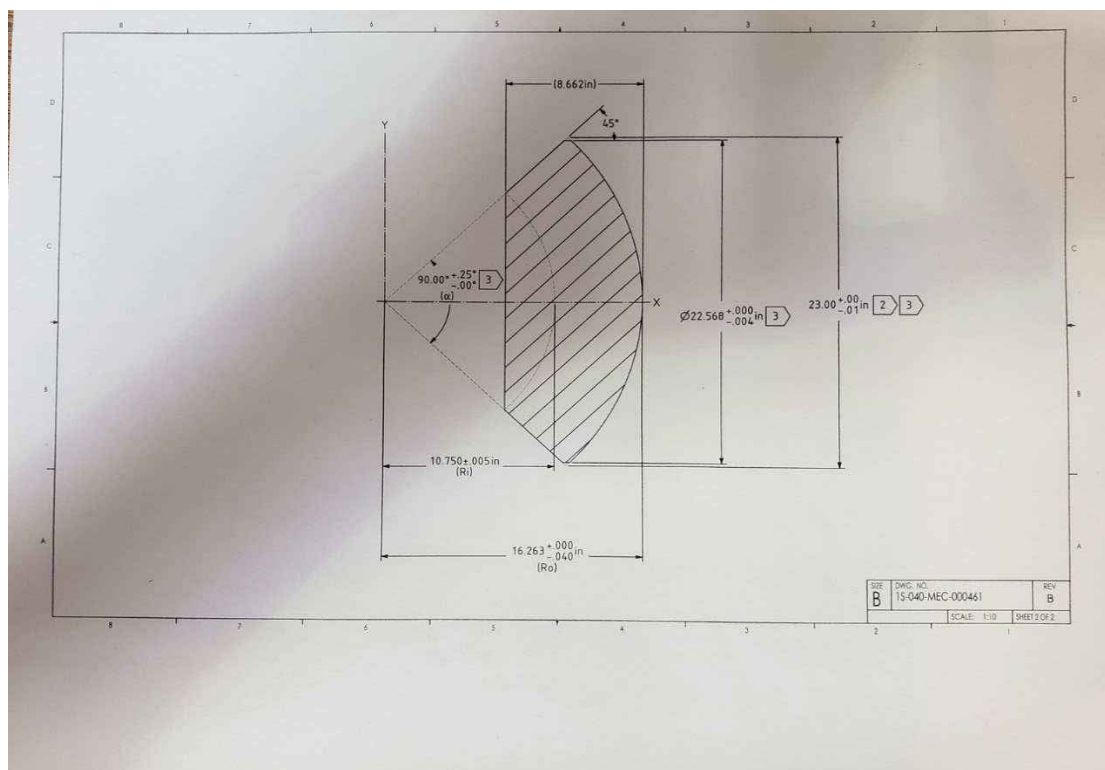
4.17.2.2. OceanGate chose the viewport option without the testing and certification documentation. For a manufacturer to proceed under the certification process, an approved drawing was required. If OceanGate had opted for a certified window, they would have first needed to have their design reviewed by a designer, manufacturer, or appropriate third-party authority. The decision not to request PVHO documentation was influenced not only by the extra costs for material testing and documentation at Heinz Fritz GmbH's facility but also by the anticipated length of the design review process. The window was built based on Drawing 1S-040-MEC-000461 REV B, dated October 10, 2017, which Heinz Fritz GmbH received via email on April 19, 2020, from an OceanGate employee.

Figure 94: OceanGate Drawing 1S-040-MEC-000461 Rev. B. Source: OceanGate.

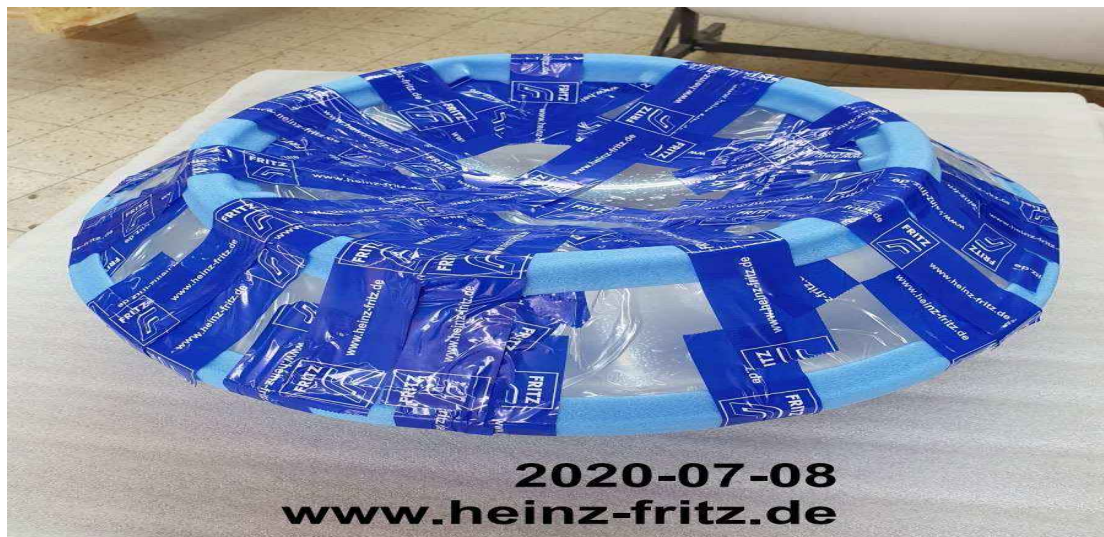
4.17.2.4. Next, according to the ASME PVHO-1 standard, the safety pressure for a Spherical Acrylic Window was calculated. Using the window's design file, the thickness (t) of the window was 140.75 mm, and the inner diameter (Di) of the viewing area was 386.151 mm. This gave a thickness-to-diameter ratio of 0.3645. Using a chart from the ASME PVHO-1 standard, the critical pressure for the window was found to be about 172 MPa (or 1,720 bar).

4.17.2.5. Using a formula and conversion factors, the design pressure for the window was calculated, assuming a temperature of 10° Celsius (C). The formula used was Short-Term Critical Pressure (STCP) = CF \times P, where P is the design pressure, and CF is the conversion factor. To find the pressure (P), the formula is rearranged to $P = \text{STCP} / \text{CF}$ or in this case $P = 172 \text{ MPa} / 4 = 43 \text{ MPa}$ (or 430 bar). This result indicates the window could handle pressure equivalent to a depth of about 4,300 m (14,108 feet).

Figure 95: Window manufactured by Heinz Fritz GmbH. Source: Heinz Fritz GmbH.

4.17.2.7. Heinz Fritz GmbH manufactured an acrylic window for OceanGate according to the provided drawing and delivered it to OceanGate without any

certification documents or PVHO Forms. According to Heinz Fritz, the manufacturing process followed PVHO standards, using the identical raw materials, machinery, grinding, polishing, and annealing methods that they had used during their manufacture of past windows that met the PVHO standard.

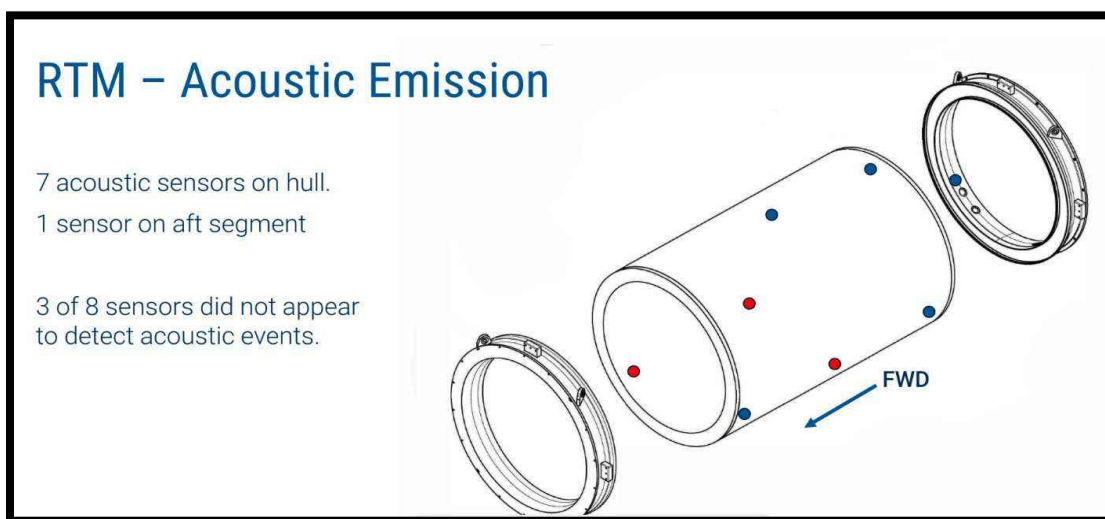
4.18.20. According to archived RTM data that OceanGate provided to the MBI from TITAN operations, acoustic emissions data for sensors one, three, and five provided no acoustic activity from dives 75 through 83³¹. All other sensors (two, four, six, seven and eight) showed acoustic activity for the dives.

4.18.21. According to the Project Execution Plan for 2023, OceanGate no longer had a Director of Engineering on staff. When the previous Director of Engineering was asked about the lack of AE data for sensors one, three, and five, he stated that he was unaware of the lack of data and that the sensors should have been checked before each dive.

Figure 105: Layout of acoustic emissions sensors in TITAN hull. Blue dots are the location of sensors that provided acoustic Activity. The red dots were the location of the sensors that did not show activity from Dive 76 through Dive 83. Source: NTSB Materials Laboratory Factual Report.

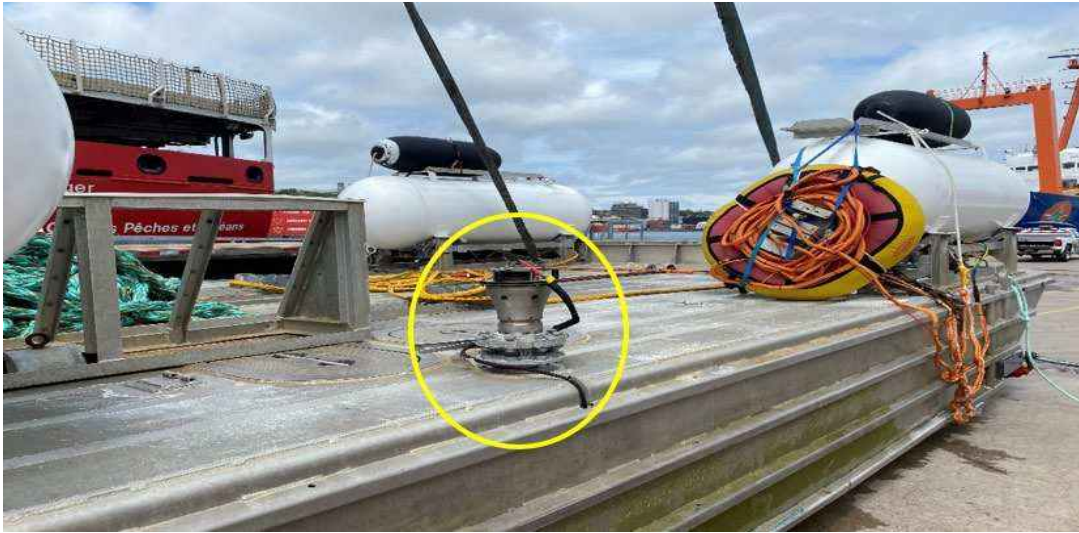
Figure 112: The LARS ballasting valve is pictured within the yellow circle added by MBI. The photograph was taken by the MBI in St. John's, Newfoundland post-casualty on June 25, 2023. Source: USCG.

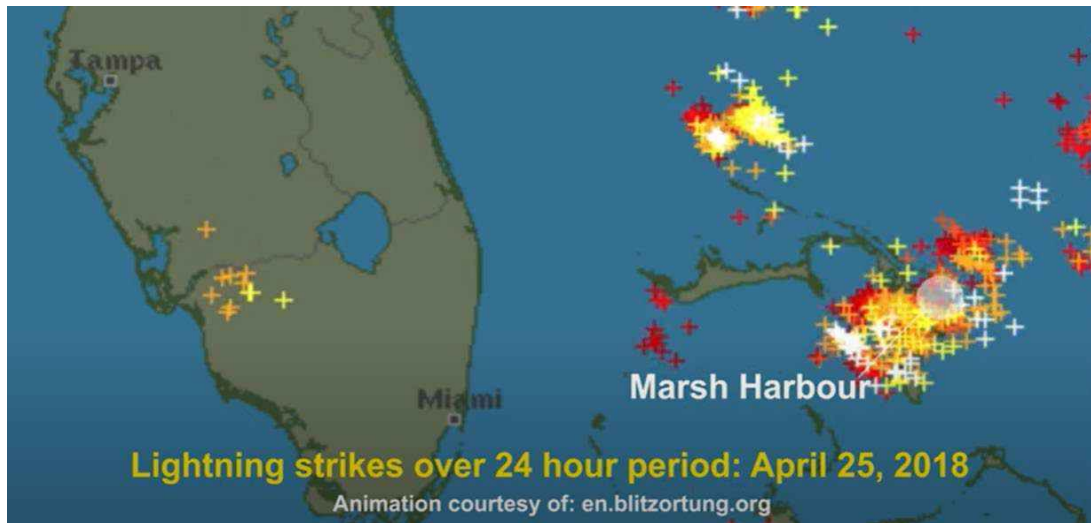
Figure 118: Lightning activity over Marsh Harbour, Bahamas, April 25, 2018. Source: OceanGate Expeditions.

4.22.3. On April 30, 2018, the TITAN was transferred to the LARS platform. During vessel checks, the team observed sporadic electrical system behavior and concluded that, although the TITAN had not been directly struck by lightning, it sustained severe component damage due to overcurrent potentially generated by a nearby lightning strike. The TITAN's maintenance log recorded the replacement of multiple routers, switches, and relay board components. While the engineering team worked on re-wiring the TITAN, the operations team conducted LARS test dives and reconnaissance in preparation for TITAN test dives in the Sea of Abaco.

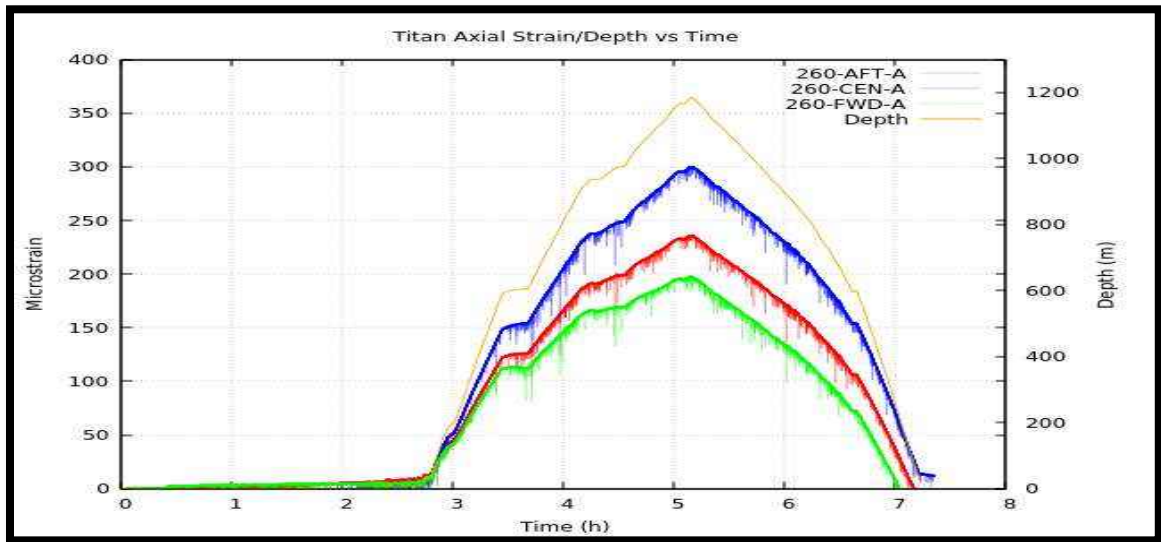
4.22.9. OceanGate's Director of Engineering analyzed the strain data for the unmanned dives and determined for both the 1,200 m (3,937 foot) and 2,500 m (8,202 foot) dives that there was a close correlation between the measured strain values and the depth profile, which indicated that the strain sensors were functioning properly, as shown in Figure 123. Figure 123 displays the axial and hoop strain measurements from an aft-to-forward direction, with consistent color codes representing the hull's internal surface. A

review of the graphs revealed consistent tracking of case movement with load application. However, the Director of Engineering further stated that several anomalies warrant further investigation, including the following items: (a) equal axial and hoop strain mid-case, (b) significant differences in axial strain between the forward and aft sections, (c) significant differences in hoop strain between the forward and aft sections, and (d) the inversion of axial and hoop strain trends between the forward and aft sections.

Figure 123: TITAN strain data from Dive 24 to 1,200 m on June 21, 2018. Source: Former OceanGate Director of Engineering Report.

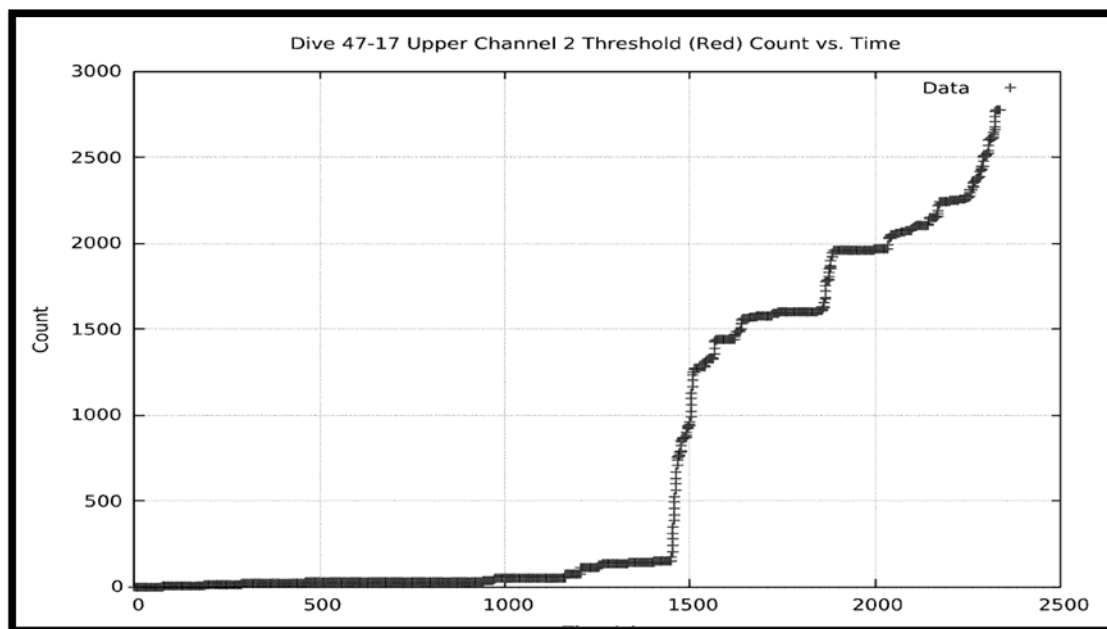
“While I think your concept of RTA (Real-Time Acoustic Monitoring) is sound, I am not sure it applies in this case. The acoustic signatures we observed yesterday do not appear to correspond with typical failure modes such as adhesive bond failure, delamination of air cavities, or random fiber breakage. In my assessment and based on the discussion NAME REDACTED³⁵ and I had last night, which he concurs with, the sounds we heard seemed indicative of a localized flaw or defect in the hull structure being subjected to significant external pressures, resulting in crushing or damage. The intensity and persistence of the sounds, particularly their continuation at depth, coupled with sounds recorded around 300 feet that suggest a release of

stored energy, point to the possibility of a specific area of the hull material experiencing progressive degradation or becoming ‘spongy’.”

4.22.15.1. The owner/pilot of the submarine IDABEL testified to the MBI that the noises heard during his dive on the first TITAN hull had a sharp, percussive quality, resembling the sound of gunshots, and appeared to emanate from a localized region of the submersible’s hull.

Figure 129: TITAN Dive 47 acoustic event count for channel 2. Source: OceanGate.

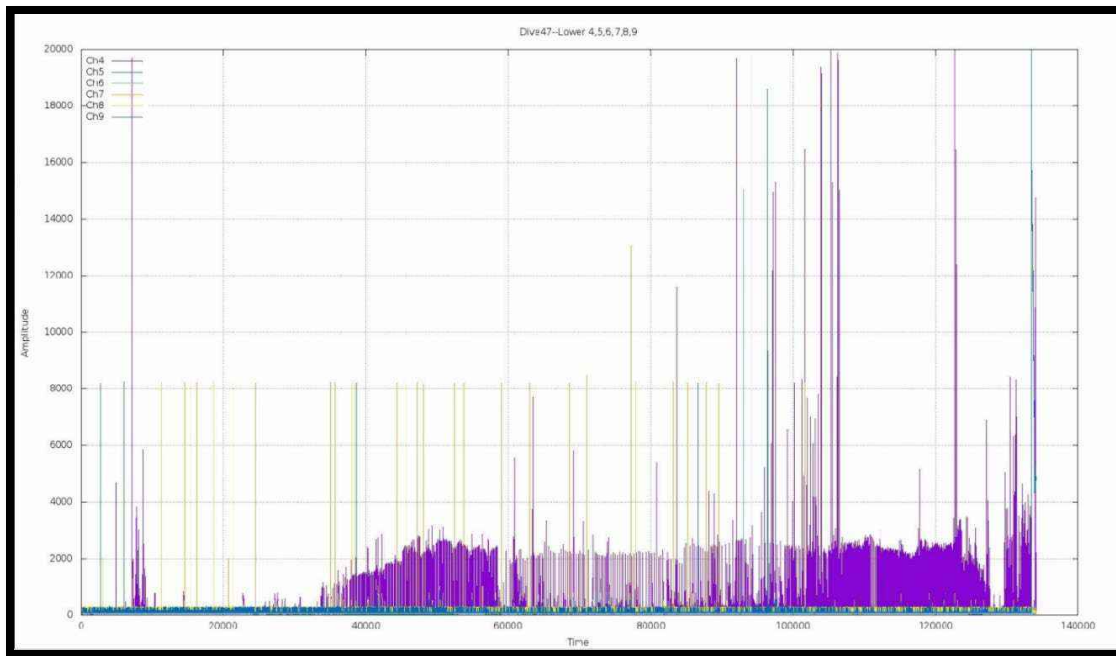
Figure 130: TITAN Dive 47 acoustic event sensor amplitude for lower sensors. Source: OceanGate.

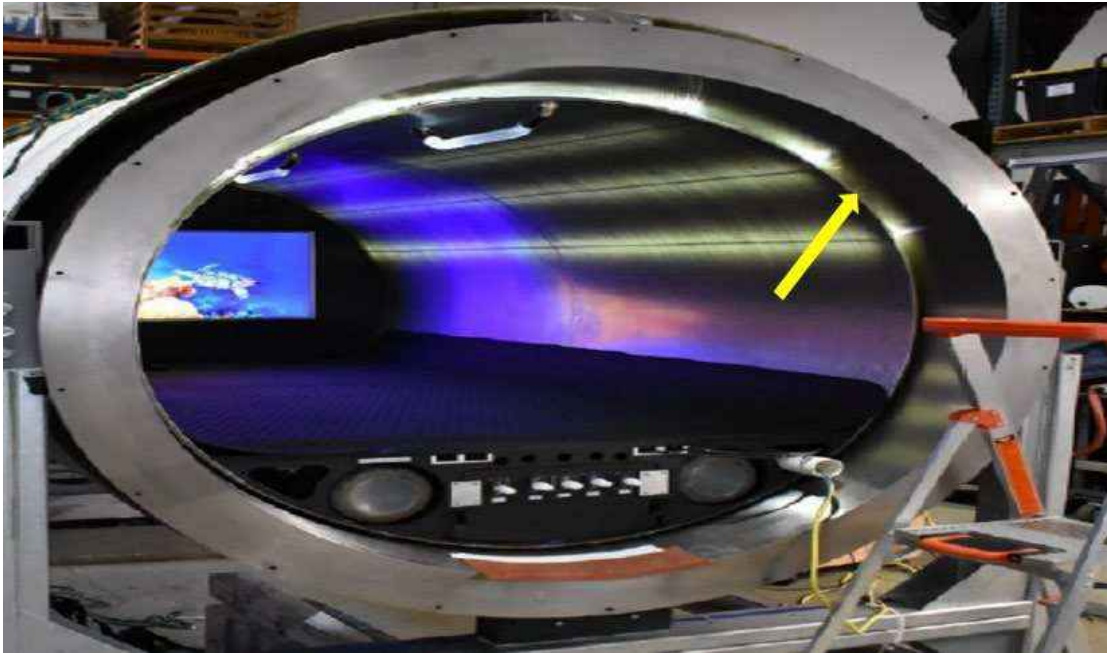
4.22.17. On May 29, 2019, during a pre-dive inspection in the Bahamas, a TITAN pilot illuminated the forward space between the hull and the insert and identified what appeared to be a crack in the carbon fiber structure. This finding prompted immediate notification to the appropriate OceanGate personnel, and upon further investigation and removal of part of the insert, the crack was confirmed to be in the carbon fiber that comprised the inner layer of the hull. According to a former OceanGate Director of Engineering, the crack extended approximately four feet longitudinally while extending about a third of the way around the hull transversely.

4.22.17.1. The TITAN’s carbon fiber outer hull was coated with a polyurethane layer, which concealed the underlying carbon fiber from external view. Internally, an HDPE (high-density polyethylene) insert was positioned

approximately three-quarters of an inch away from the hull, creating a small gap between the hull and the internal structure.

Figure 131: Yellow arrow (added by MBI) pointing to the $\frac{3}{4}$ " gap between the TITAN's carbon fiber hull and its insert.
