UNITED STATES COAST GUARD

**REPORT OF THE MARINE BOARD OF INVESTIGATION
INTO THE
IMPLOSION OF THE SUBMERSIBLE TITAN
(CG 1788361) IN THE NORTH ATLANTIC OCEAN
NEAR THE WRECK SITE OF THE RMS TITANIC
RESULTING IN THE LOSS OF FIVE LIVES
ON JUNE 18, 2023**

MISLE ACTIVITY NUMBER: 7724663

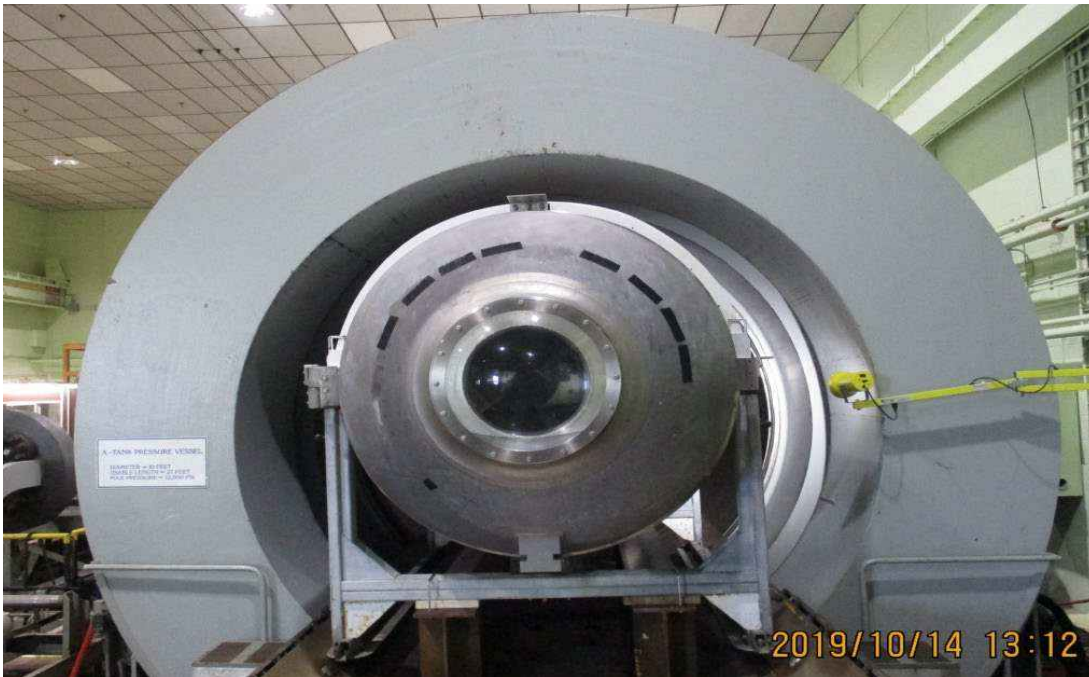
Figure 134: First TITAN hull inside Deep Ocean Test Facility chamber on October 14, 2019. Source: OceanGate.

4.23.1. In October of 2019 the first TITAN hull was shipped to the Deep Ocean Testing Facility (DOTF) in Bethesda, Maryland to conduct a pressure test to rate the hull with the crack in the carbon fiber. The cost of the testing was \$60,200 for five days. The testing began at 9:08 a.m. on October 15, 2019, and was completed at 4:49 p.m. the same day. The highest psi achieved was 4,722 psi which is equivalent to an ocean depth of 3,743 m (12,280 feet).

4.23.4. In a January 9, 2020, article published by GeekWire.com³⁹, Mr. Rush stated that testing at the DOTF had revealed signs of cyclic fatigue in the first TITAN hull. As a result, the hull's rated depth was reduced to 3,000 m, rendering it insufficient for reaching the TITANIC wreck site. The article also noted that OceanGate had successfully secured \$18.1 million in new funding, entirely sourced from inside investors which was “laying the financial groundwork for an expansion of its fleet of deep-sea submersibles and setting the stage for dives to the 108-year-old Titanic shipwreck in 2021.”

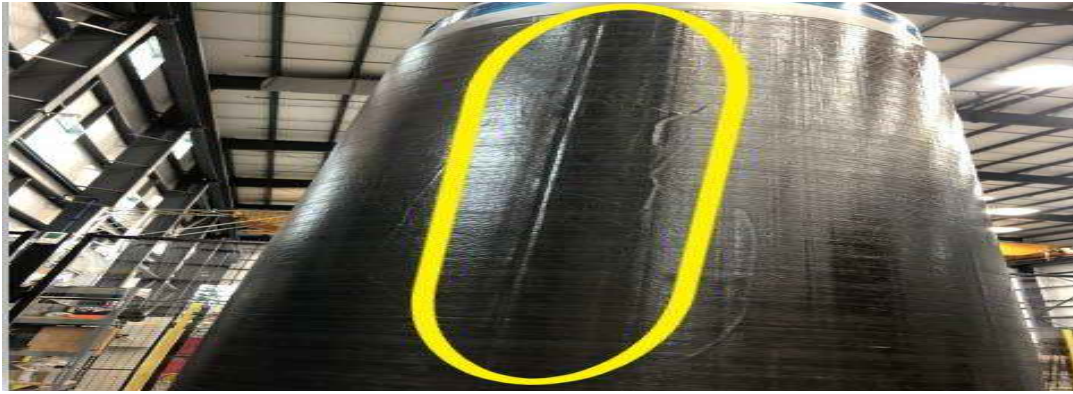
4.27.2.1. On May 19, 2020, a wrinkle was identified at ply 40 in the one-third scale model that was perfectly axial from top to bottom. As a result, a decision was made to restart the manufacturing of the one-third scale model.

Figure 139: Wrinkle in the one-third scale hull model for Final TITAN hull (yellow circle added by MBI). Source: OceanGate Expeditions.

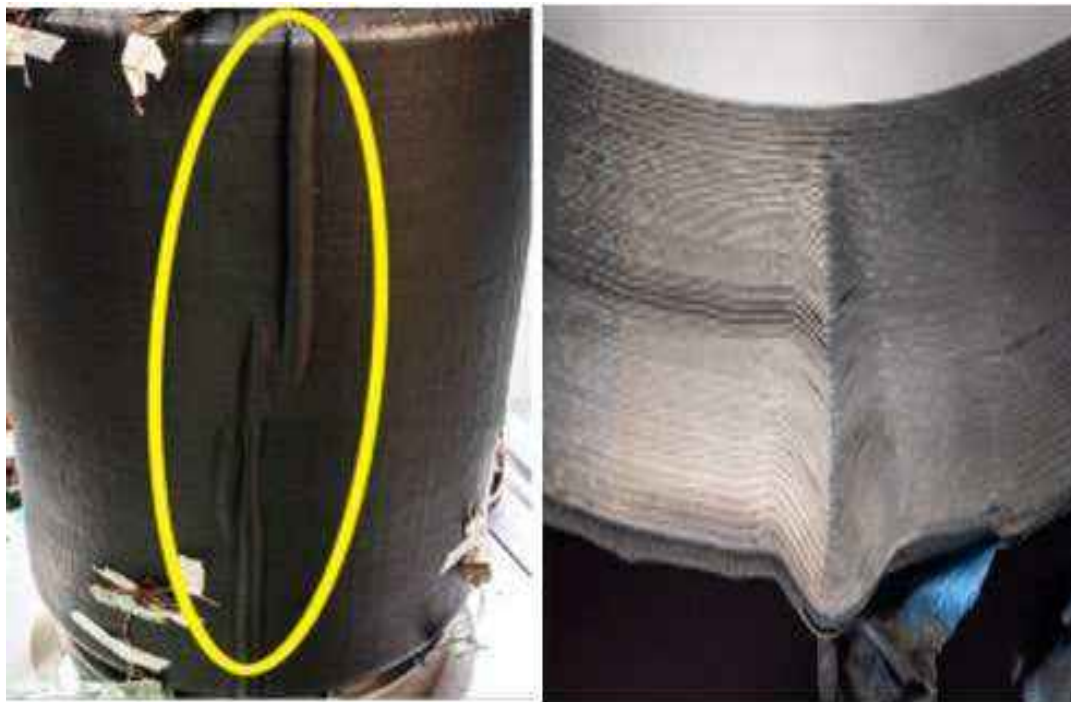
4.27.2.3. After the cure, large wrinkles were identified in the one-third scale model.

Figure 140: Wrinkles on the surface and cross section cut of one-third scale model for the final TITAN hull post autoclave cure (yellow circle added by MBI). Source: OceanGate.

4.27.2.6. On July 27, 2020, OceanGate conducted pressure testing on a one-third scale model of their hull. UW-APL, which conducted the testing, invoiced OceanGate for 7.25 hours of work. However, a UW-APL representative indicated in an email to a colleague that the test resulted in a catastrophic failure. A subsequent analysis by Collier determined the hull failed at approximately 3,000 meters (9,843 feet). Collier further clarified that the wrinkles observed in the hull (as depicted in Figure 140) would have been particularly vulnerable due to a combination of factors: misaligned hoop fibers not properly aligned with the load-bearing direction, a resin-rich composition within the wrinkle compared to the surrounding laminate, the relative softness of the resin compared to the fibers, and significant delamination within the wrinkle causing voids that were more susceptible to compression than either the fibers or the resin

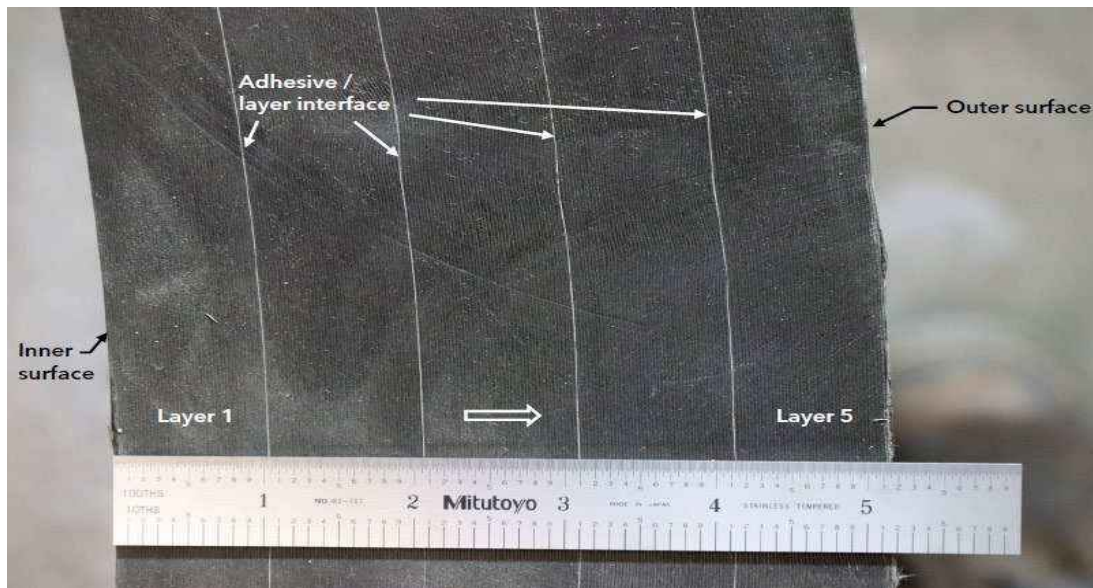
Figure 148: TITAN final hull cross-section showing co-bonded layers. Pieces from full-scale and test hulls were examined in Seattle by MBI the Engineering Team and taken to NTSB lab for material testing. Source: NTSB Materials Laboratory Factual Report.

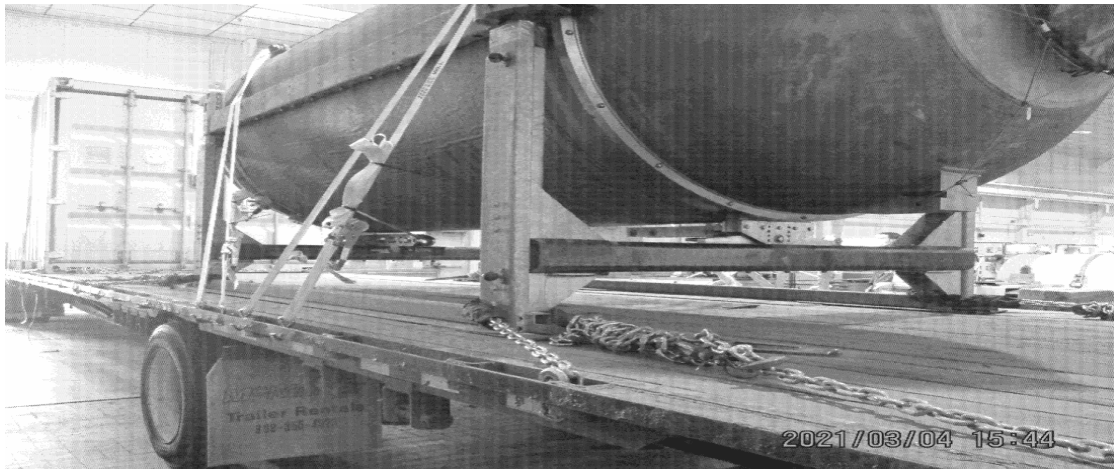
4.28.6. On March 4, 2021, the final TITAN hull departed the DOTF via flatbed truck. When the submersible departed for transport on the roadway, it was not wrapped in any protective material.

Figure 153: TITAN on flatbed prior to departing the DOTF on March 4, 2021. Source: DOTF.

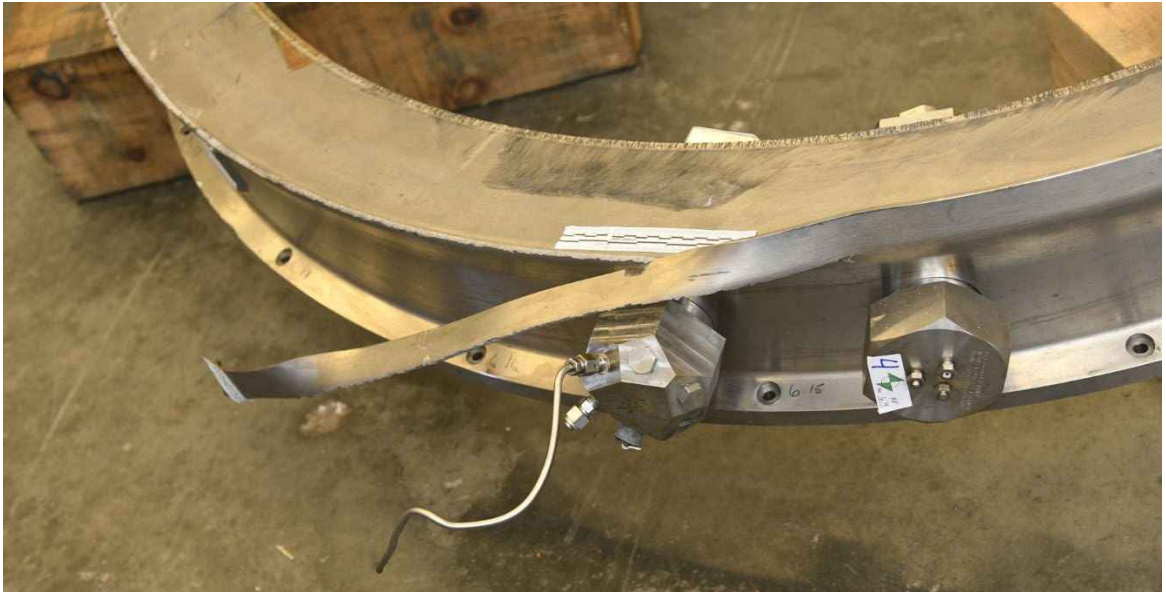
Figure 157: The TITAN's aft segment is pictured post-accident on July 5, 2023. Two of TITAN's penetrators are visible. The aft segment had four penetrators equipped to supply electrical, air, and hydraulic systems. Source: FBI Evidence Response Team (ERT).

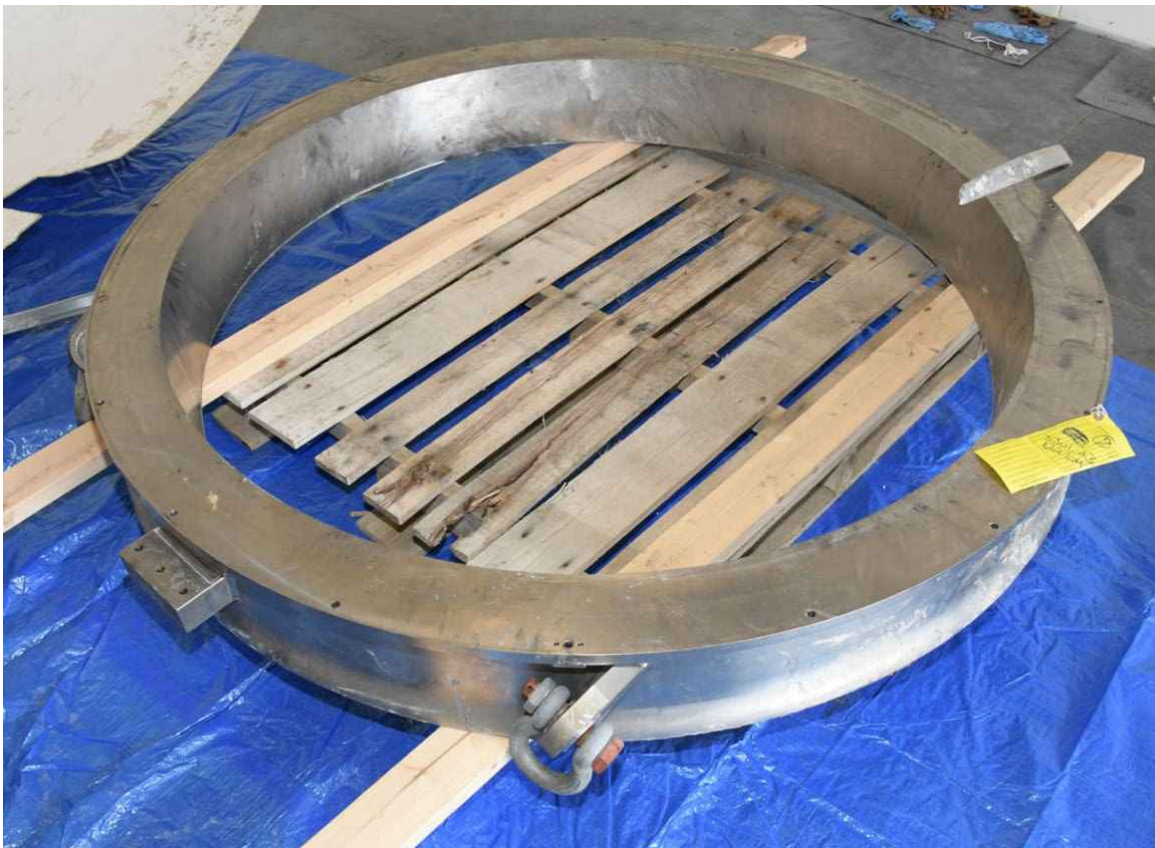
“The domes, the rings in the domes, were never designed to take excessive load in the shear direction. That would be a sliding interface.... If you can think of the weight of the hull on the clevis, shear would be pushing on this little lip here and that's, it's a small dimension. The point of (the small clevis) was just to keep (the segment) glued in place because subsea structures, a beautiful thing about them, is it's uniform loading all the way around.”

Figure 159: The TITAN's forward segment is pictured post-accident on July 5, 2023. One of the lifting eyes, which was added to the segments by OceanGate in March of 2021, is visible at the bottom of the photo. Source: FBI ERT.

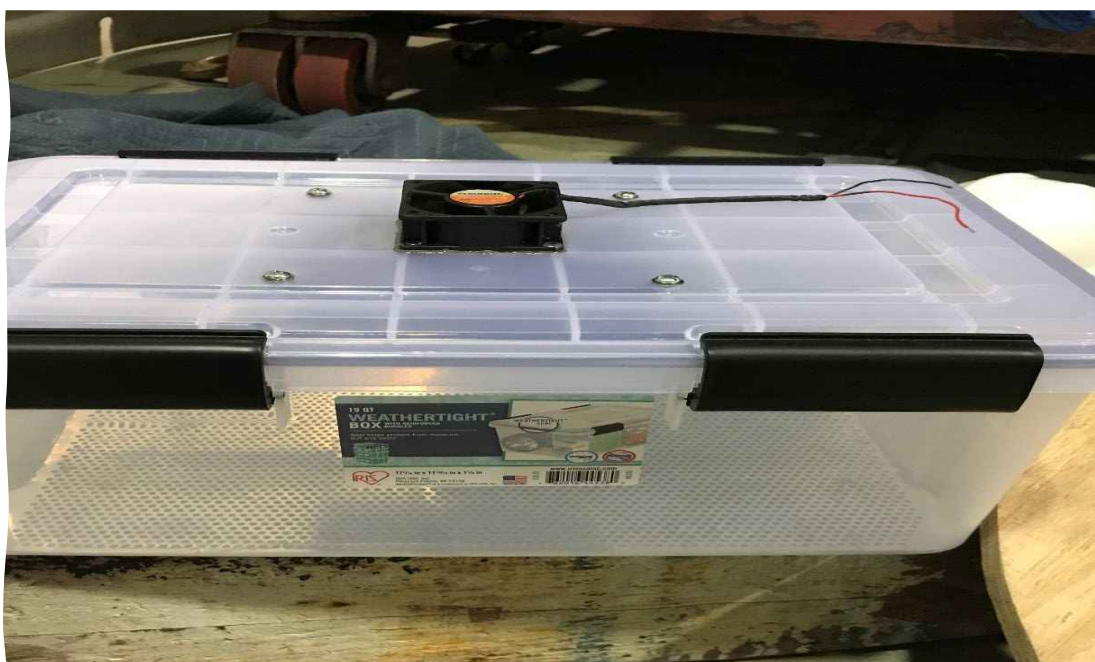
4.29.6.2. According to a former OceanGate Director of Engineering, the initial scrubber system in the TITAN, designed and built by Mr. Rush, was a "homemade" system that consistently failed to maintain adequate oxygen levels. This system was not in use on the final TITAN hull. The date of its replacement is unknown. The Director of Engineering provided the following testimony to the MBI:

“The scrubber was a homemade Stockton thing. I tried to get rid of it multiple times. Always was told no. It was literally made from a Tupperware container that came from Walmart or Amazon or somebody like that. It had liked a screen in the bottom with an air space underneath. You would pour the scrubber into this thing which was a granular chemical material, soap and lime is what it is, right. You'd pour that in there, and then there was a lid, a Tupperware lid that went on and in that Tupperware lid there was a computer fan. You'd attach the computer fan to a battery. That would pull air out of the environment, push it into the scrubber material and then, you know, through the grid at the bottom and out some vent somewhere. So, this thing never really kept up. If you put four people in the sub, it really couldn't keep up with the occupants' breathing rate. So -- and it looked like it was a total piece of junk. I mean it looked like a Tupperware container from Walmart with computer fan on the top.”

Figure 178: TITAN's "homemade" CO₂ scrubber. Source: Former Director of Marine Operations.

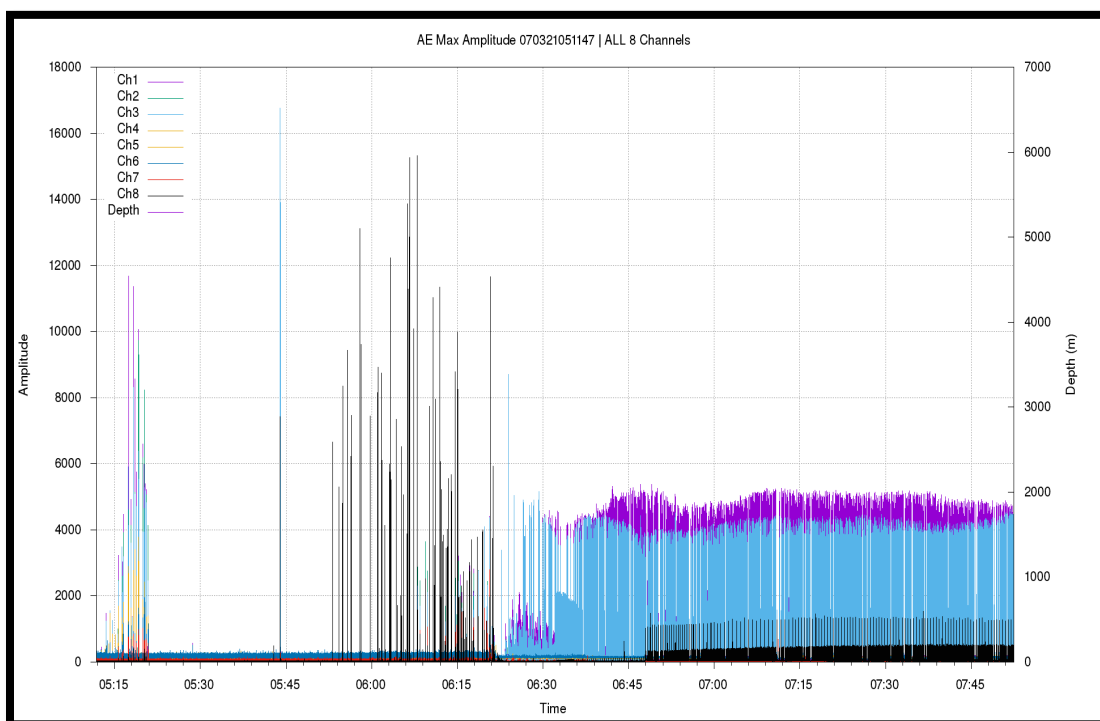
4.33.8.2. Additional issues encountered during Dive 62 included: two drop weights jammed in the starboard channel, anomalous "hits" on acoustic sensors #1 and #3 (later attributed by OceanGate to non-mechanical sources), intermittent DVL functionality, and an external hull high-pressure valve being incorrectly positioned for the dive.

Figure 201: TITAN's acoustic emissions for Dive 62. Source: OceanGate.

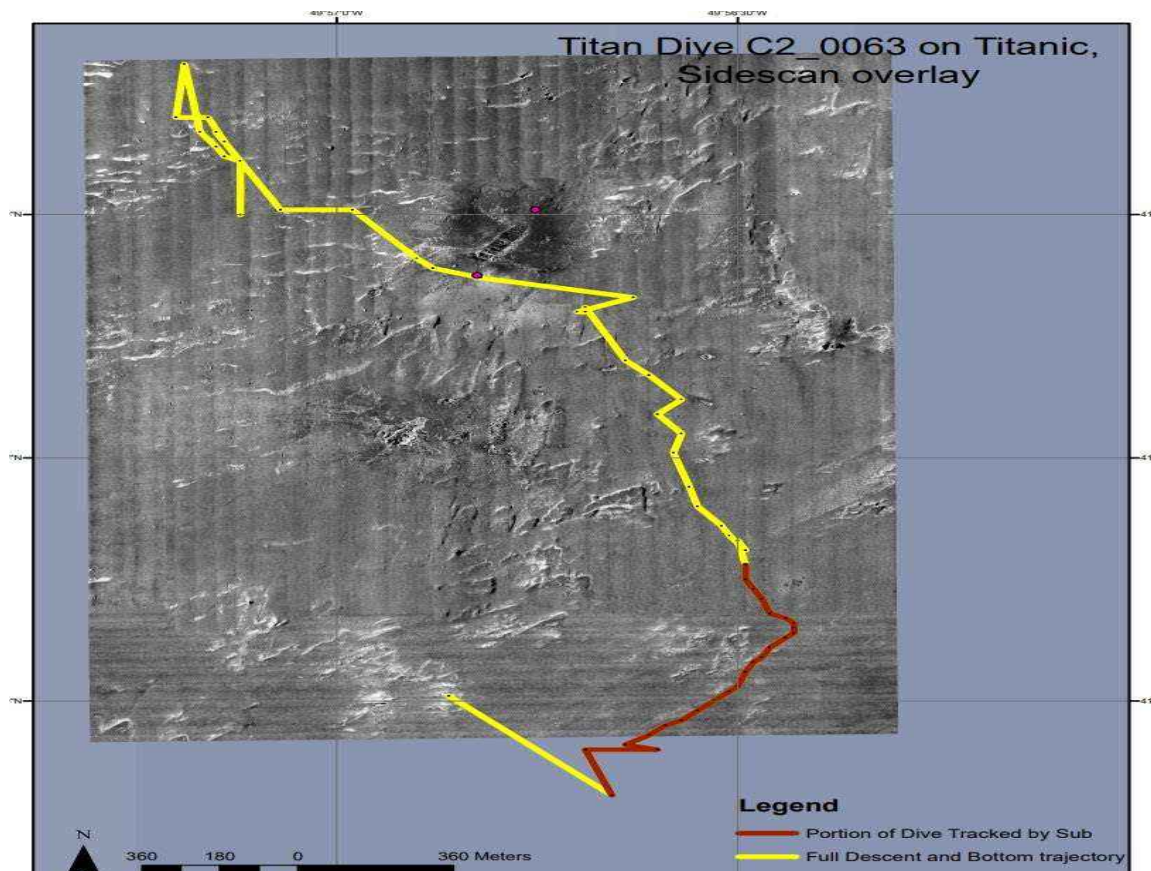
Figure 203: TITAN Dive 63 track is indicated by the yellow and red line. The TITANIC wreck’s bow and stern are identified by two pink dots. Source: OceanGate.

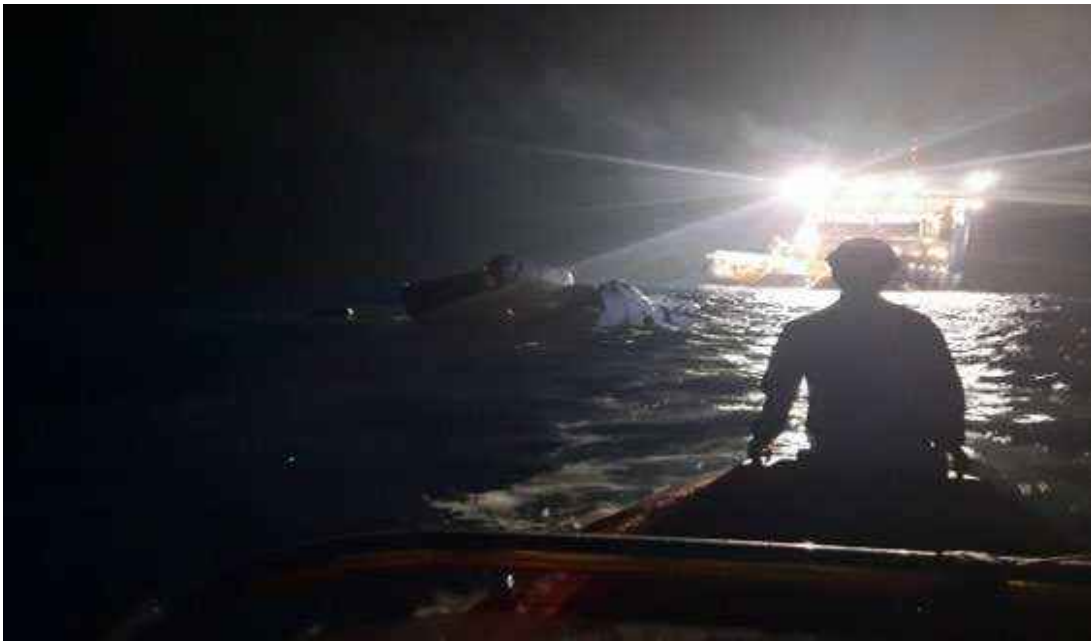
4.33.11.2. During Dive 63, the electric motors controlling TITAN's drop weight system failed and the crew was unable to surface on schedule. The crew aboard the TITAN attempted to repair the malfunction by rewiring the drop weight motor actuator, but their efforts were unsuccessful. The crew then tried to dislodge the weights from the tray by rocking the submersible, but this approach also failed. Unable to release the weights through either method, it became

necessary to jettison the entire drop weight tray, which enabled the TITAN to ascend to the surface. The failure of the drop weight system was classified by OceanGate as an “incident” following the dive, and a formal report was subsequently filed according to witnesses interviewed by the MBI. However, the MBI was not provided with a copy of the incident report during the investigation. Additionally, during the same dive, the TITAN’s aft port fairing was detached, the Blue View sonar system became inoperative, and the DVL experienced intermittent functionality.

Figure 204: Image of the final TITAN hull after surfacing from Dive 63. Source: HORIZON ARCTIC crew member.

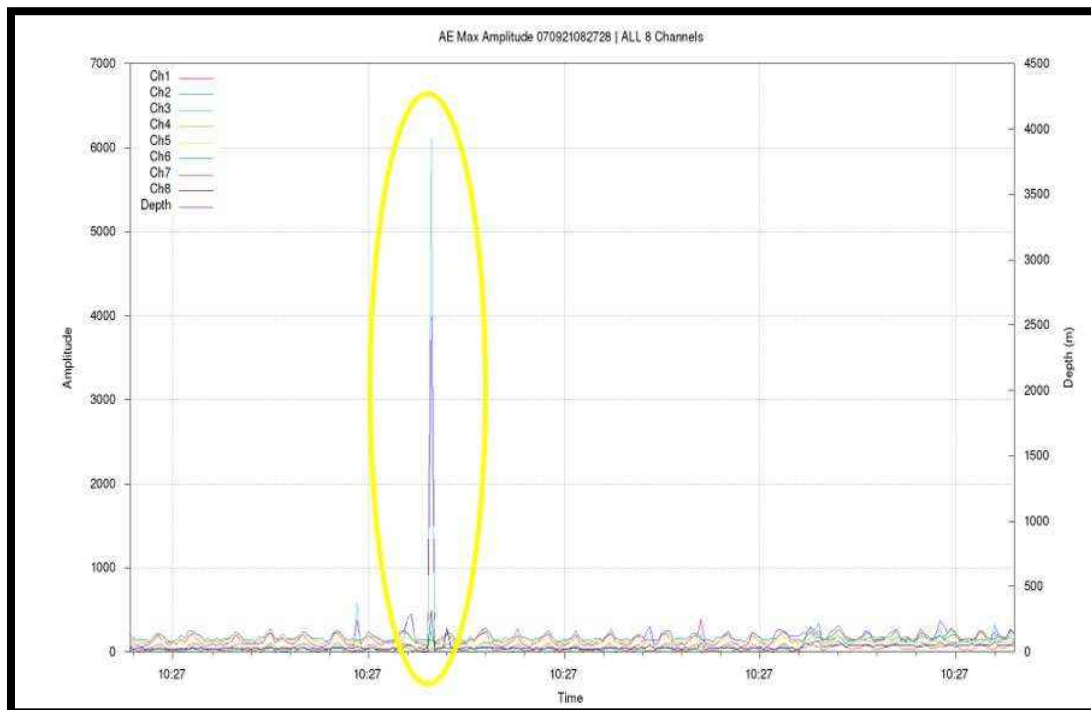
4.33.11.3. OceanGate’s Director of Logistics who also served as co-pilot of the TITAN during Dive 63 made the following statement to the MBI: “Heard what I thought was what Stockton had described as a, as a -- he described the sound of a -- the carbon fiber cracking as a, as a slap of the ruler on the table, and the -- and I heard a sound related to that on one dive at depth, but that was the only one, one incident of that.”

Figure 205: TITAN Dive 63 Acoustic Emissions chart showing the data recorded from a "ruler slap" sound (highlighted in the yellow circle added by MBI). The sound was heard by OceanGate's co-pilot on the mission. Source: OceanGate.

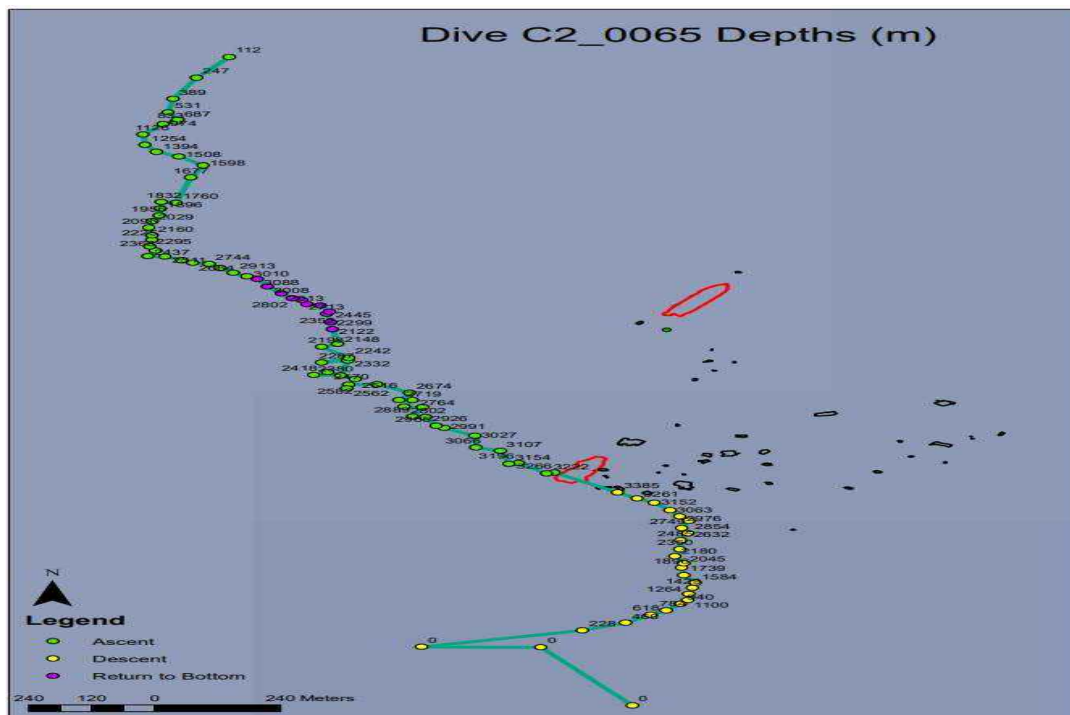
Figure 209: TITAN Dive 65 dive profile. Starting from the bottom of the graphic, the yellow dots indicate TITAN’s initial descent, the green dots indicate TITAN’s initial attempt to ascend with thrusters, the purple dots indicate TITAN’s redescend after its thrusters used up the battery power, and the last set of green dots indicate TITAN’s final ascent to the surface after partially releasing the drop tray. Source: OceanGate.

4.33.15.3. After 3.5 hours of troubleshooting and redescending to the bottom, the crew aboard the TITAN was able to manipulate the hydraulic pump for the drop weight tray just enough to release a portion of the tray's weights needed to resurface, without releasing the entire tray.

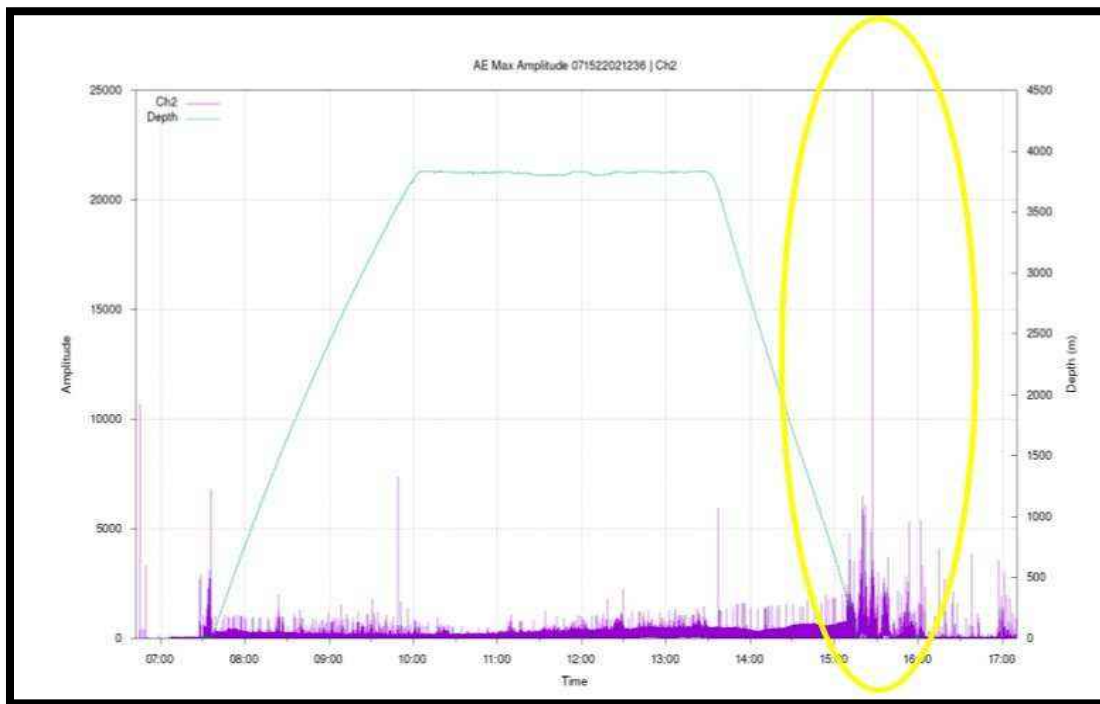
4.34.8.1. A mission specialist stated the following to the MBI regarding the last portion of Dive 80, "When we were ascending, I don't recall the depth, but I think we were fairly close to the surface, though still underwater, when there was a large bang or cracking sound. And, of course, sonic events in a submersible are alarming, so we were all concerned that maybe there was a crack in the hull." The TITAN's RTM system acoustic sensors captured the bang which was more than 25,000 millivolts (mV) amplitude.

4.34.8.2. According to a mission specialist aboard the TITAN during Dive 80, OceanGate performed a post-dive external assessment of the TITAN due to the loud bang. However, the TITAN's insert was never removed to examine the structural integrity of the hull's interior carbon fiber layer. OceanGate subsequently concluded that the "loud bang" heard during the dive was caused by a shift in the TITAN's position within its frame. The mission specialist stated the following to the MBI regarding his understanding of OceanGate's explanation: "It turned out, upon inspection after we got on the ship, that the body of the fuselage of the TITAN had just jumped in its carriage, so there was no damage."

Figure 215: Dive 80 Acoustic Emissions Data for channel 2 (which is located on the forward port side of the TITAN hull). The yellow circle (added by MBI) highlights the acoustic emission for time of the “loud bang” which occurred as the TITAN was still submerged but nearing the surface. Source: OceanGate.

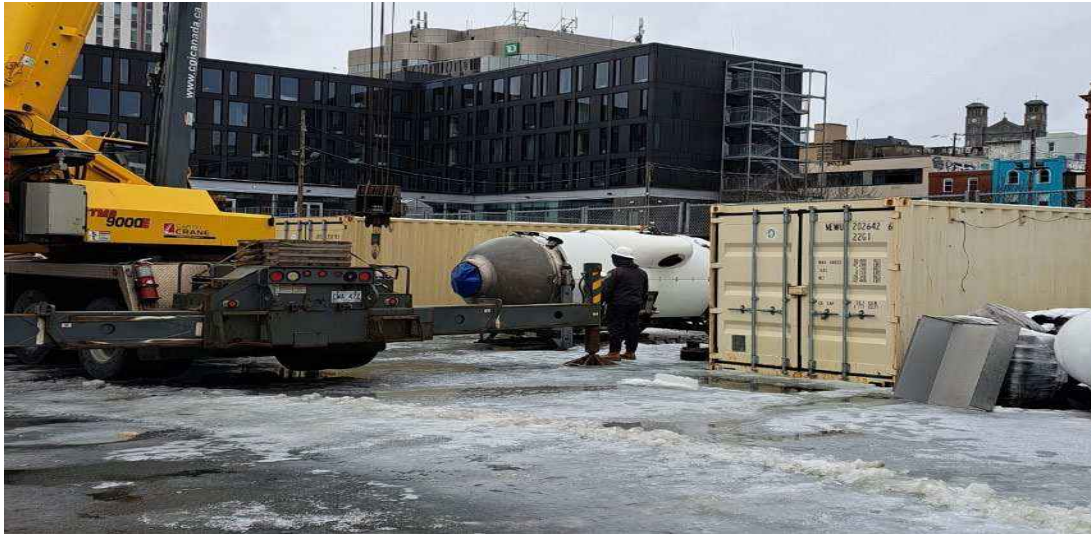
4.35.2. On July 26, 2022, the TITAN, the LARS, and associated equipment were demobilized at the A Harvey Marine Base in St. John's, Canada. The TITAN and its equipment were subsequently placed in the parking lot of the facility for approximately 7 months of storage. The TITAN's equipment was stored in two containers; however, the TITAN was not covered nor provided protection from the environment (see Figure 221).

Figure 221: TITAN being prepped at the A Harvey Marine Base parking lot for transfer to the Marine Institute of Memorial University of Newfoundland on February 6, 2023. Source: Former OceanGate Electrical Engineer.

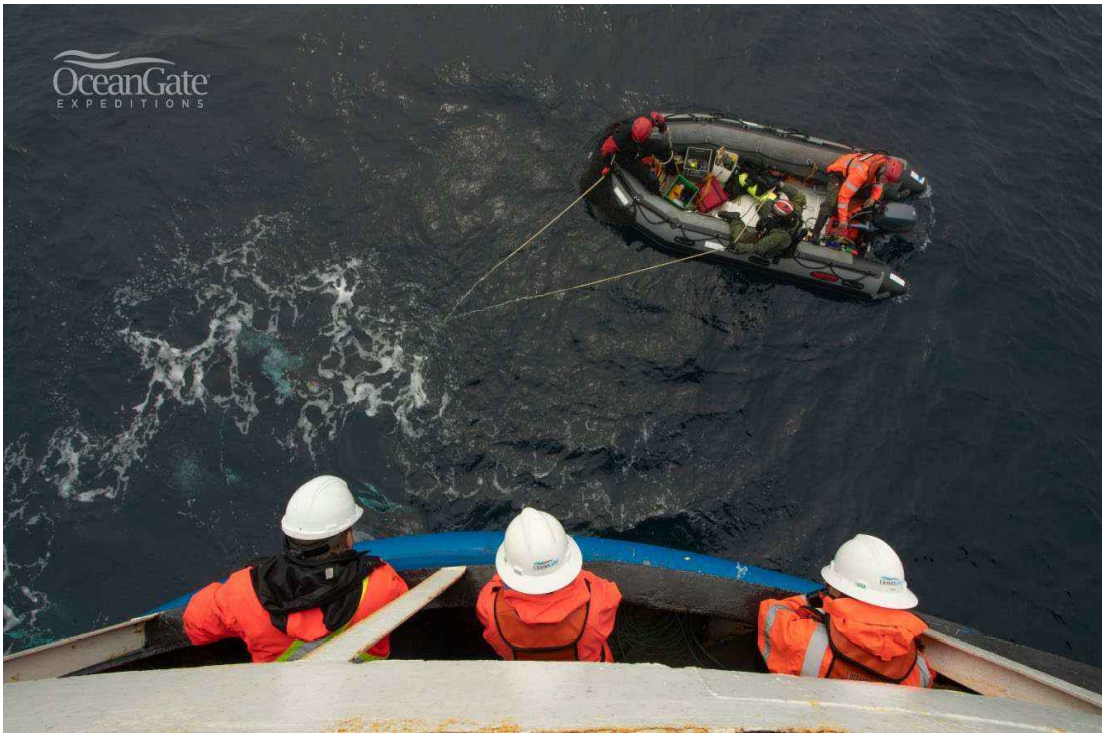
4.38.34. On June 7, 2023, at 1:14 p.m., the POLAR PRINCE departed St. John's for the beginning of Mission 4. The POLAR PRINCE headed west on a course for Sable Island National Park. According to mission specialists on Mission 4, the weather in the vicinity of the TITANIC wreck site was not conducive for dive operations, so the POLAR PRINCE transited to an area with more favorable conditions. Along the way, the towline for the TITAN and LARS became fouled in the POLAR PRINCE's propeller. As a result, the POLAR PRINCE was unable to maneuver and remained adrift for approximately six hours until the towline could be cut out and removed from the propellers by divers.

Figure 244: Overhead view from POLAR PRINCE of divers attempting to remove a towline that had fouled POLAR PRINCE's propeller on June 7, 2023. Source: OceanGate Expeditions.

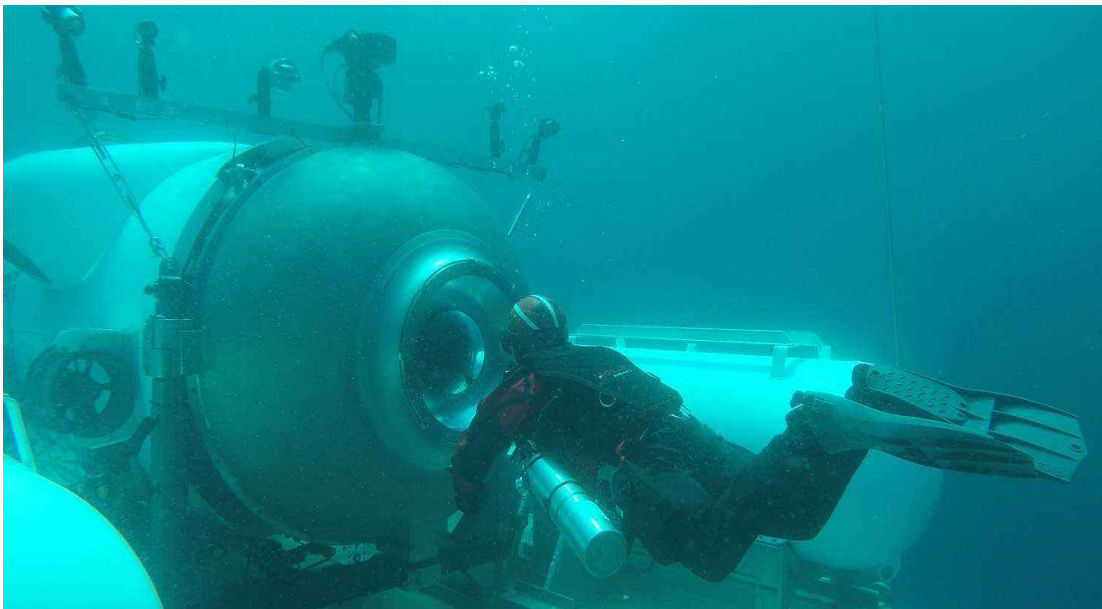
4.38.37. Two mission specialists (a married couple) from Dive 87 stated to the MBI that they were two of the three mission specialists participating in the dive, along with Mr. Rush and OceanGate’s Scientific Director. During a joint MBI interview, the couple explained that the TITAN was 30 feet underwater, preparing to detach from the LARS platform when the final system undergoing a check, the variable ballast system, malfunctioned. After several attempts to resolve the issue, the TITAN’s crew communicated with the support divers via written messages to ask for assistance. The mission specialists used a piece of paper and wrote, “VBT?” before holding it up to the window (see Figure 249) of the dome to communicate with the assist divers. The divers understood that VBT indicated that there was a potential issue with the platform’s variable ballast tanks and the TITAN’s dive support team attempted to troubleshoot the issue. However, after unsuccessful attempts, Mr. Rush (serving as the pilot for the dive) decided to surface, believing the ballast problem would be easy to fix as the surface. The mission specialist recalled to the MBI that Mr. Rush stated, “This should be a really trivial thing to fix, so let’s just surface again. We’re going to fix the variable ballast and then do our dive.”

Figure 249: Image of TITAN support diver receiving written instructions from inside the TITAN during a dive that had to be subsequently aborted due to malfunctions. The dive was designated as Dive 87, the dive prior to the dive that resulted in TITAN’s implosion (Dive 88). Source: OceanGate.

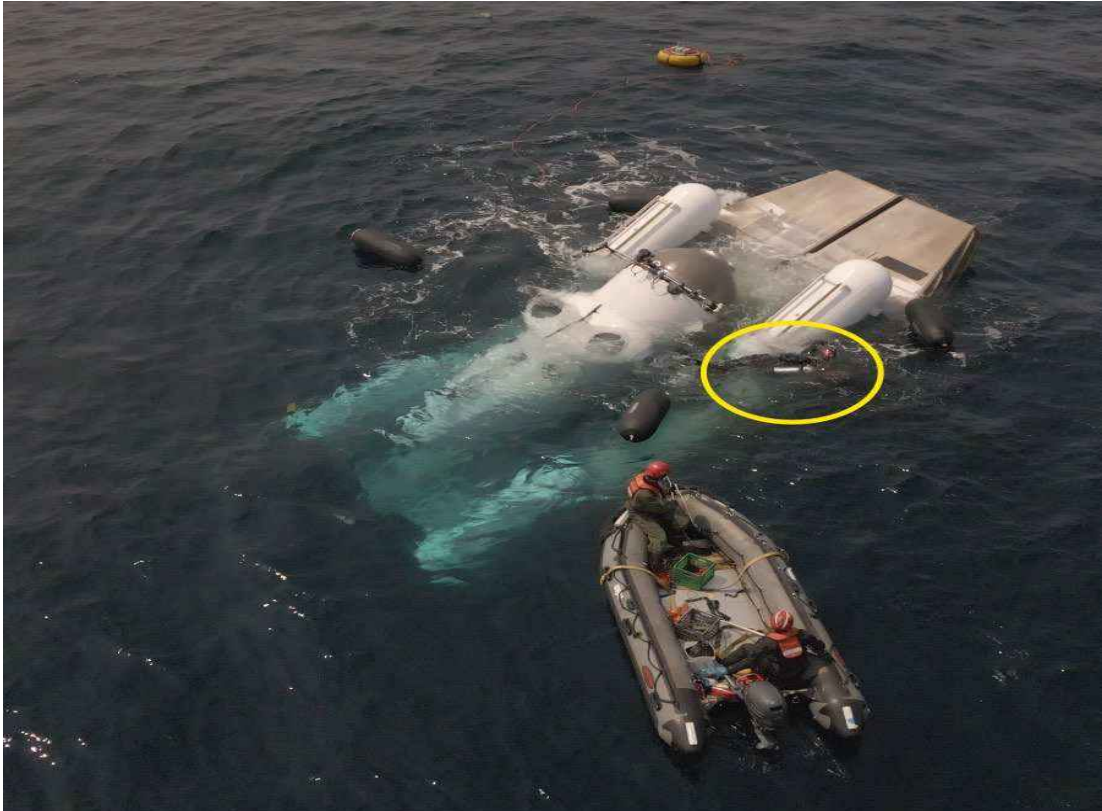
personnel made an error with the platform's ballasting system that caused the TITAN to rise uncontrollably by the bow at a 45-degree angle, with the back of the platform still filled with water. The mission specialist stated, "We were all braced in the front, and suddenly we just flew up into the air. It tossed us like laundry. (The other mission specialist) was upside down. We ended up going up at a 45-degree angle and then slammed back down violently. I was holding onto the handle, but it was a rough ride." The mission specialists confirmed that the TITAN's bow was not properly secured to the LARS and that the stern remained hinged to it. As a result, the TITAN's bow was continuously lifted off the platform by passing swells, which would subsequently cause the TITAN's bow to repeatedly slam back down to the metal platform.

Figure 250: Overhead view of OceanGate surface support personnel and divers attempting to fix a ballast system malfunction on the LARS platform during Dive 87. The yellow circle, added by the MBI, marks a diver in the water. Source: OceanGate.

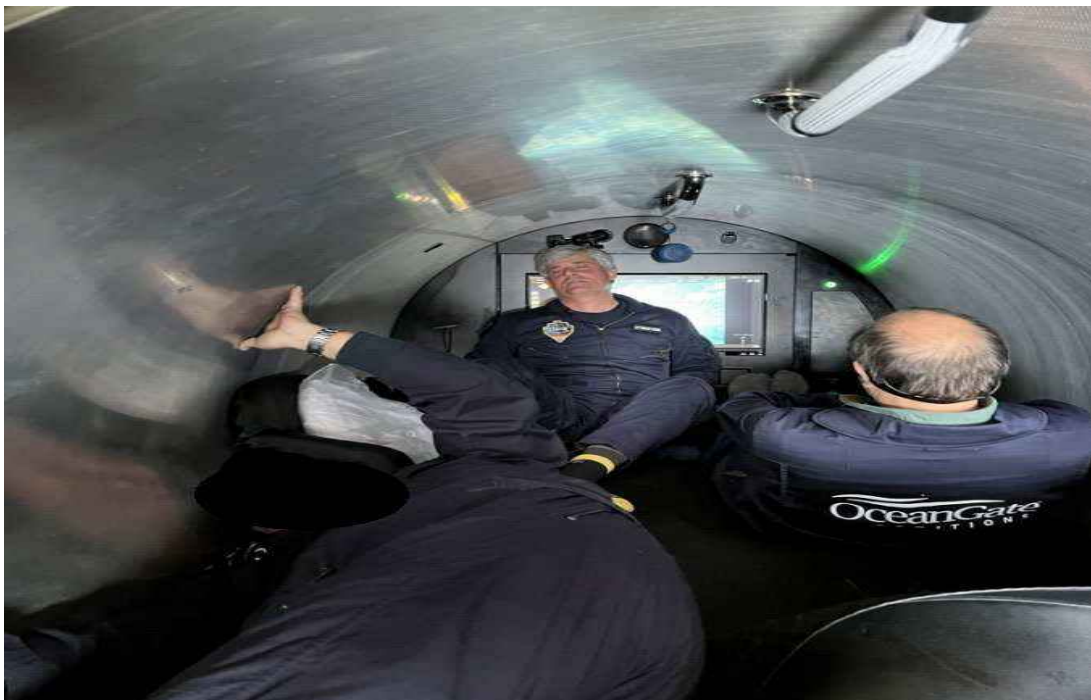
Figure 251: Inside of TITAN during Dive 87 incident. Photo taken from the forward dome area looking aft and down. Mr. Rush is sitting against the back wall, the dive’s Chief Scientist is standing on the back wall, and a mission specialist in the front left is positioned upside-down. Source: Former OceanGate mission specialist.

4.38.41.1. The Chief Scientist described the situation (see Figure 251) to the MBI by stating, "There's nothing to hold on to inside the submersible, it's just a fairly smooth tube. The pilot crashed into the rear bulkhead, and the rest of the passengers tumbled about. I ended up standing on the rear bulkhead, one passenger was hanging upside down, and the other two managed to wedge themselves into the bow end cap."

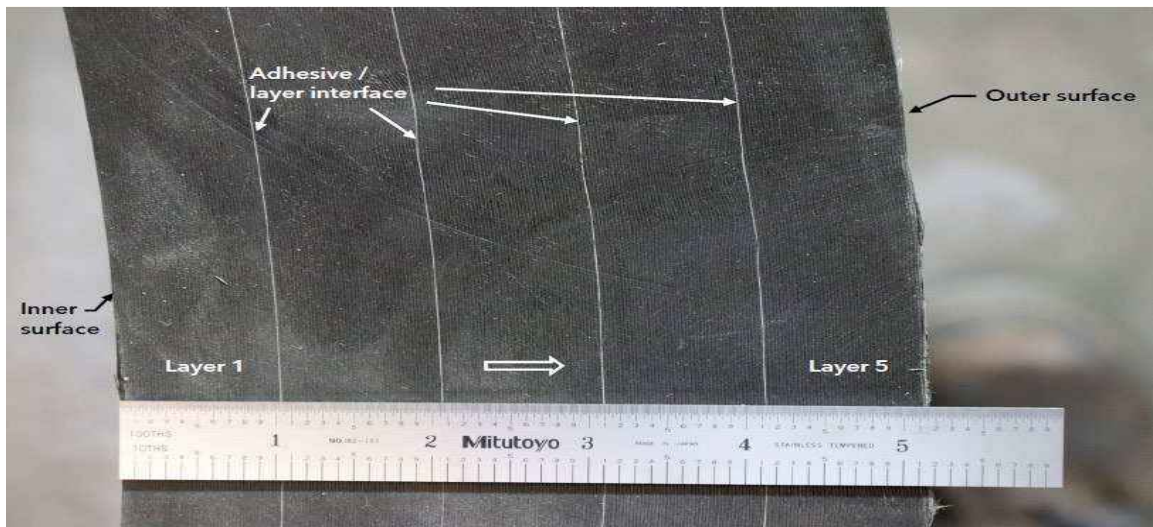
In a post-casualty assessment, the cut-off ends (left over from the fabrication of the main carbon fiber cylinder) of the final TITAN's carbon fiber pressure hull were analyzed and material testing was conducted. According to the report completed by NTSB⁵⁰, the hull was constructed using unidirectional, filament-wound carbon fiber pre-impregnated with epoxy resin. The build sequence involved layering two cylindrical plies under tension, followed by one longitudinal ply without tension, repeated until the target number of plies was reached. The winding direction and bias alternated with each cylindrical ply, resulting in a helical pattern. The final structure consisted of 133 plies, with intermediate debulking steps. The calculated hull thickness was approximately 5.02 inches, based on material specifications, while the average thickness of the trimmed ends measured around 5.16 inches. The discrepancy between the main hull and the trimmed ends was likely caused by excessive adhesive, voids, and wrinkles in the carbon fiber.

Figure 255: TITAN cut off ends cross section through the hull wall showing the co-bonded layered structure. Source: NTSB Materials Laboratory Factual Report.

Additionally, the NTSB report noted that voids were observed in the adhesive due to fiber bridging or tenting at one or both sides of smaller amplitude wrinkles. Other wrinkles exhibited signs of grinding, suggesting that OceanGate sanded down the wrinkled regions on each carbon fiber layer to be flush with the outer surface. As detailed in the NTSB report, as many as 12 ground layers of carbon fiber were observed in a sample sent to the NTSB lab for analysis. One of the cut-off ends was thoroughly examined to identify the number of fiber bridging/tenting and grinding features in each layer. The findings are summarized in the Figure 256 with Layer 1 being the inner hull. The anomalies identified were consistently present across all quadrants of TITAN's hull. In several cases, the NTSB noted that the presence of a ground out wrinkle or fiber bridge in one layer led to the formation of another bridge or wrinkle in the adjacent layer above.

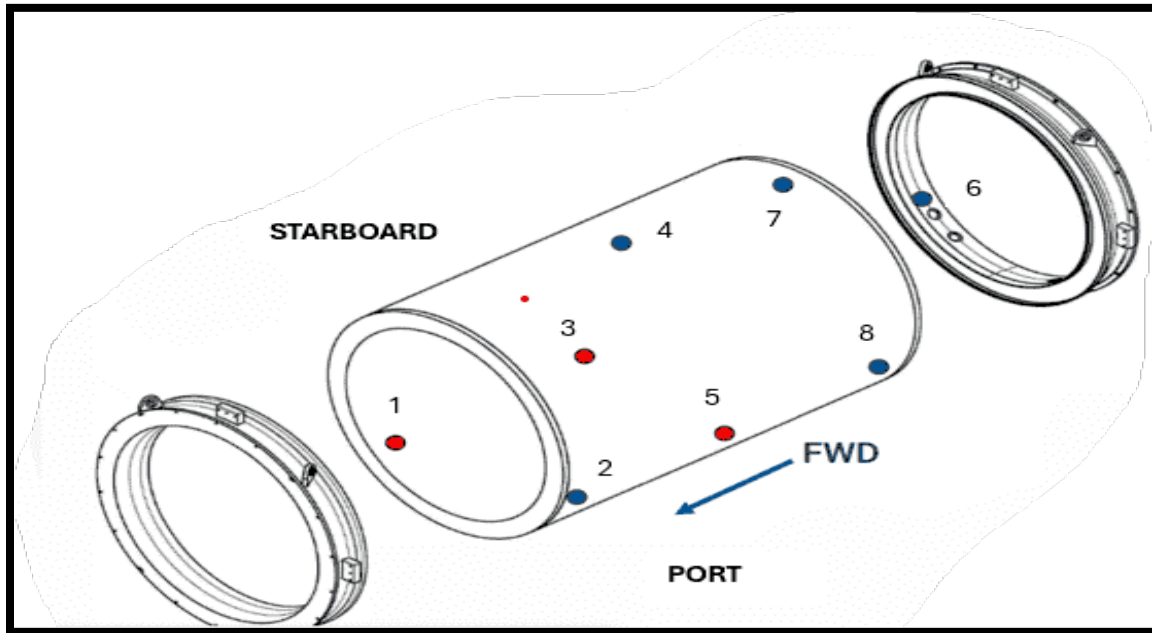
of the acoustic sensors are shown below. Channels 1, 3, and 5 are shown in red because they were confirmed by the MBI to be inoperable for the entire 2022 TITANIC Expedition and most likely remained inoperable for the duration of the 2023 Expedition.

Figure 259: Titan's AE sensor location. Source: USCG.

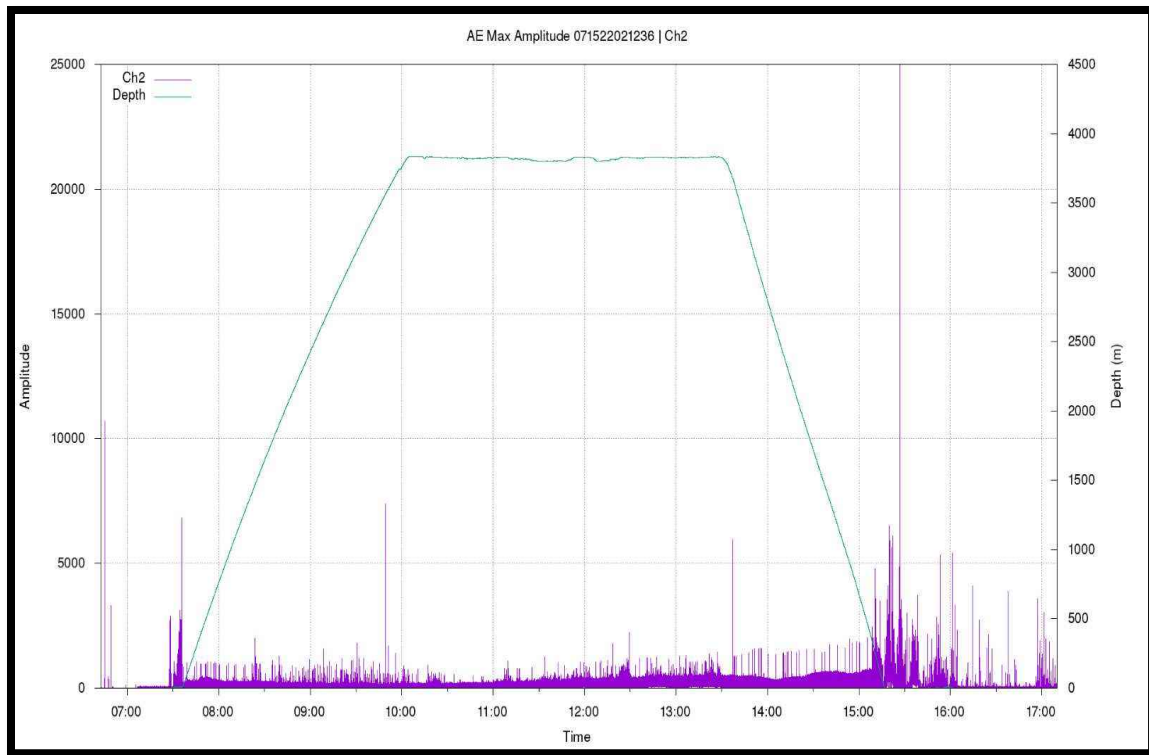
At 3:26:45 p.m., the TITAN's RTM system recorded a major acoustic emission event that included the following significant readings: AE Channel 2 peaked at 25,687 mV, AE Channel 4 at 25,589 mV, AE Channel 6 at 18,131 mV, AE Channel 7 (3.75 in from aft segment 0° / top dead center, aft) at 25,369 mV, and AE Channel 8 (3.75 inch from aft segment - 110° CCW from top / aft port) at 18,966 mV. In contrast, AE Channel 1 (3.75 inch from forward segment - 110° CW from top / forward starboard), AE Channel 3 (mid span - 110° CW from top / middle starboard), and AE Channel 5 (mid span - 110° CCW from top / middle port) registered amplitudes below 250 mV, indicating that those AE sensors were inoperable. This major acoustic emission is clearly visible on the acoustic emissions plot for AE Channel 2 shown in Figure 260.

Figure 260: Dive 80 TITAN RTM System AE Channel 2 Plot. The units for the amplitude of the acoustic emission are millivolts (mV). The blue line indicates the depth of TITAN in meters (m) over the duration of the dive. Source: OceanGate.

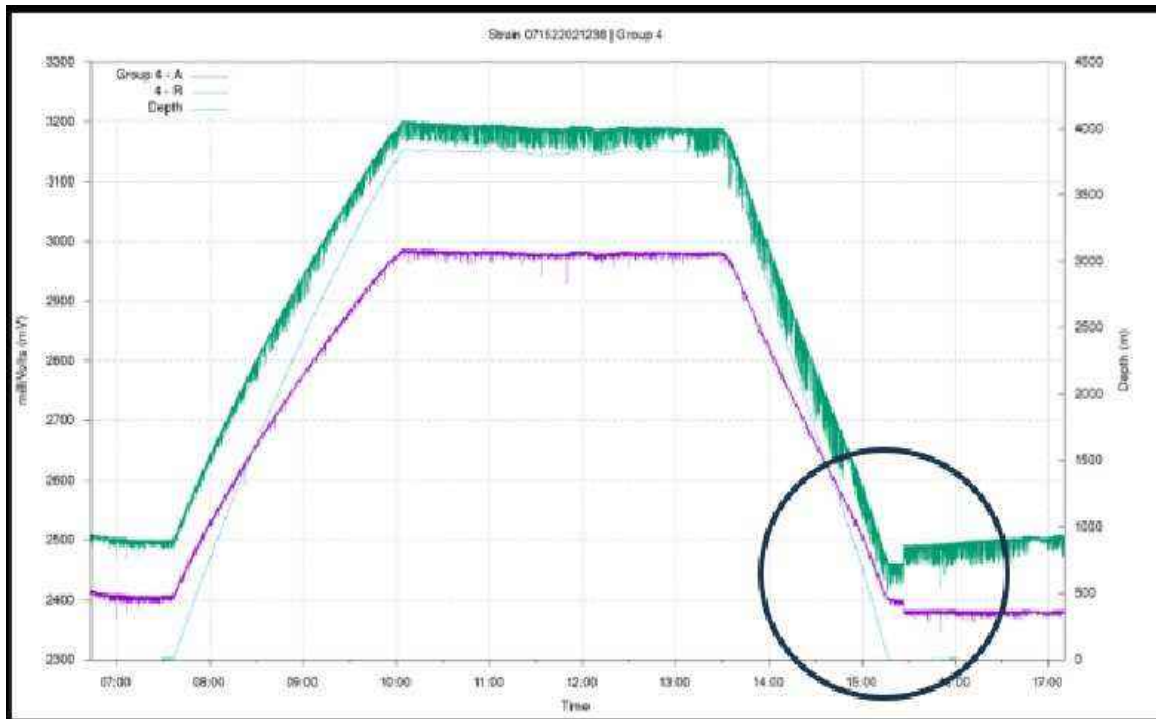
At the same time as the RTM system was recording the significant acoustic emissions - 3:26:45 p.m. - the strain readings for Group 4, which were co-located with acoustic emission sensors for AE Channel 2 showed abrupt changes. The TITAN's hoop strain⁵³ (green line, labeled "R" in Figure 261), increased by 15.62 mV. The longitudinal strain⁵⁴ (purple line, labeled "A") decreased by 30.5 mV. This abrupt change is clearly visible in the plot of TITAN's Dive 80 strain gauge data displayed in Figure 261.

Figure 261: Dive 80 Strain gauge group 4 plot. Source: OceanGate.
