UNITED STATES COAST GUARD

**REPORT OF THE MARINE BOARD OF INVESTIGATION
INTO THE
IMPLOSION OF THE SUBMERSIBLE TITAN
(CG 1788361) IN THE NORTH ATLANTIC OCEAN
NEAR THE WRECK SITE OF THE RMS TITANIC
RESULTING IN THE LOSS OF FIVE LIVES
ON JUNE 18, 2023**

MISLE ACTIVITY NUMBER: 7724663

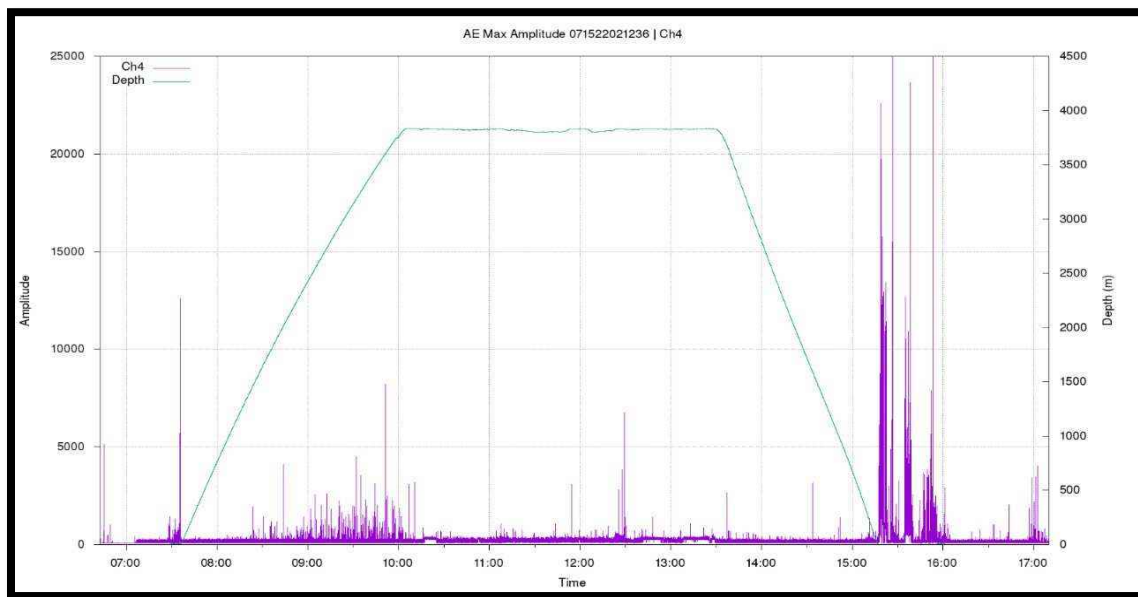
The major acoustic emission at 3:26:45 p.m. was also visible in the AE Channel 4 plot, as shown below.

Figure 262: Dive 80 AE Channel 4 Plot. Source: OceanGate.

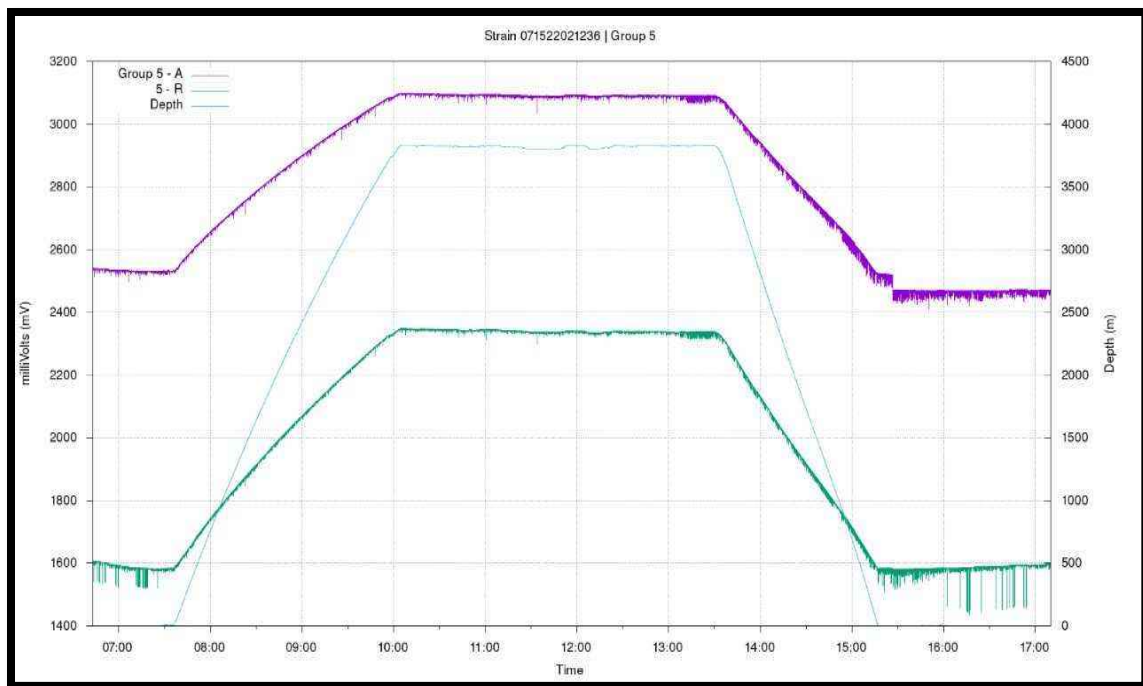
Similar to the strain readings in Group 4, the strain gauges in Group 5, co-located with the AE Channel 4 sensor, recorded shifts in strain. The hoop strain (green line, labeled “R”) increased by 49.12 mV and the longitudinal strain (purple line, labeled “A”) increased by 4.5 mV in Figure 263.

Figure 263: Dive 80 Strain Gauge Group 5 Plot. Source: OceanGate.

These shifts in strain for TITAN's hoop and longitudinal strain in both Group 4 and Group 5 occurred in a fraction of a second and coincided with the large amplitude acoustic event on Dive 80 at 3:26:45 p.m.

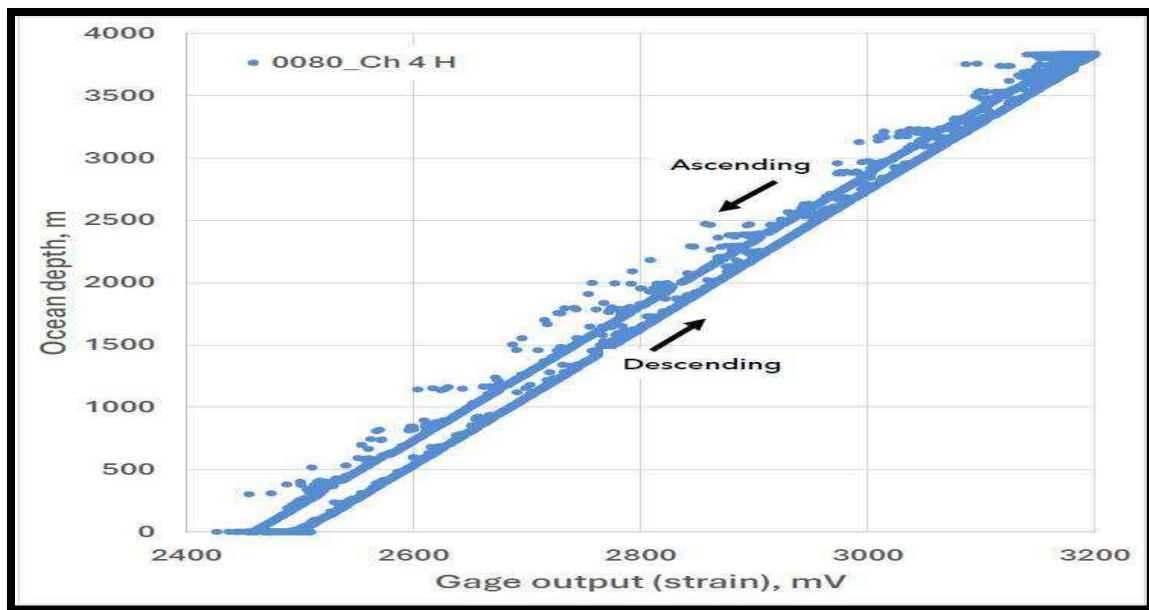
For the remaining TITAN dives that occurred after Dive 80's large amplitude event, changes were observed in the strain response of the hull, as noted in the NTSB's report (Appendix B and C). Figure 264 shows the variation in hoop strain gauge output with ocean depth for Group 4 on Dive 80. This was prior to the audible event that was heard by personnel in the TITAN and by support personnel at the surface in a small boat. The audible event occurred as the TITAN was still submerged and approaching the surface. The strain gauge output is plotted on the horizontal axis and ocean depth is plotted on the vertical axis. Because of the strain reduction at depth, the ascent curve is at a lower strain value than the descent curve. Both descending and ascending curves appeared to be linear in Figure 264.

Figure 264: Plot of dive depth as a function of strain gauge output for TITAN's Dive 80 – Gauge Group 4 – hoop strain gauge. Source: NTSB Materials Laboratory Factual Report.

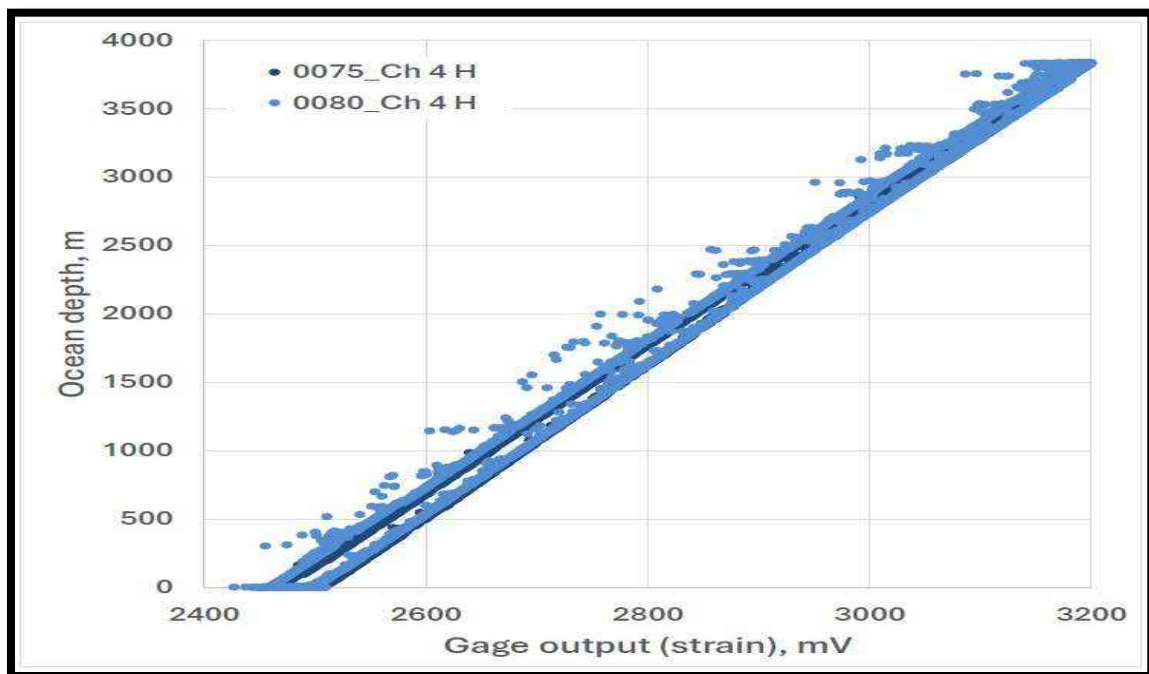
Figure 265 is a comparison between Dive 80 (light blue) and Dive 75 (dark blue). Both dives showed the same linear response (as did Dives 76 and 79, which are not shown).

Figure 265: Plot of dive depth as a function of strain gauge output for Dives 75 and 80 – Gauge Group 4 – hoop strain gauge. Source: NTSB Materials Laboratory Factual Report.

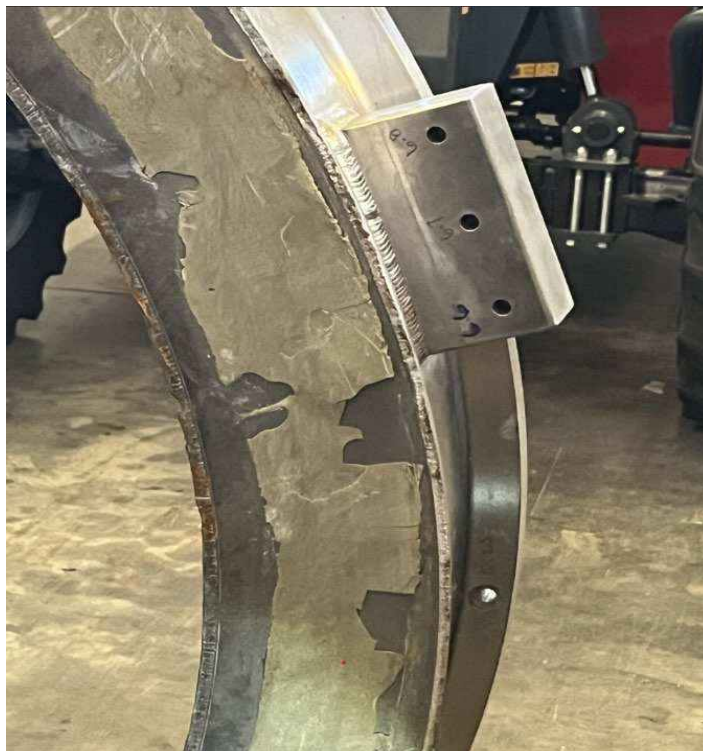
Examination of the recovered TITAN debris revealed that the adhesive used to bond the hull to the titanium segments had disbonded from the entire forward segment. The adhesive was mostly disbonded from the aft segment, except for an approximately 90-degree arc located at and centered approximately about the top of the submersible, shown in Figures 268 and 269. The adhesive contained an imprint of the machined edge of the carbon fiber hull near the outer surface, while the inner surface showed a rubbed appearance beginning near the base of layer 4 and extending radially inward as shown in Figure 269. Additionally, an imprint of one of the spacers were present.

Figure 268: Aft segment with remaining adhesive. Source: USCG.
