## Engineering Success and Disaster: American Railroad Bridges, 1840–1900

By Mark Aldrich

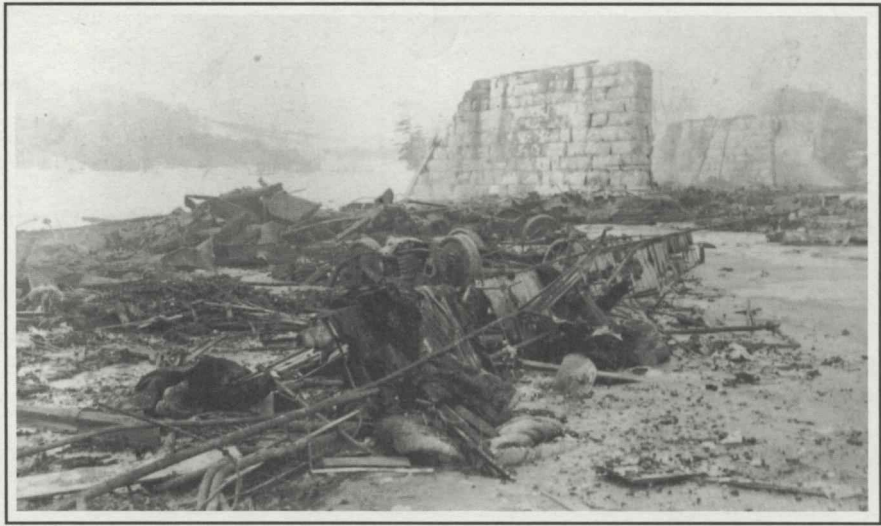
**Fig. 7—**What remained of the Woodstock bridge after the wreck of February 5, 1887. Engineers disagreed whether or not this constituted a bridge failure, because the accident resulted from a derailment and the bridge burned as a consequence. Yet, an adequately guarded bridge would probably have averted the tragedy. (Courtesy Vermont Historical Society)

The usual results of an accident with such flooring were nicely illustrated on Saturday, February 5, 1887, on the Woodstock bridge, near White River Junction, Vermont. The Central Vermont's Boston–Montreal express apparently hit a broken rail and derailed about 450 feet before the bridge, which was a deck truss. The last three cars pitched over the edge, falling about 42 feet to the ice below where one of the car stoves set them ablaze, incinerating 29 victims, injuring many more, and burning the bridge down (Fig. 7).

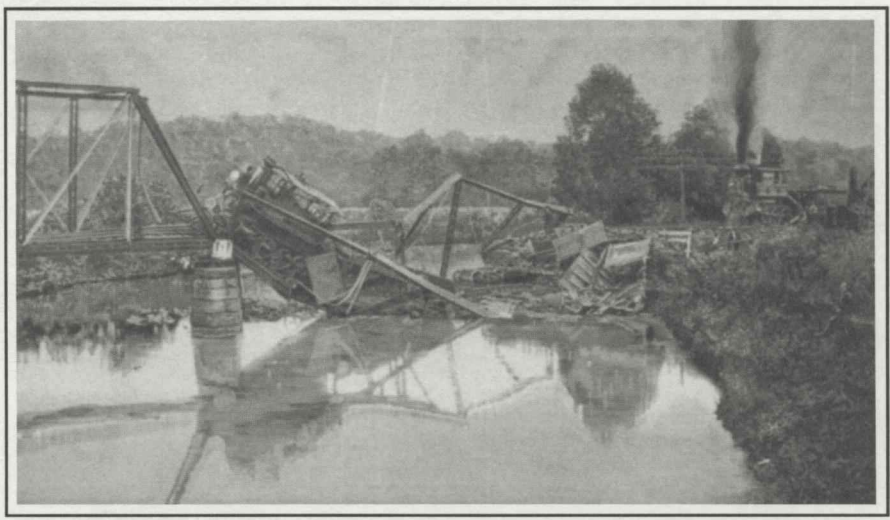
**Fig. 10**—When a B&O locomotive hit a cow on this pin-connected bridge on April 30, 1887, throwing her into the truss, the bridge collapsed.

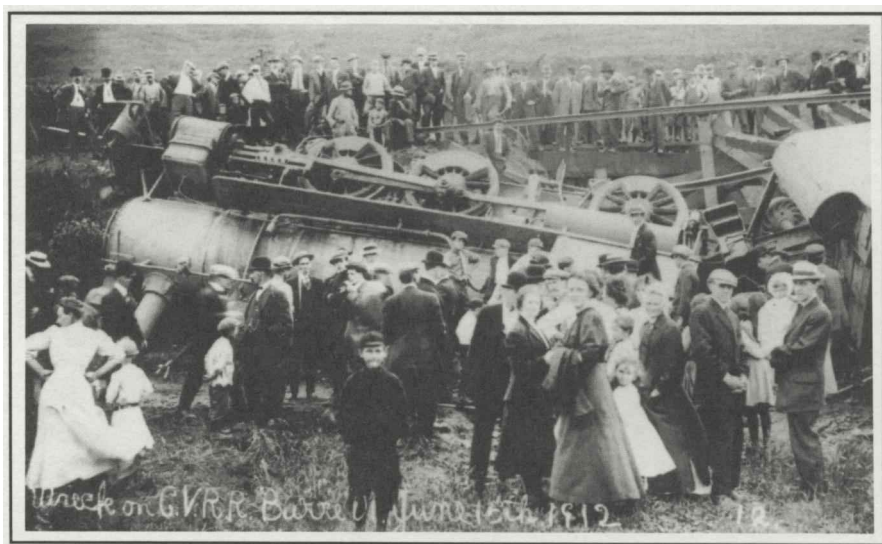
**Fig. 12**—Although bridge failures continued to plague railroad travel early in this century, their number declined. This 1912 collapse of an old wooden bridge killed at least one man. (Courtesy Vermont Historical Society)

Beginning in the 1890s, these efforts contained the problem of bridge failures. Many companies described instances of derailments that did not become disasters due to improvements in floors and trusses, but the only available statistical evidence derives from the *Railroad Gazette*'s compilation, for the Interstate Commerce Commission accident statistics did not allow separate tabulation of bridge failures. The *Gazette*'s data, while providing an undercount, can be used to spot trends. They reveal an annual average of twenty-four bridge accidents during the five years between 1873 and 1877, rising to thirty-eight per year in the half decade 1888–1892, and then declining to twenty-five from 1896 to 1900, even as the number of train miles and bridges was sharply increasing. In this century these trends continued, and bridge disasters slowly faded from public consciousness (Fig. 12).
